REPORT DOCUMENTATION PAGE		READ INSTRUCTIONS BEFORE COMPLETING FORM
1. REPORT NUMBER	2. GOVT ACCESSION NO. AD-A091139	3. RECIPIENT'S CATALOG NUMBER
4. TITLE (and Subtitle) Phase I Inspection Report Loon Lake Dam Upper Hudson River Basin, Warrent County, New York Inventory No 795		5. TYPE OF REPORT & PERIOD COVERED Phase I Inspection Report National Dam Safety Program

UPPER HUDSON RIVER BASIN

LOON LAKE DAM

PHASE I INSPECTION REPORT
NATIONAL DAM SAFETY PROGRAM
NAME OF DAM - LOON LAKE DAM ID# - NY 795

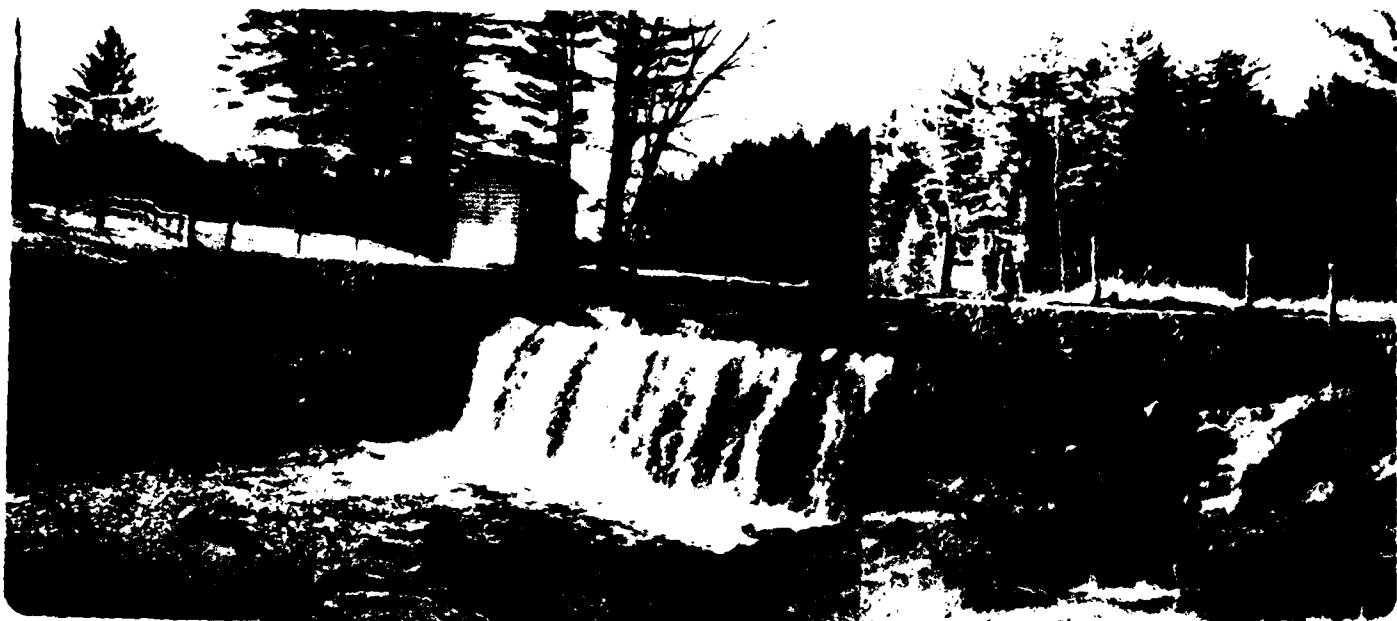
1. Loon Lake Dam as viewed from
New York State Route 8 and 9.
Auxiliary Dam is visible in
background.

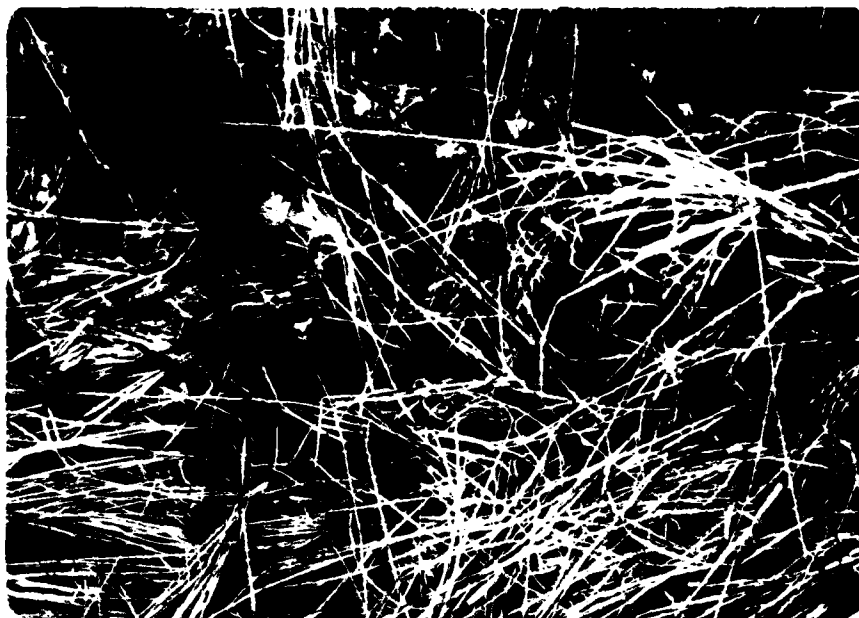
3. Area of minor seepage near west abutment.

The visual inspection revealed that the dam is generally in good condition with only minor surface spalling of the concrete surfaces. The sluice gate structure is in operating condition and was generally in good structural condition. The minor seepage near the west abutment appears to have been the remains of an effort to seal what was described as substantial leakage in this area in 1977. Continual surveillance should be maintained at this point of seepage to detect any worsening of the present condition. Appropriate steps should be taken to seal off the seepage, should the condition worsen.

The field observations for the present study indicate the dam and the abutments are founded in a glacial boulder till. Exposures of such material are seen nearby downstream of the dam. A till of this type is usually relatively impermeable. However, a minor seep is present

The available information limits evaluation of the factors which could affect the westerly and easterly dam/abutment sections of this structure. The source of the seepage noted at the dam's westerly end requires further investigation. The lack of information extends to the as-built properties of the older, original masonry section comprising the upstream portion of the existing spillway; this section may penetrate to a greater depth than indicated by present available information (and as used in the stability analysis for the present study). A deeper section would increase the spillway's resistance to sliding and overturning and would affect the underdam seepage and uplift.

1. Seepage near the west abutment of the dam should be kept under close surveillance to detect any increase in flow. Immediate repair measures should be undertaken in the event that seepage increases.

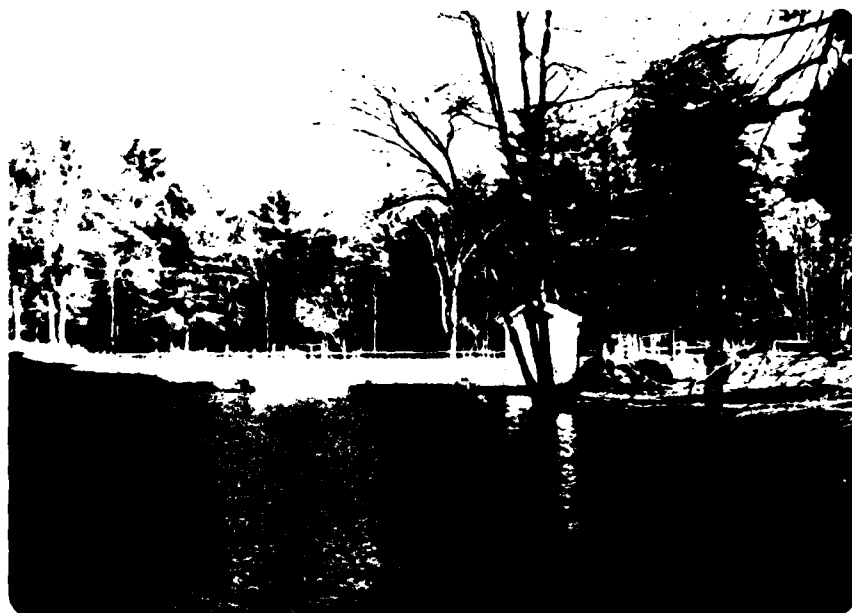
6. View of Dam from upstream.
New York State Route 8 and 9
visible in background.

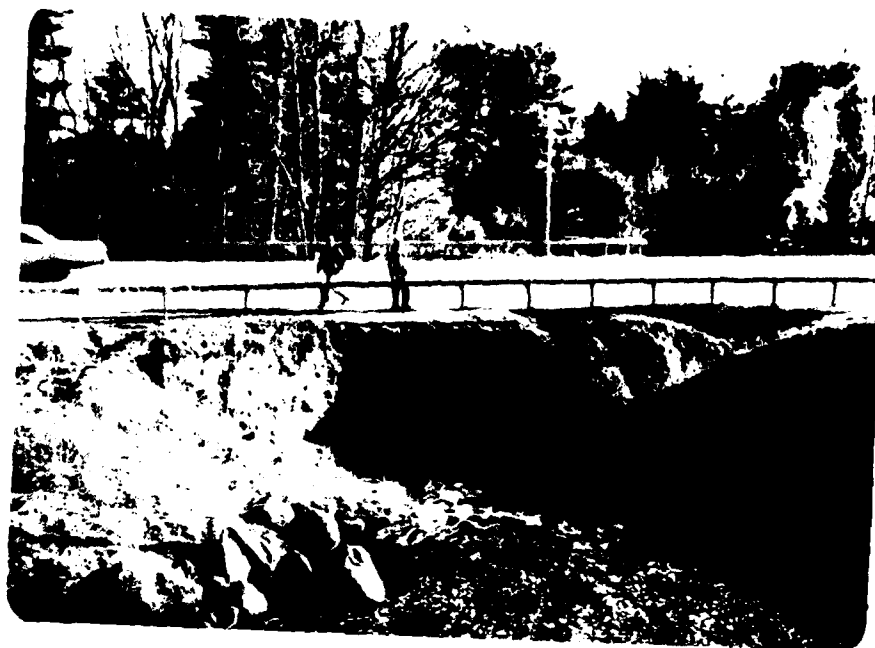
7. Receiving stream showing
bridge at New York State
Route 8 and 9.

The downstream channel is formed in sand and gravel and passes through a concrete box culvert (see photograph No. 7) approximately 100 feet downstream from the dam. New York State Route 8 and 9 crosses the receiving stream at this point. This highway is a major traffic route through the area. Downstream from the highway culvert, the channel is heavily overgrown with willows and alders. No evidence of recent erosion was noted in the channel.

The box culvert just downstream of the dam acts as a flow restriction under high flows. Analysis based on the limited information obtained for this study indicate that the dam will be submerged under the 1/2 PMF and PMF events due to this downstream construction. This condition would result in somewhat lower discharge capacities for the spillway under high flows than indicated here.

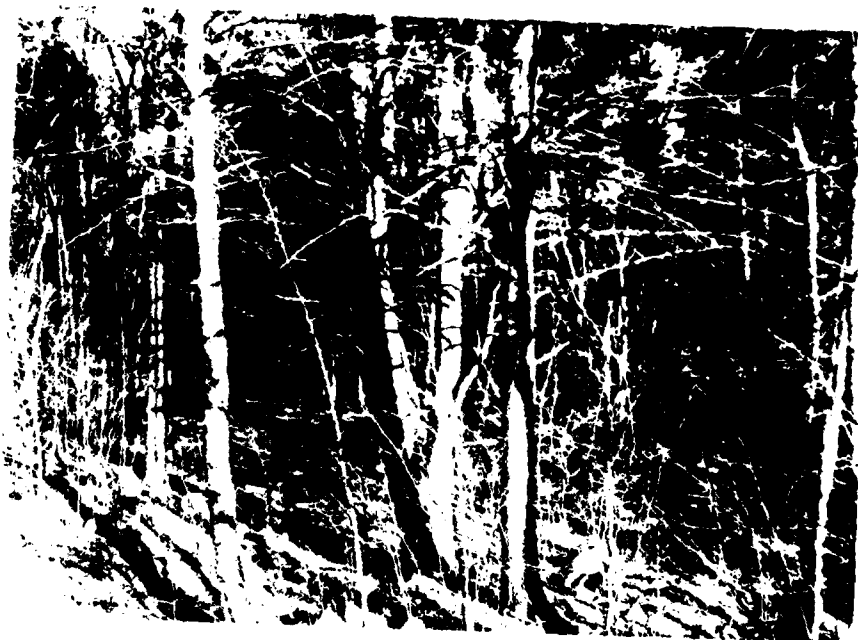
8. Receiving stream below
bridge at New York State
Route 8 and 9.

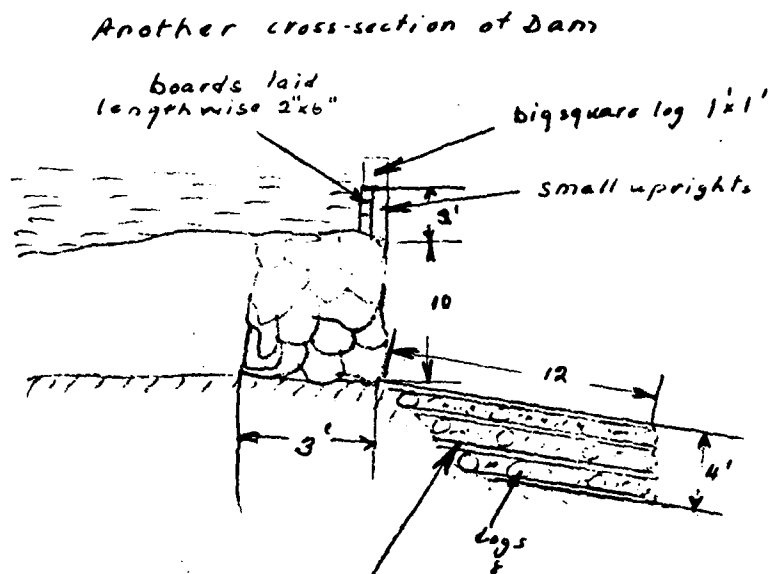
This is spillway. It consists of flat boards nailed next to each other to logs laid cross-wise. The boards are most all washed away and the logs are rotted.

There is no abutment. Natural rock embankment prevents water from flowing.

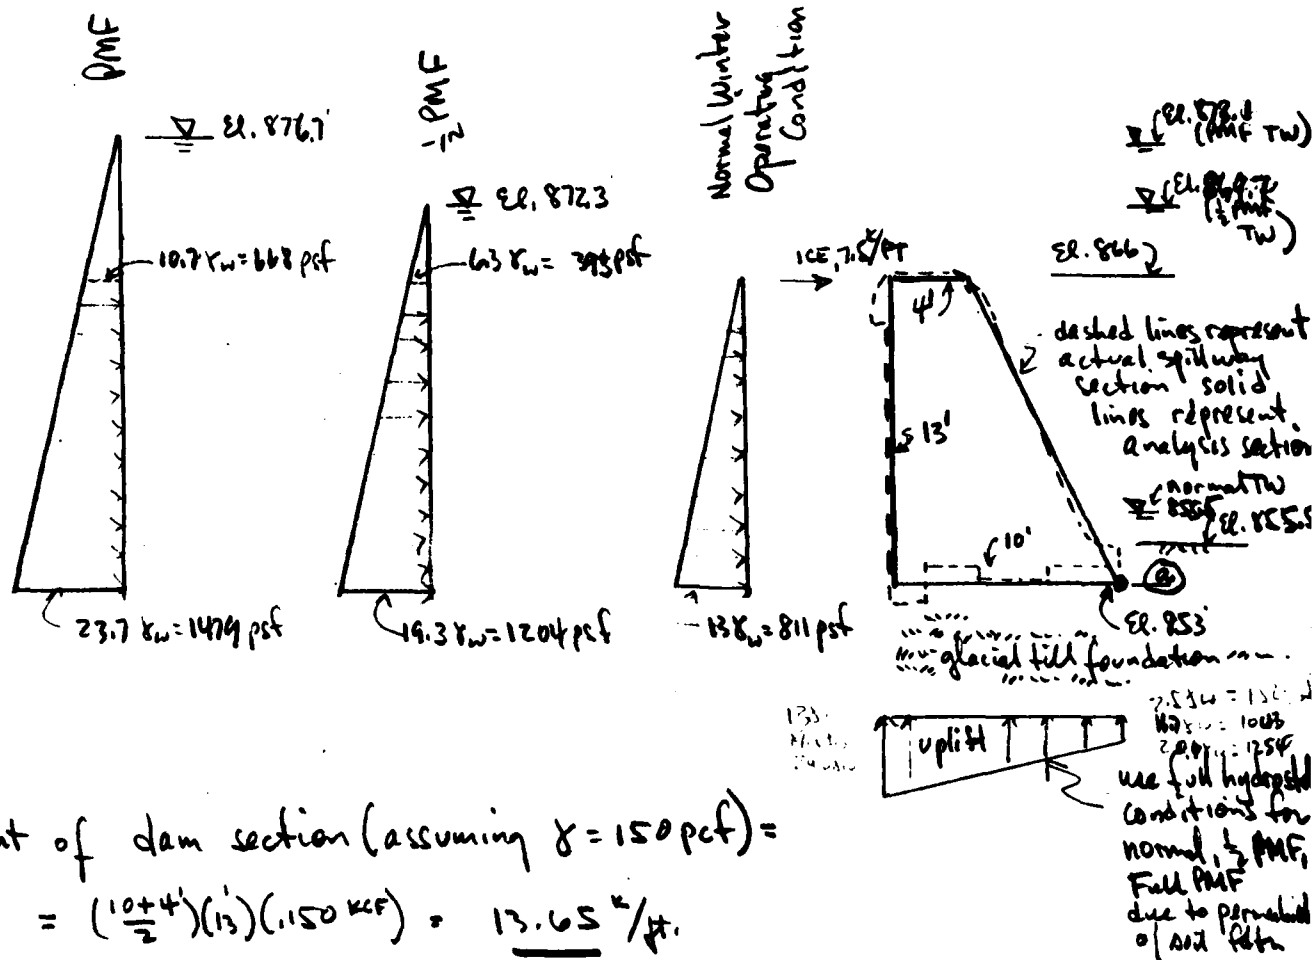
Assumed Dam Section and Loading Conditions

The analysis indicate unsatisfactory stability against overturning and sliding for the dam subject to forces possible during normal winter operations which include ice loading, according to Corps of Engineers' evaluation criteria, (i.e., factor of safety less than unity, and, where the resultant of forces acting on the dam is located outside of the middle-third of the base, tensile stresses would develop in the dam section, a condition which is structurally undesirable).

Critical to the analysis for cases indicating instability is the item of uplift water pressure acting on the base of the dam. For each case analysed, the uplift force was based on a full headwater hydrostatic pressure acting on the dam's upstream corner and a full tailwater hydrostatic pressure acting at the dam's downstream corner. Uplift pressures were assumed to vary linearly between the dam's upstream and downstream corners, and act upon 100 percent of the dam base. It is possible the site's glacial till foundation is relatively impermeable and full uplift as assumed might not act, particularly for the 1/2 PMF and PMF case because of the relatively short time period that the condition would exist.
