SPRUCE RESERVOIR

NDI I.D. PA-00587

PHASE I INSPECTION REPORT
NATIONAL DAM INSPECTION PROGRAM

D'APPOLONIA CONSULTING ENGINEERS
10 DUFF ROAD
PITTSBURGH, PA. 15235

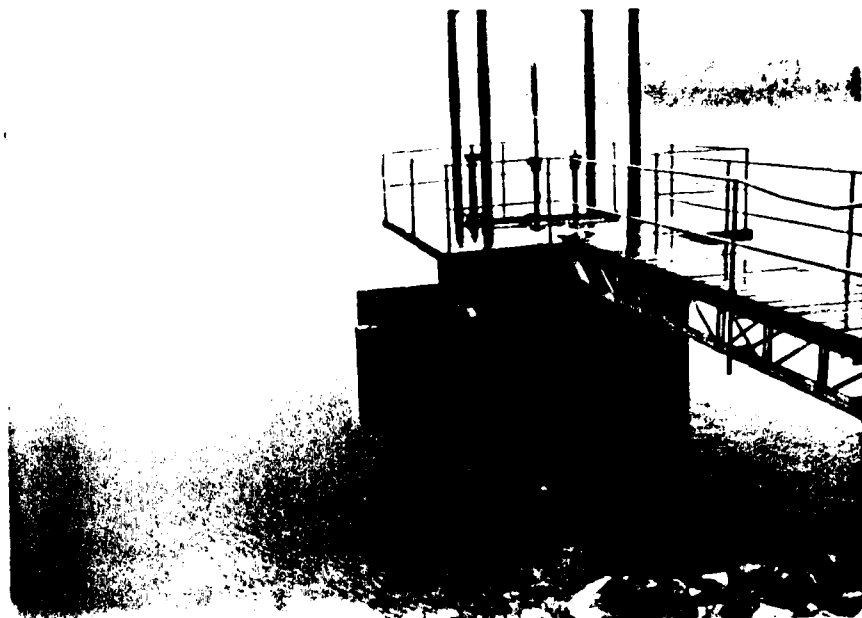
Photograph No. 5
Reservoir outlet structure.
