DELAWARE RIVER BASIN
TRIBUTARY TO LITTLE NESHAMINY CREEK, BUCKS COUNTY
PENNSYLVANIA
NDS ID PA. 01066
DER ID 9-176

WARRINGTON TOWNSHIP
RETENTION BASIN

PHASE I INSPECTION REPORT
NATIONAL DAM INSPECTION PROGRAM

✓ WOODWARD-CLYDE CONSULTANTS
5120 Butler Pike
Plymouth Meeting, Pennsylvania 19462

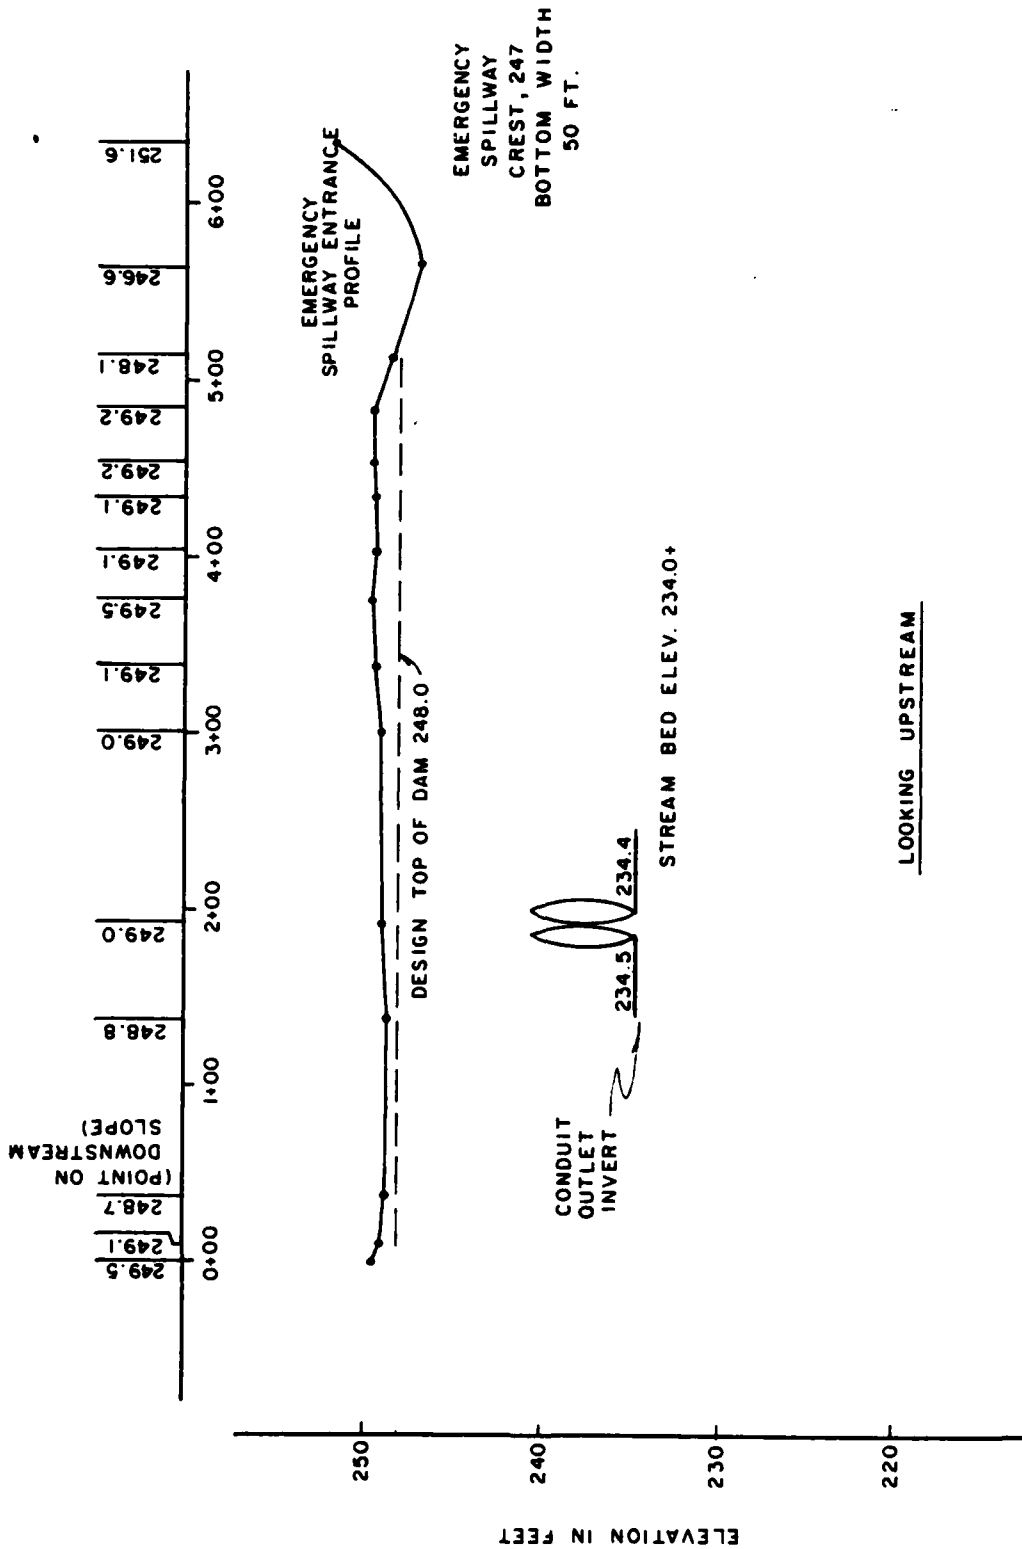
FIELD OBSERVATION PROFILE
 WARRINGTON TOWNSHIP DAM
 SHEET 5B OF 11

<u>VISUAL EXAMINATION OF</u>	<u>OBSERVATIONS</u>	<u>REMARKS OR RECOMMENDATIONS</u>
SURFACE CRACKS	<i>None observed.</i>	
UNUSUAL MOVEMENT OR CRACKING AT OR BEYOND THE TOE	<i>None observed.</i>	
SLOUGHING OR EROSION OF EMBANKMENT AND ABUTMENT SLOPES		<i>Little or no erosion has occurred on downstream face. Upstream face along water line has been damaged by foot traffic.</i>
VERTICAL AND HORIZONTAL ALIGNMENT OF THE CREST		<i>See Sheet 5B of 11.</i>
RIPRAP FAILURES		<i>No riprap.</i>

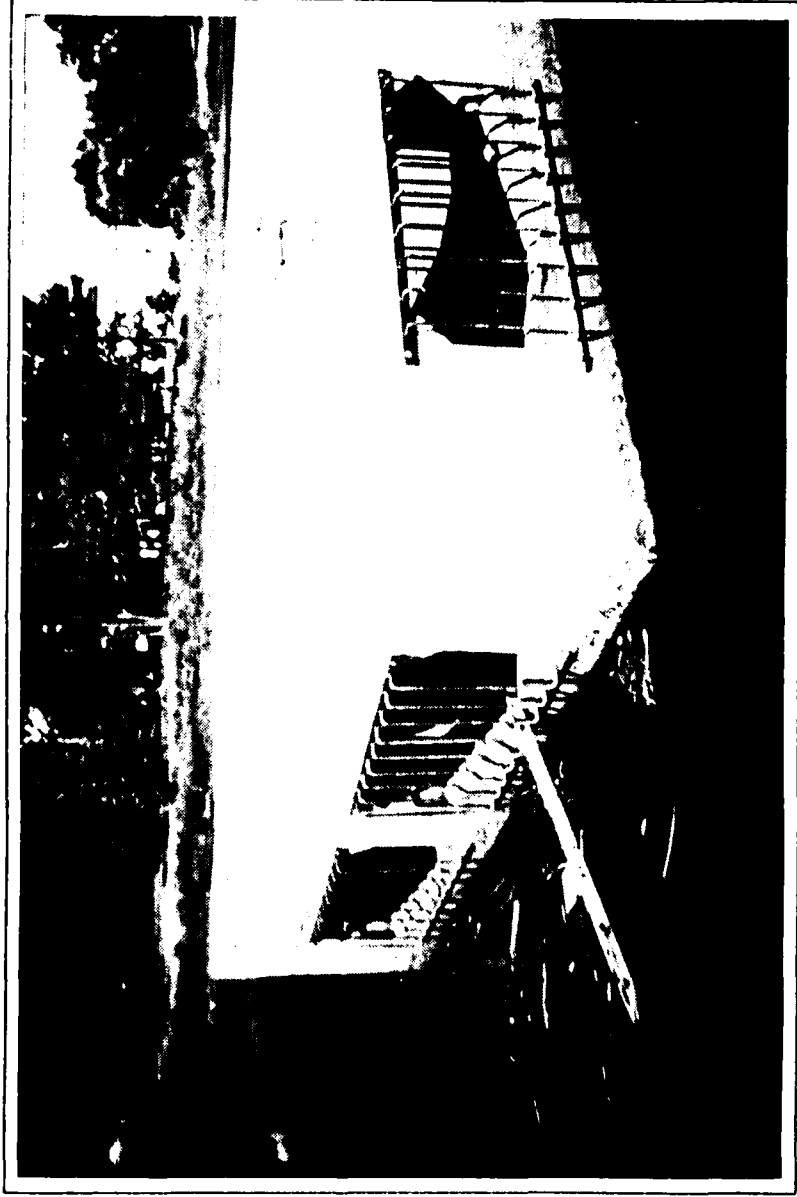
1. Principal Spillway. As shown on the plates, the riser box is located at the upstream toe of the embankment. The exterior portion of the riser above the waterline and the interior of the riser were inspected and found to be in good condition with no signs of excessive concrete deterioration, spalling or other structural deficiency or defects. There was some seepage through one riser wall with leachate deposits. The access hatch lid is missing from the top of the riser. As-built drawings indicate a gate valve stem extending through the top of the riser, permitting the gate valve to be operated from the top of the riser. There is no valve stem and

RISER WITH INSIDE DIMENSIONS OF
8 FEET BY 14.7 FEET.
