LAKE RENEE DAM

Number
(NDS ID NO) PA-732

PHASE I INSPECTION REPORT, NATIONAL DAM INSPECTION PROGRAM

SEPTEMBER, 1980

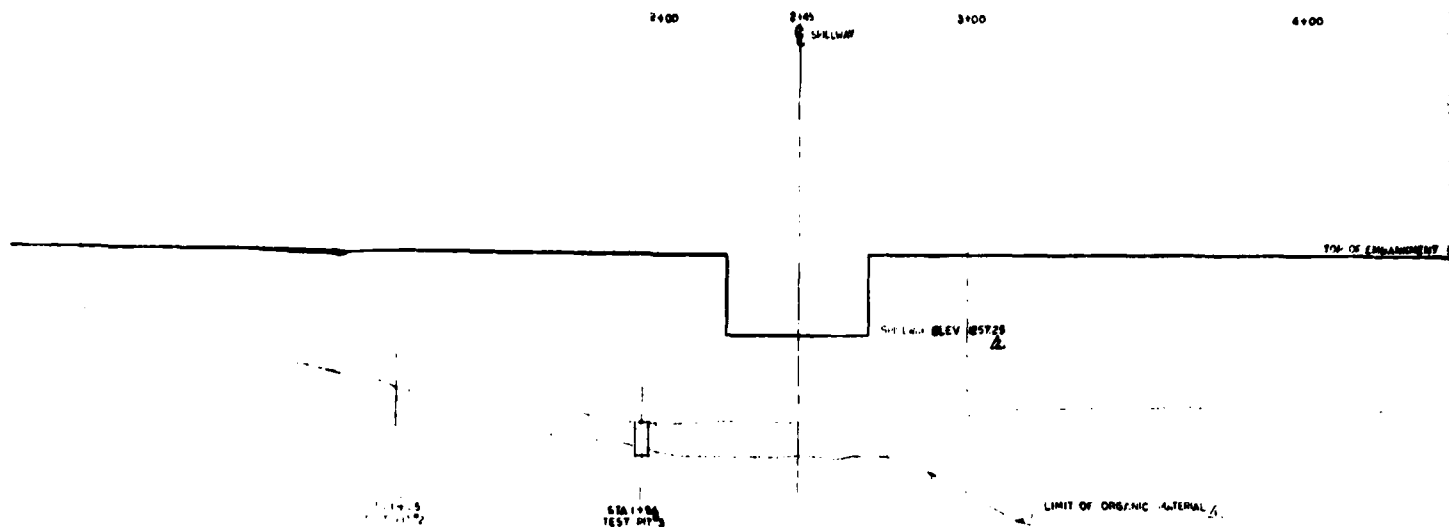
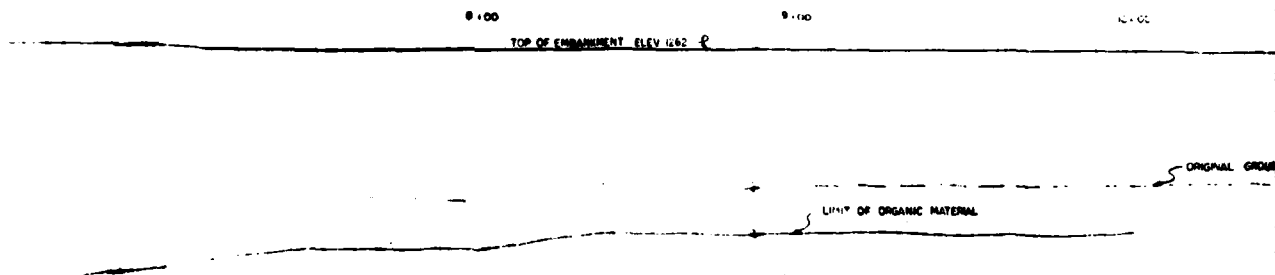
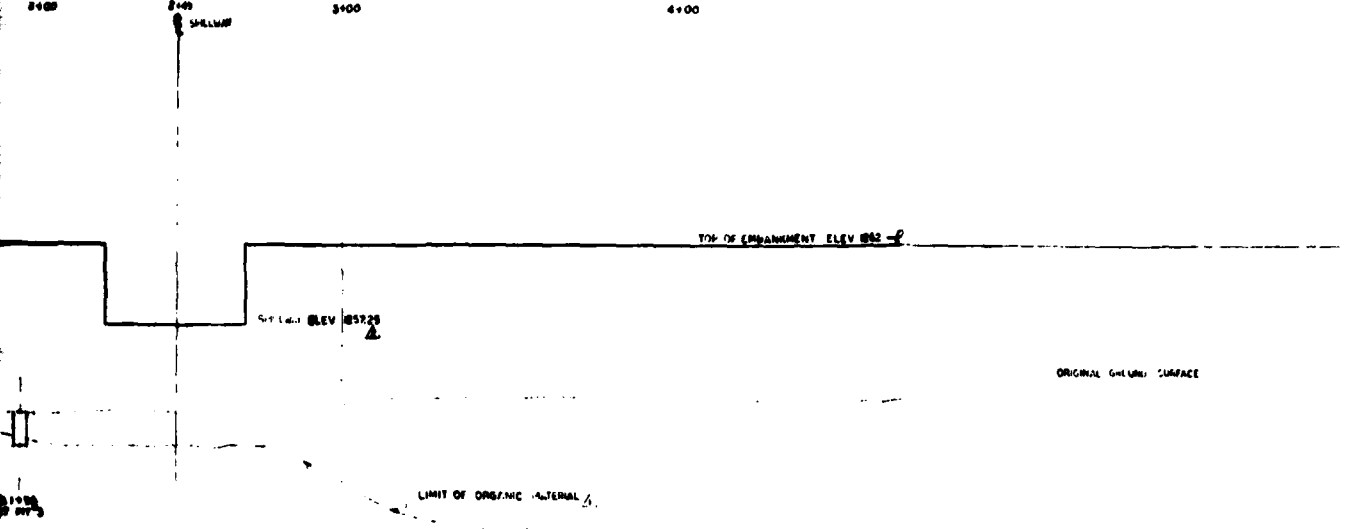
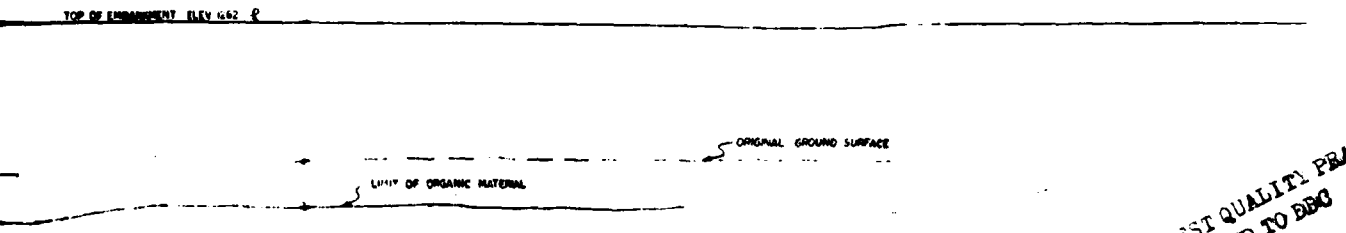
MARGEL LAKE ESTATES Delaware Gap, Pike Co., Pa.	
LAKE RENEE EMBANKMENT - PROFILE	
DATE: MARCH 9, 1978 SCALE: AS NOTED DRAWN BY: P. S. GIBSON	ENGINEER: ENGINEERING, INC. EAST STRONGSBURG, PA. (Dwg. No. M-72-2120)

b. Dam. The dam appears to be in fair condition. From a brief survey conducted during the inspection it was noted that the main embankment crest is uneven with a low spot near the left abutment. The upstream and downstream slope are partially grass covered. The embankment crest is not grass covered. The crest width is measured to be 10 feet. The upstream slope was measured to be 2H:1V. The downstream slope is 2.5H:1V. Erosion was noted on the downstream slope adjacent to the spillway wingwalls. The potential for further erosion exists along the downstream slope adjacent to both spillway wingwalls.

2. Eroded areas adjacent to the spillway wingwalls should be repaired and measures should be taken to prevent further erosion. Observed low areas on the crest of the dam should be filled to design elevations.
