LAKE LINGANORE

NDI ID NO. MD-21

PHASE I INSPECTION REPORT
NATIONAL DAM INSPECTION PROGRAM

RUMMEL, KLEPPER & KAHL
Consulting Engineers
Baltimore, Maryland 21202

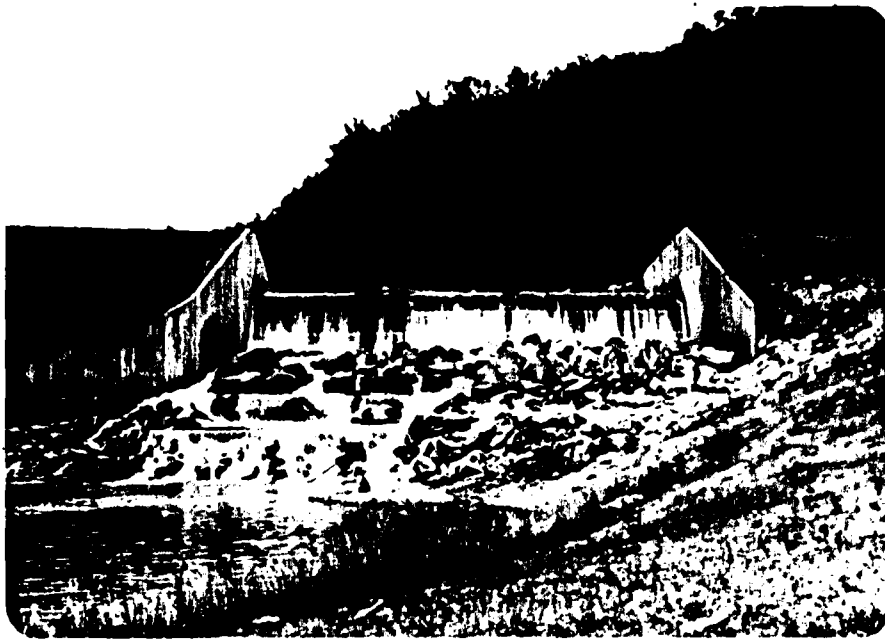
Spillway and stilling pond

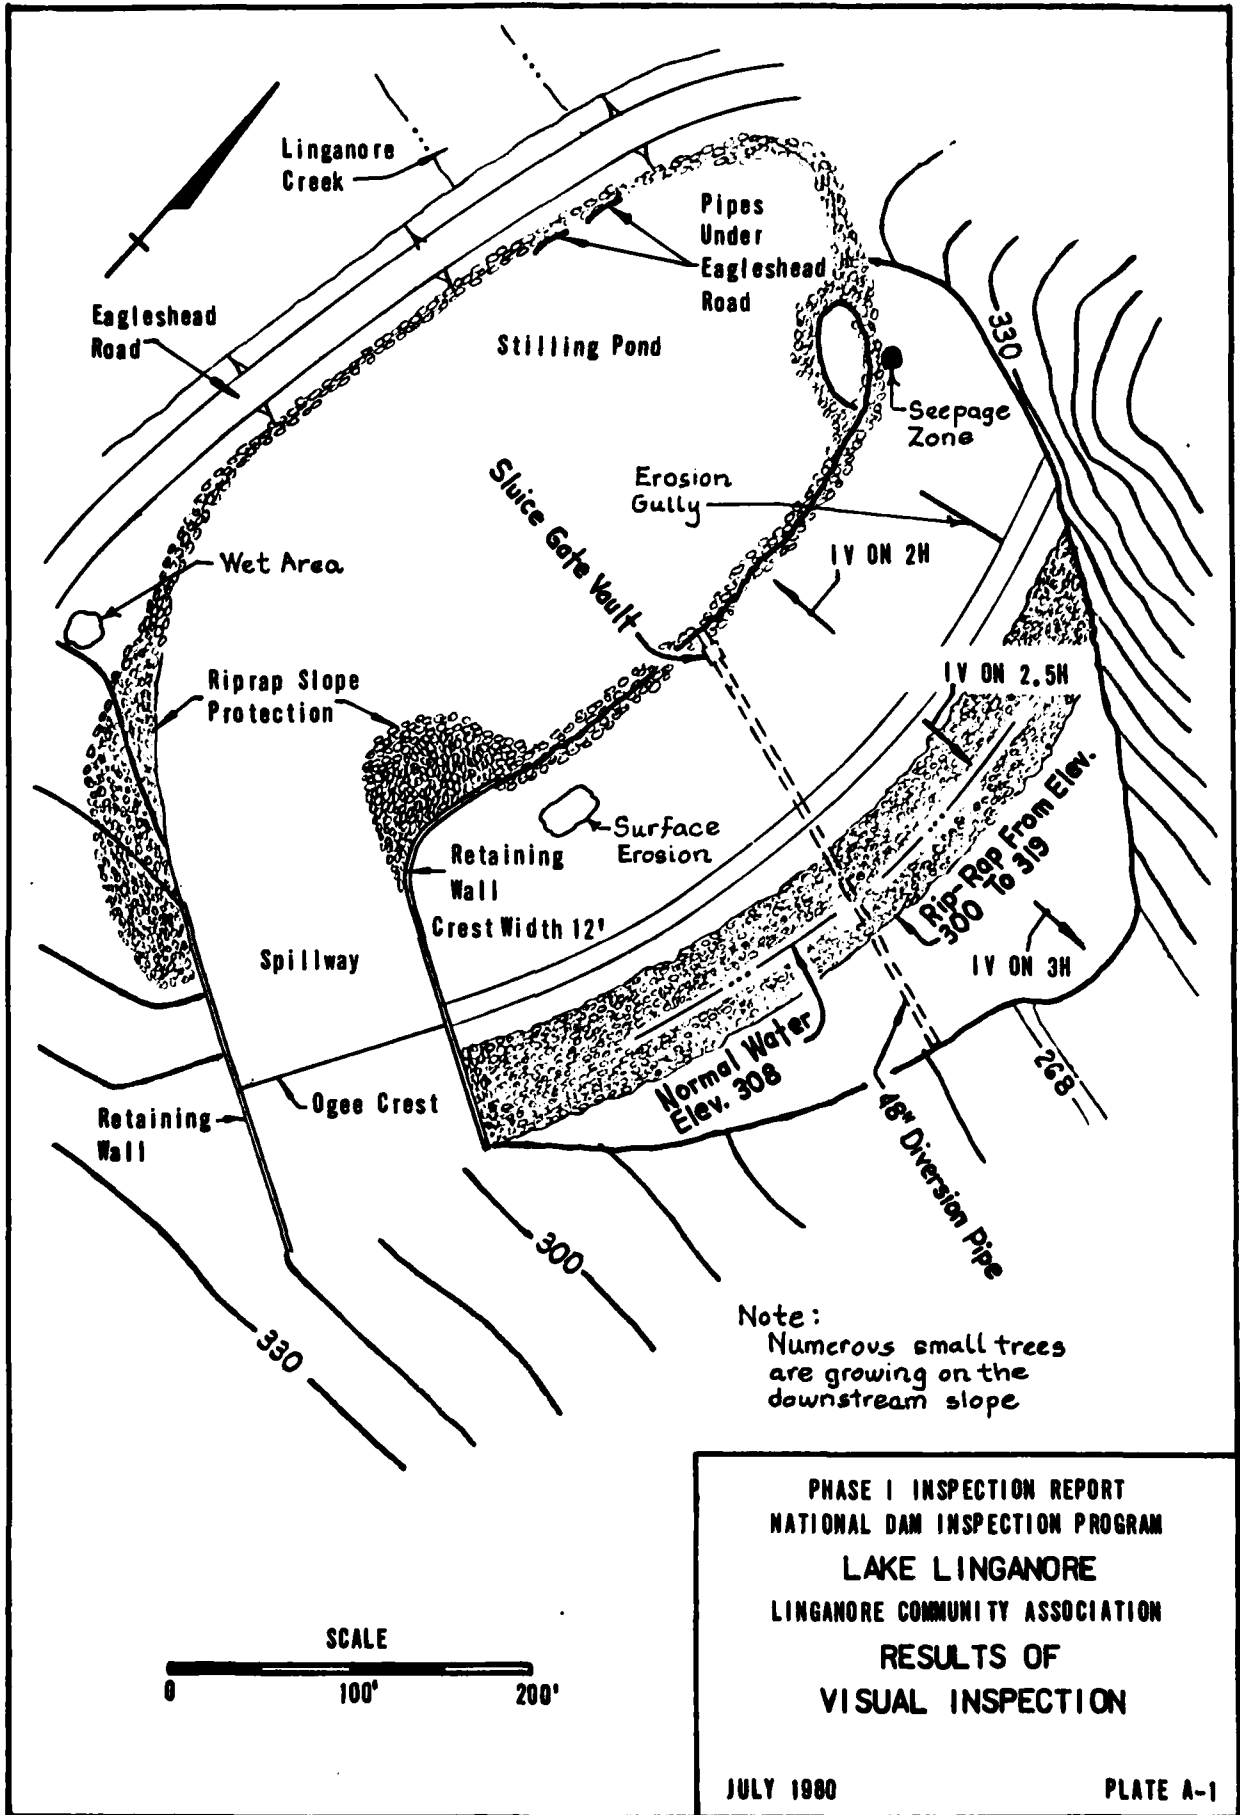
Note:
 Numerous small trees
 are growing on the
 downstream slope
