LAKE CATALPA DAM

NDS ID NO. PA-560

PHASE I INSPECTION REPORT
NATIONAL DAM INSPECTION PROGRAM

SEPTEMBER, 1980

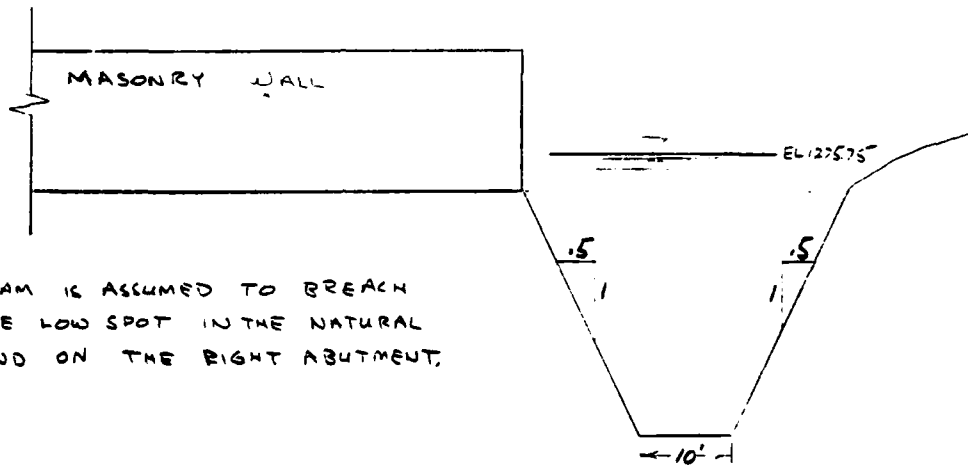
BREACH PARAMETERS

THE DAM IS ASSUMED TO BREACH
AT THE LOW SPOT IN THE NATURAL
GROUND ON THE RIGHT ABUTMENT.

BREACH WIDTH (BRWD) = 10'
SIDE SLOPE (Z) = 0.5
BOTTOM ELEV. (ELBM) = 1265
FAILURE TIME (TFAIL) = 4 HRS
INITIAL WATER ELEV. (WSEL) = 1271.5
FAILURE ELEV. (FALEL) = 1275.75
