DRUID HILL LAKE

NDI ID NO. MD-109

PHASE I INSPECTION REPORT  
NATIONAL DAM INSPECTION PROGRAM

JULY 1980

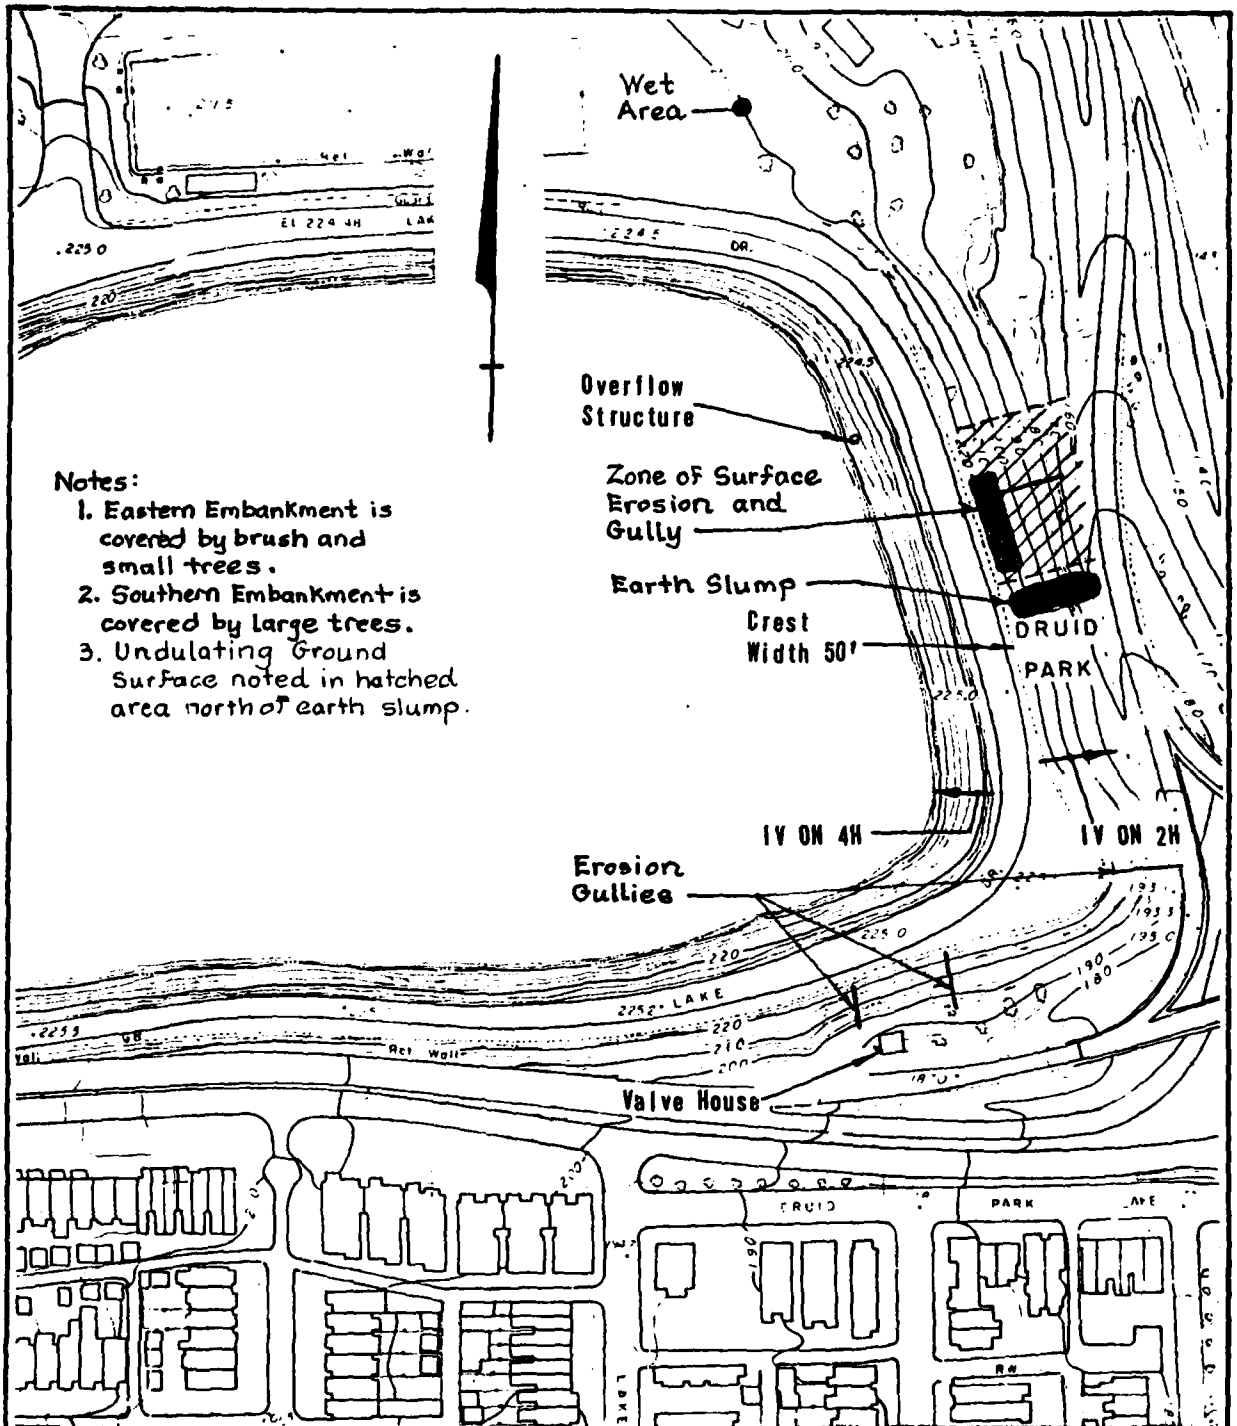
1. Eastern Embankment is covered by brush and small trees.
2. Southern Embankment is covered by large trees.
3. Undulating Ground Surface noted in hatched area north of earth slump.

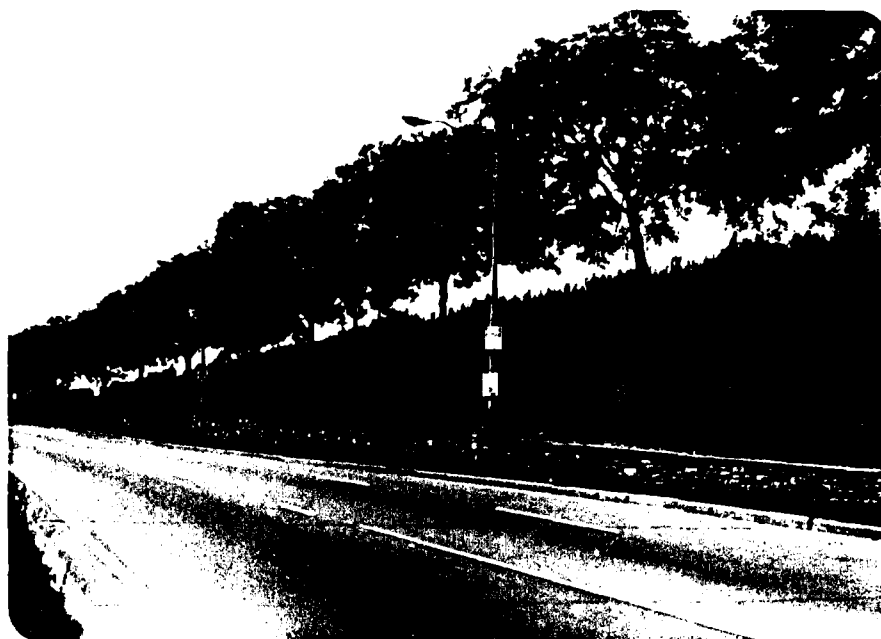
The downstream slope of the southern embankment is heavily vegetated, but only a few small erosion gullies were noted. Approximately the western half of the southern embankment has been landscaped with forsythia shrubs and mulch.

C. Downstream slope of southern embankment
