JOHNSON'S POND

NDI ID NO. MD-11

PHASE I INSPECTION REPORT
NATIONAL DAM INSPECTION PROGRAM

JULY 1980

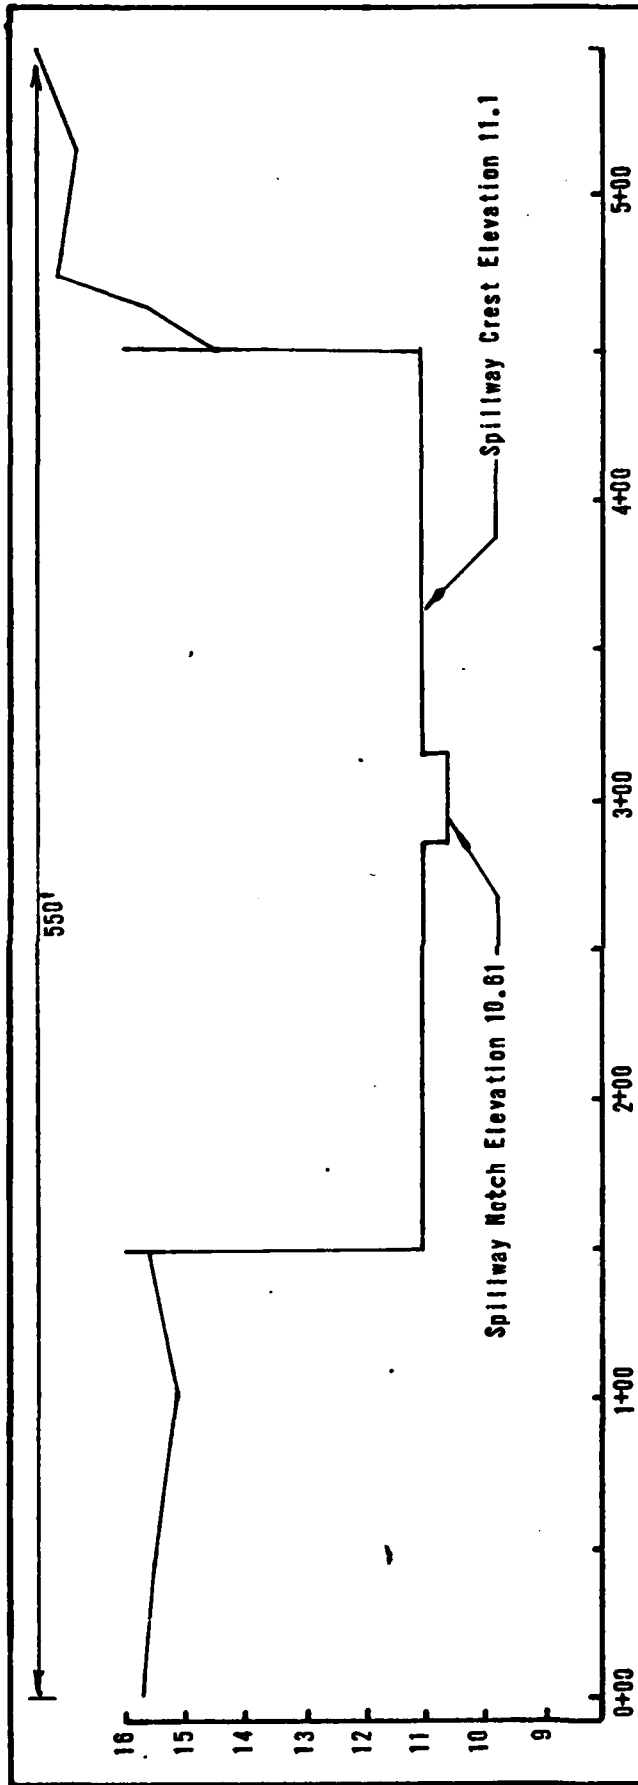
DAM CREST PROFILE
(LOOKING DOWNSTREAM)

The crest of the clay fill embankment was surveyed and the variance in elevation was 10 inches between the high and low point on the left side, and was 36 inches between the high and low point on the right side. It should be noted that the contract drawings show that the clay fill on both sides of the ogee spillway was to be constructed even with the top of the wingwalls, or to elevation 16. The low point of the fill was elevation 14.5 noted adjacent to the right wingwall. The crest elevations measured on the left side of the dam ranged from 15.1 to 15.8. Since there is no evidence that any fill was removed from the crest by natural processes, it is presumed that either the fill was not constructed in accordance with the contract drawings, or regrading of the fill has been accomplished since construction of the dam.

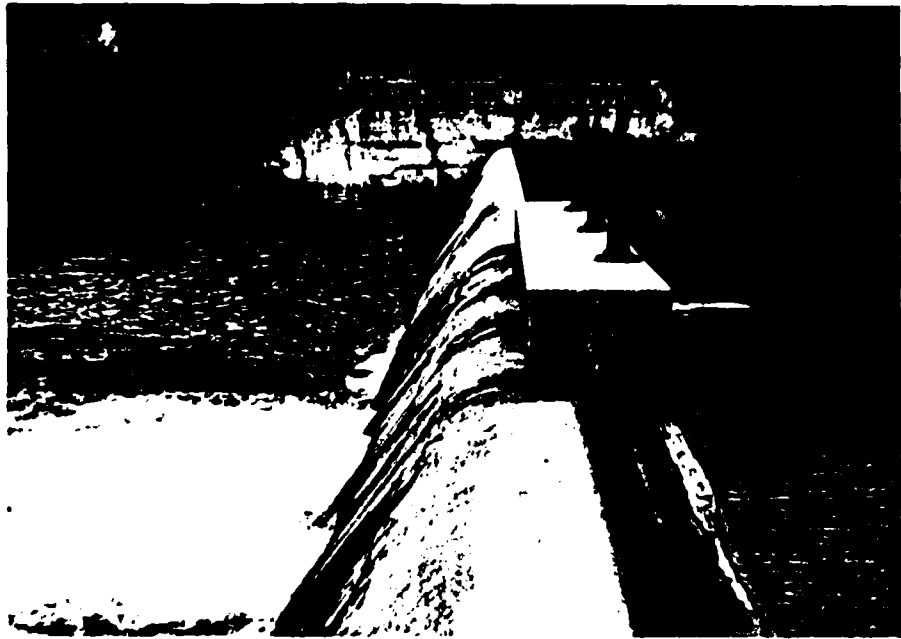
A. Dam with sluice gates open

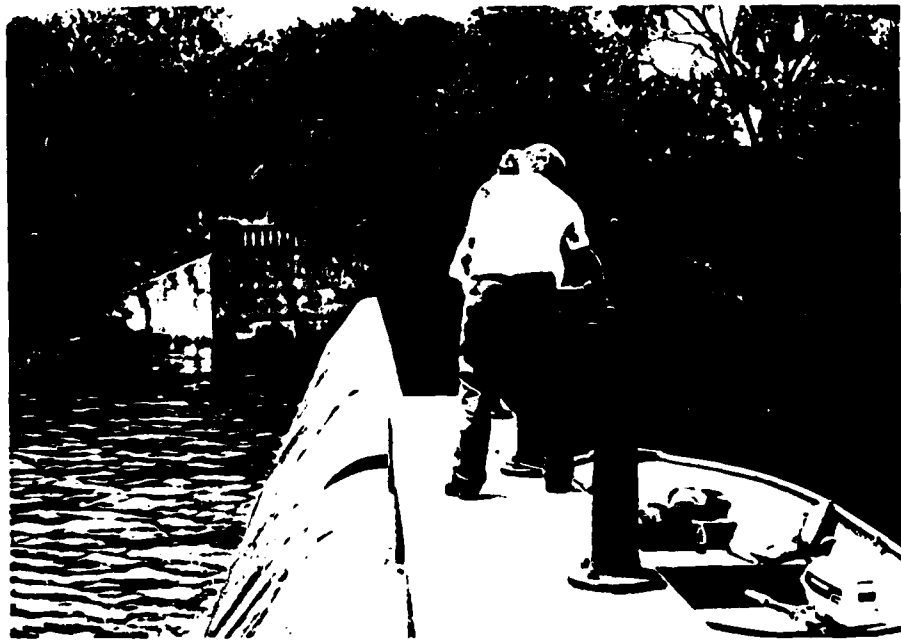
B. City of Salisbury personnel closing sluice gates

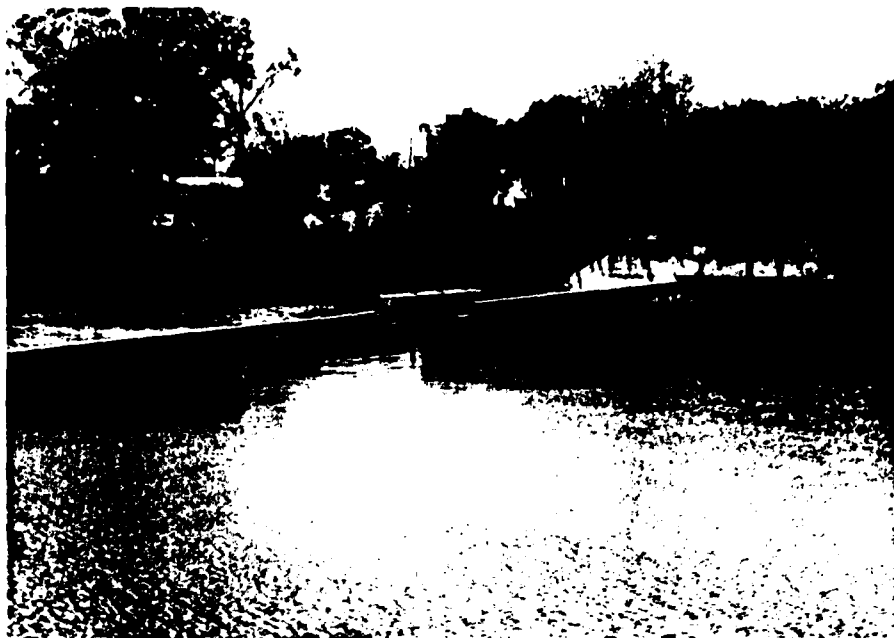
C. Upstream side of dam

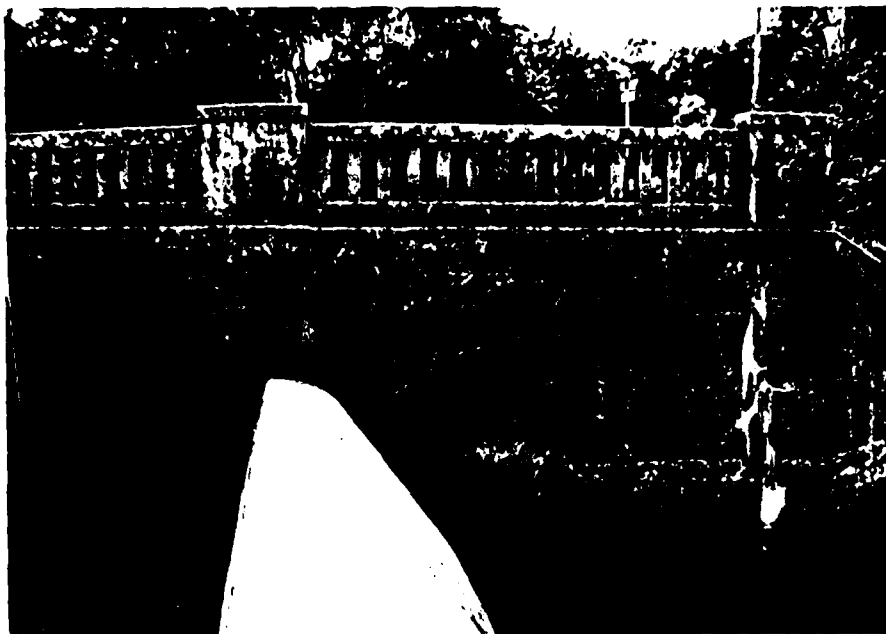
walls from the spillway crest to the top of the wingwall. The crack in the left wingwall is approximately 0.25 inch wide and the crack in the right wingwall is approximately 0.5 inch wide. Cracking is responsible for a piece of concrete being displaced on the upstream side of the spillway along a joint located 20+' left of the spillway notch. No displacement was noted along any other cracks in the spillway, and no water was noted seeping through the cracks on the downstream side of the spillway. Minor spalling of the concrete was noted on the crest of spillway near the left wingwall.

E. Structural crack in retaining wall
above dam crest at left end of dam

3.2 Evaluation. The visual examination and observations of the Johnson's Pond dam indicated that the structure is in good condition. We recommend that the cracks in the wingwalls be repaired the next time the sluice gates are open for an extended period of time.

- b. Repair the cracks which extend through the right and left wingwalls from the crest of the ogee spillway to the top of each wingwall.
- c. Repair the cracks noted in the ogee spillway before the cracks enlarge.
- d. Raise the embankment to the design elevation.
- e. Carefully inspect the ogee spillway for additional cracks, seepage through cracks, or displacement of concrete along the cracks at least once a year while the water level is down.
- f. Develop a formal warning system to alert downstream residents in the event of emergencies.

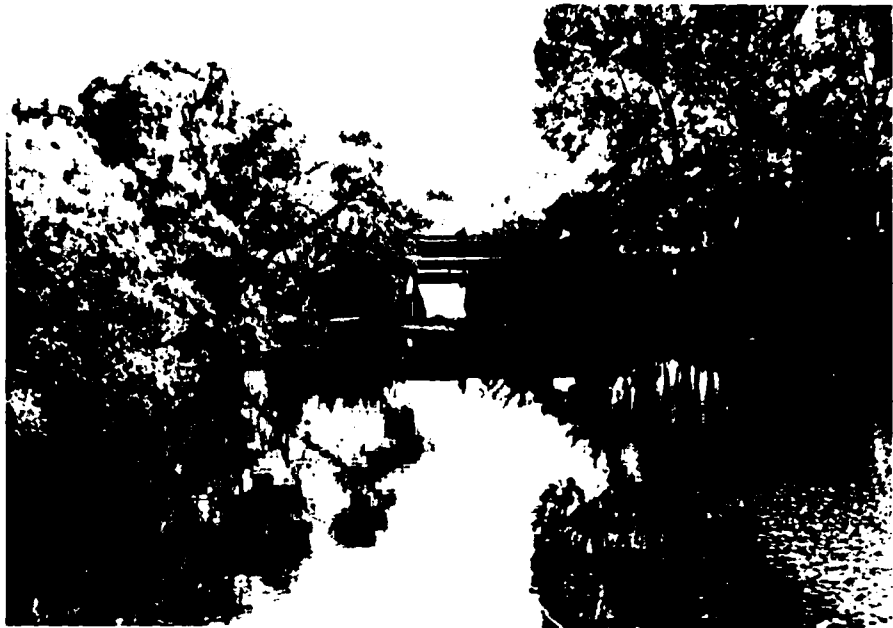
Downstream channel routings of outflow hydrographs generated by the above reservoir routings indicate that the barrier caused by the approaches to the Isabella Street bridge will produce backwater conditions extending upstream to the Johnson's Pond spillway. In addition these analyses indicate that these approaches will be overtopped if the flood event exceeds 10 percent of the PMF. If these bridge approaches fail upon overtopping, the results from the initial reservoir routing analyses for Johnson's Pond can be considered valid since backwater conditions caused by the bridge embankment would not materialize for the 50 and 100 percent PMF events. If it is assumed that the bridge approaches do not fail, this affect or resultant backwater conditions upon the spillway discharge must be considered.

G. Isabella Street Bridge crossing
river downstream of dam

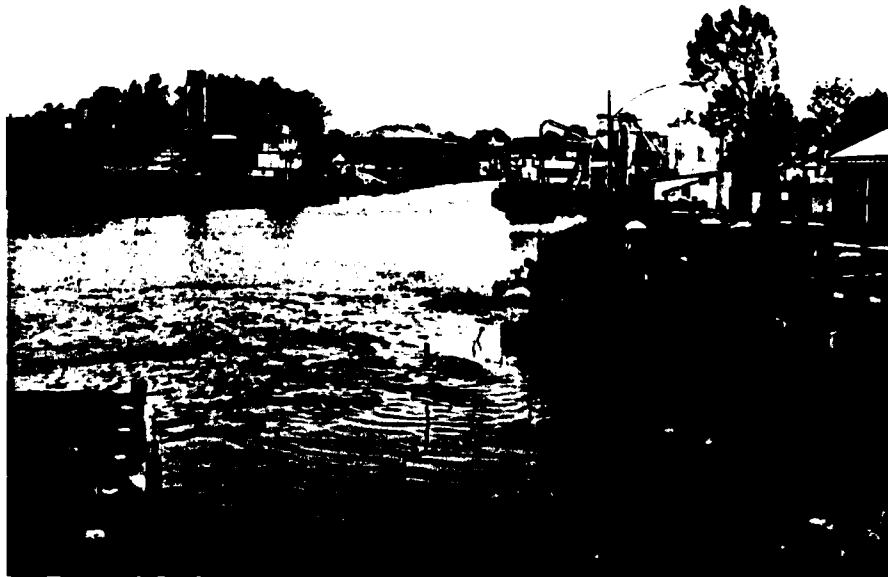
H. Downstream of Isabella Street Bridge
