PHASE I INSPECTION REPORT
NATIONAL DAM INSPECTION PROGRAM

COLUMBIA LNG
(NDI ID Number 116)

COLUMBIA LNG CORPORATION

July 1980

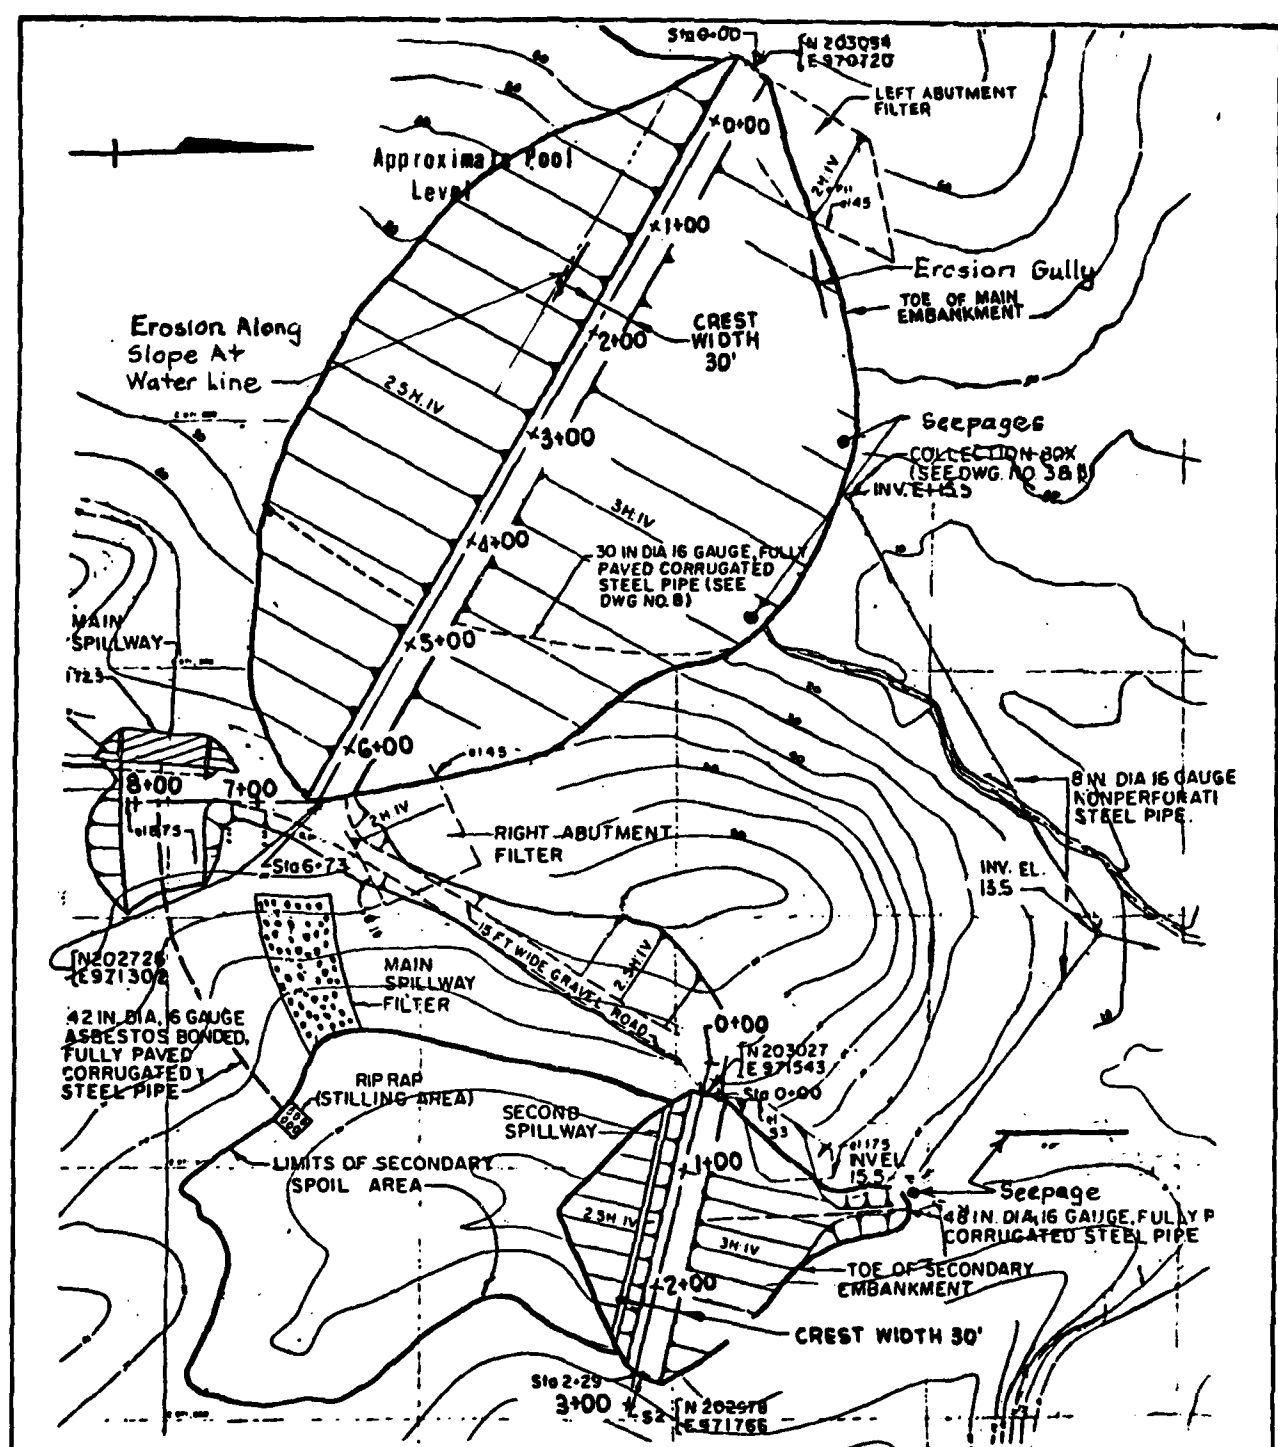
JULY 1980 PLATE A-1

RESULTS OF
 VISUAL INSPECTION

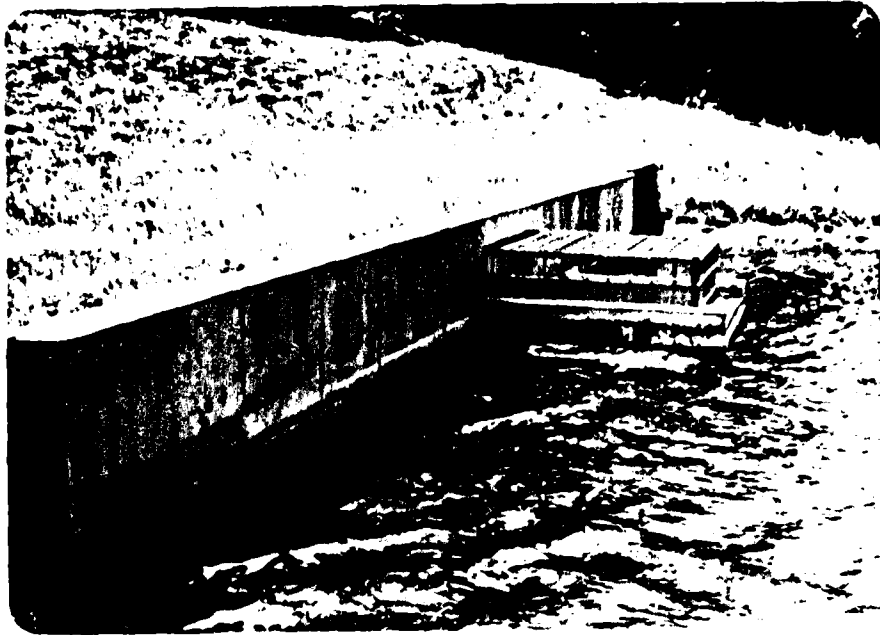
C. Main Spillway (drop inlet)

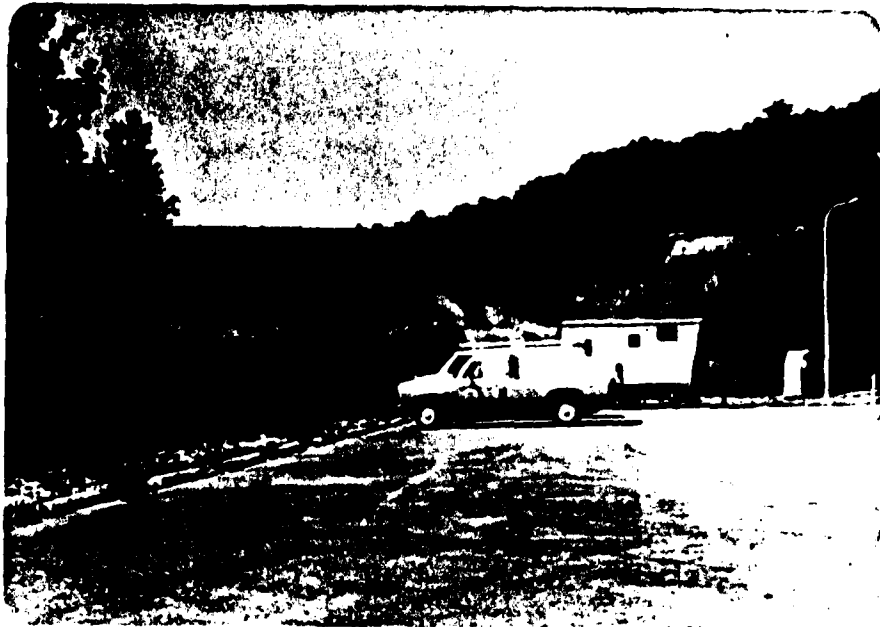
E. Guardhouse downstream of main embankment
