REPORT DOCUMENTATION PAGE		READ INSTRUCTIONS BEFORE COMPLETING FORM
1. REPORT NUMBER	2. GOVT ACCESSION NO. AD-A091 275	3. RECIPIENT'S CATALOG NUMBER
4. TITLE (and Subtitle) Phase I Inspection Report Fresh Air Fund Dam No. 2 Hudson River Basin, Dutchess County, NY Inventory No. 726		5. TYPE OF REPORT & PERIOD COVERED Phase I Inspection Report National Dam Safety Program

PHASE I INSPECTION REPORT
NATIONAL DAM SAFETY PROGRAM
FRESH AIR FUND DAM NO. 2
I.D. NO. N.Y. 726
D.E.C. NO. 212D-3254
HUDSON RIVER BASIN
DUTCHESS COUNTY, NEW YORK

This inspection was conducted to evaluate the existing conditions of the dam, to identify deficiencies and hazardous conditions, to determine if these deficiencies constitute hazards to life and property, and to recommend remedial measures where required.

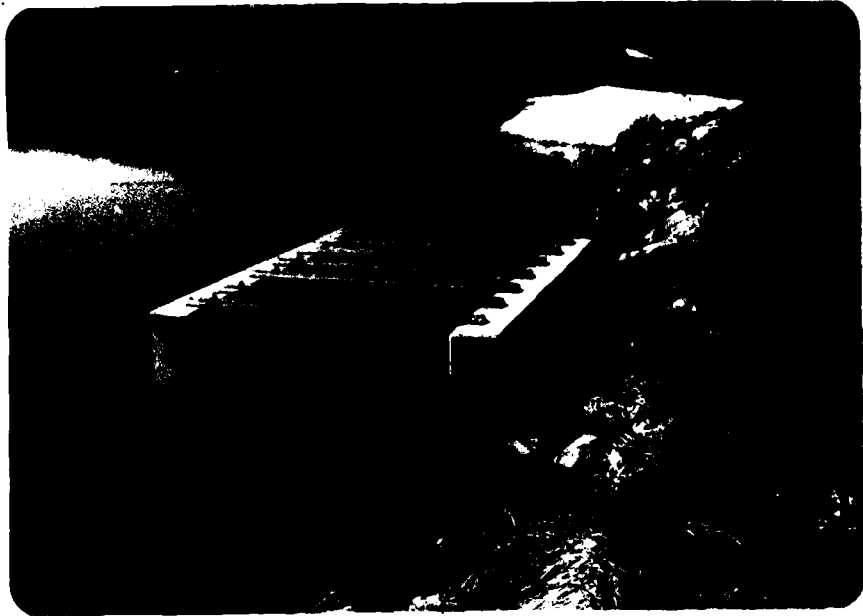
The intake structure appears to be in good condition (See Photograph No. 7). The trash rack angle irons show some signs of deterioration, and have broken loose in two places. Some boulders and twigs were seen at the bottom of the intake structure.

7. CONCRETE INTAKE STRUCTURE FOR SERVICE SPILLWAY.
NOTE TRASH RACK.

6. Repair trash rack and clean riser intake structure.
7. Recoat exposed reservoir drain pipe with bituminous material.
8. Mark gate valve stem screw to designate the complete closure of reservoir drain gate.

e. Repair of trash racks and remove debris from intake structure.
