Name Of Dam: LOWER BEAVER POND DAM  
Location: CHESTERFIELD COUNTY, VIRGINIA  
Inventory Number: VA. NO. 04106

# PHASE I INSPECTION REPORT

## NATIONAL DAM SAFETY PROGRAM

SCHNABEL ENGINEERING ASSOCIATES, P.C./  
J. K. TIMMONS AND ASSOCIATES, INC.

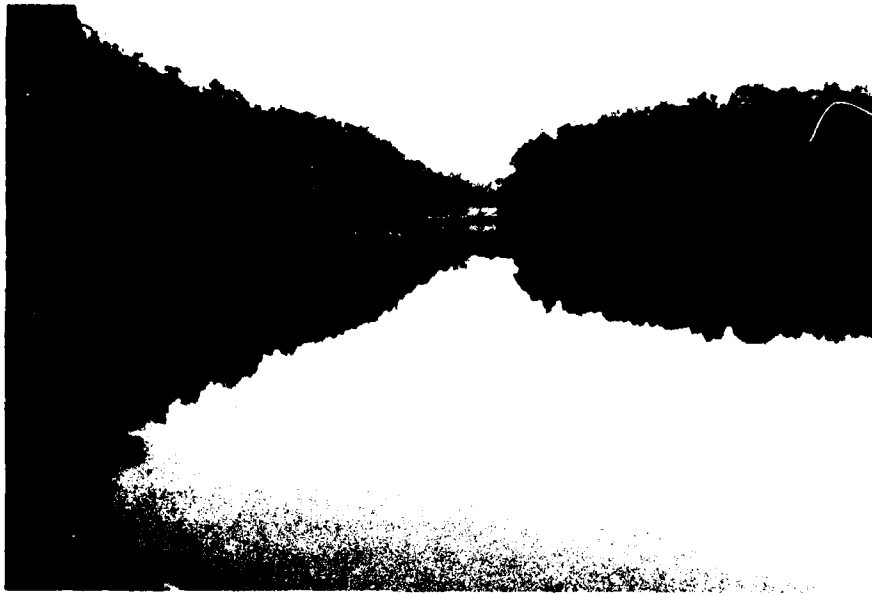
Overview Photographs

3.1.3 Reservoir Area: The reservoir area was free of debris and the perimeter was wooded (Overview Photographs, Page 5). The reservoir is located in a valley with side slopes at approximately 3H:1V. No sediment build-up was observed.

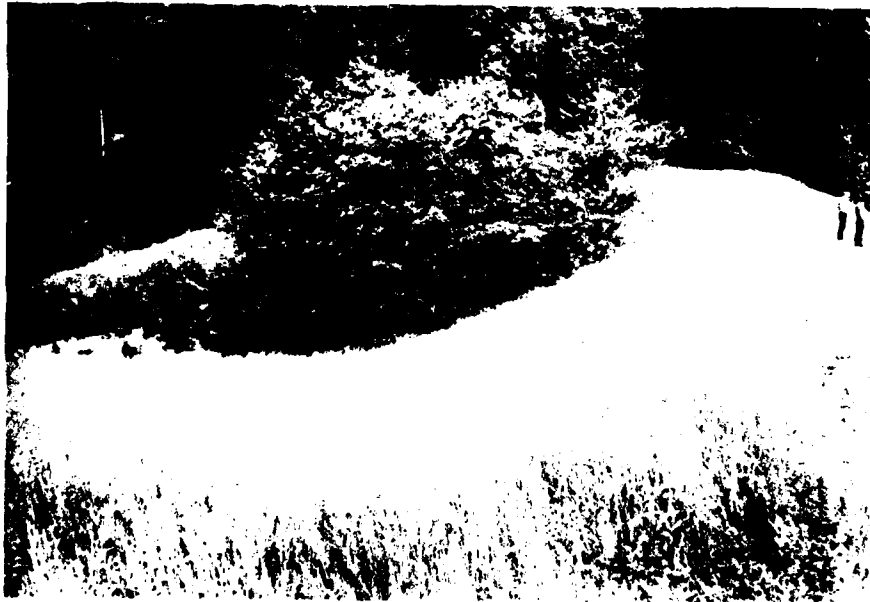
Photo No. 2

Downstream face of dam

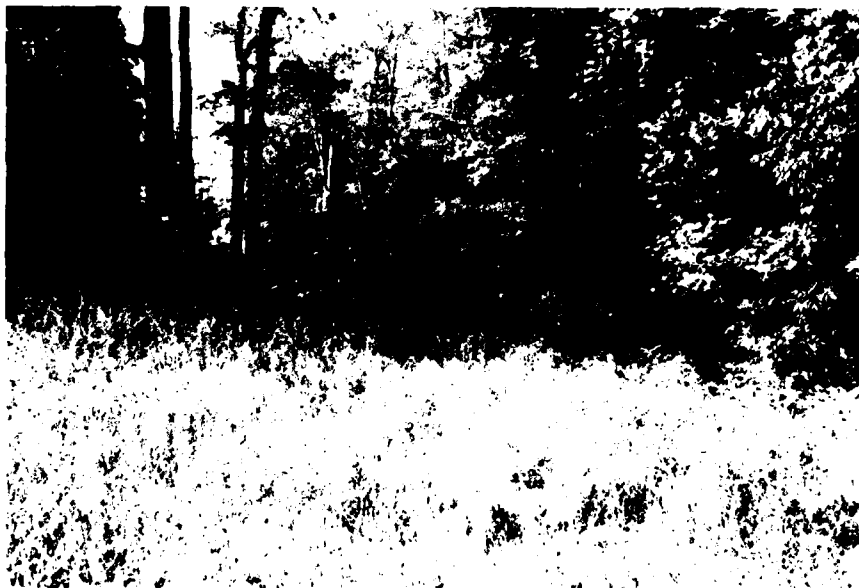
Photo No. 6

Downstream Channel  
(Arrow Denotes Channel)

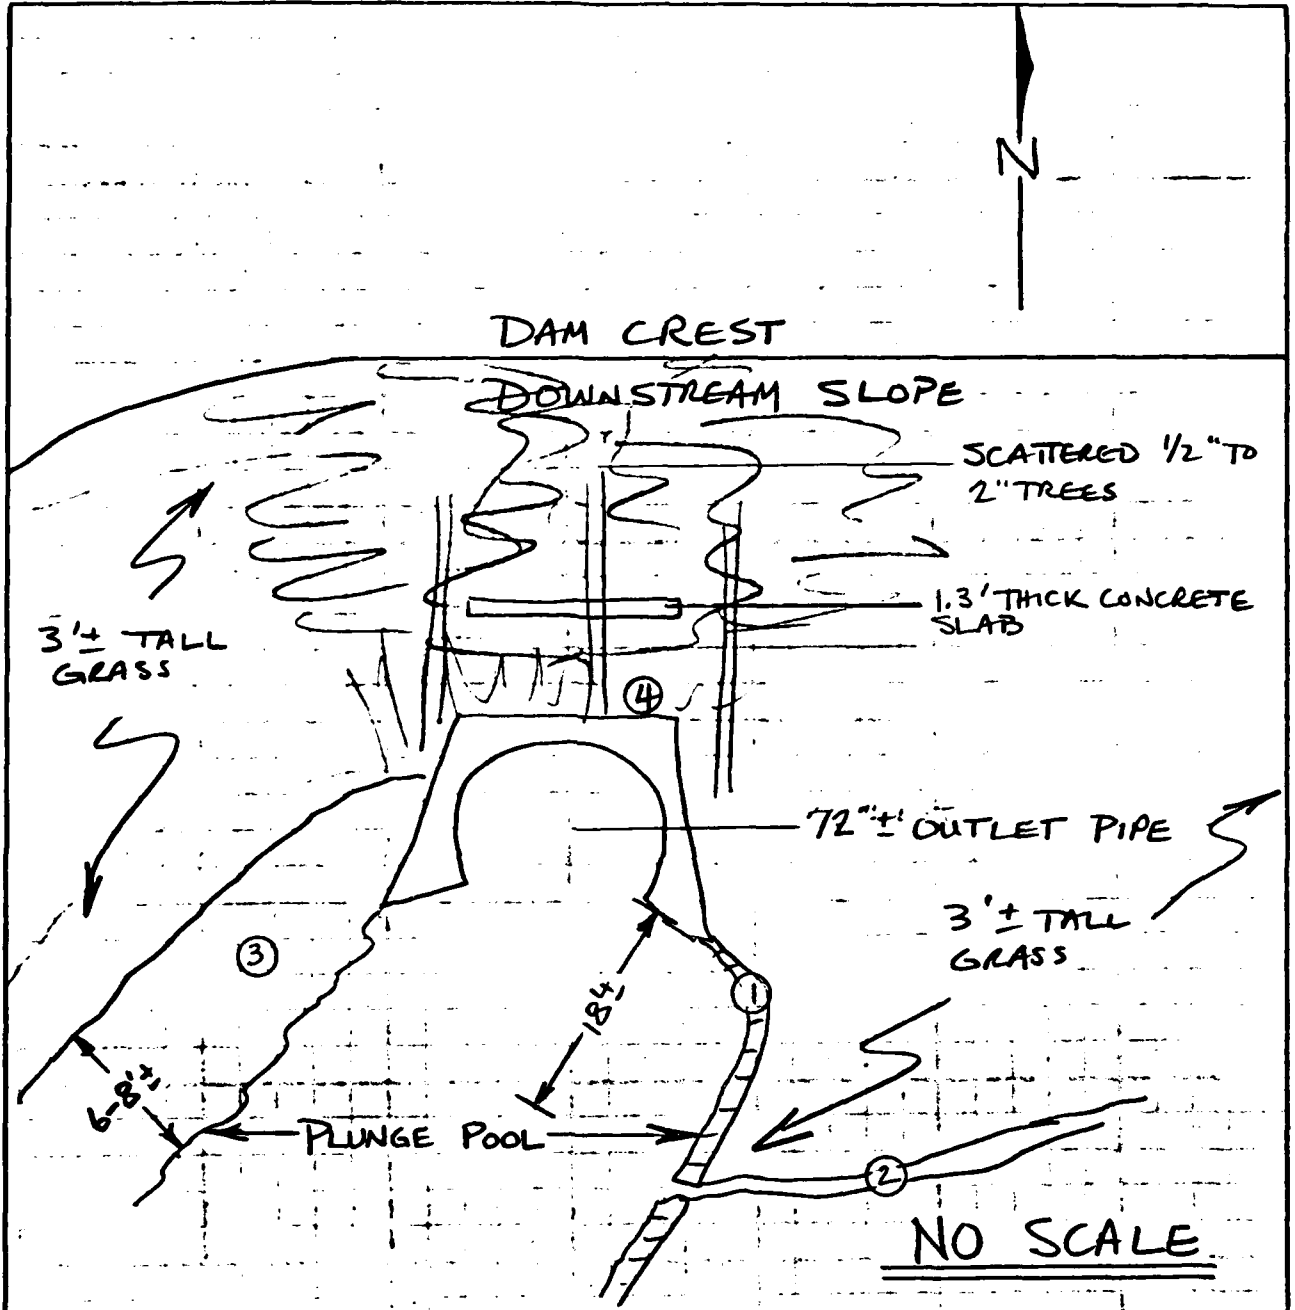
# LOWER BEAVER POND DAM FIELD SKETCH

The only surface erosion noted on the embankment exists along the left downstream slope as shown on Sheet 1 of Appendix III. A 65 to 75 ft± long erosion gulley, which is about 1 to 2 ft wide and 1 to 3 ft deep, developed as a result of extremely heavy rainfall in October, 1979. No seepage was observed along the downstream slope.

- ① 1' TO 3'± DROP FROM EDGE OF SLOPE TO POOL
- ② EROSIONAL GULLEY 1' TO 2' WIDE AND 1' TO 3' DEEP. EXTENDS 65' TO 75'± UPSLOPE TOWARD THE LEFT ABUTMENT
- ③ BARE, VERY STEEP SLOPE WITH SCATTERED SURFACE WASHING
- ④ SOIL AND BOULDERS (UP TO 5'± LONG) FILL OVER TOP OF OUTLET STRUCTURE. SEVERAL ANIMAL BURROWS PRESENT

1) The eroded area along the left downstream slope should be backfilled with compacted soil and seeded in order to prevent further erosion.

7.3.5 Animal burrowing observed above the outlet structure should be prevented. Existing holes should be backfilled with compacted soil.
