NDI No. PA 01137
PENN DER No. 63-90

RAW WATER POND.

PHASE I INSPECTION REPORT
NATIONAL DAM INSPECTION PROGRAM

SEPTEMBER 1980

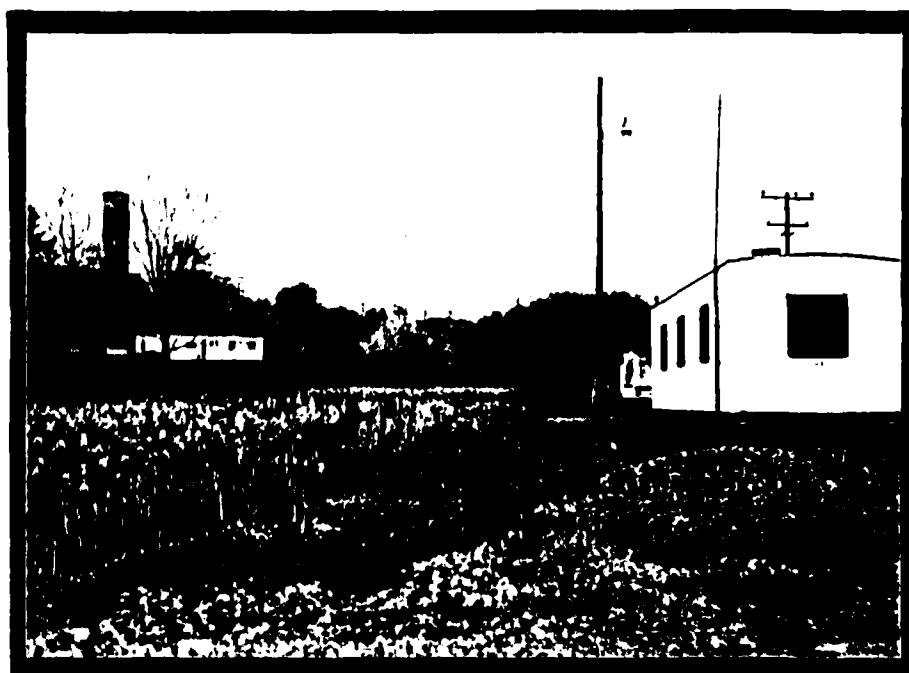
(2) Natural drainage below the Treated Water Pond is via an unnamed tributary to Sawmill Creek. In the 1.5 mile reach between the Treated Water Pond and the confluence with Sawmill Creek, 8 inhabited dwellings were observed on the floodplain at elevations low enough to be imperiled by high flows. Also, a mine portal and loadout facility and State Route 917 lie near the bottom of the valley.

Photo 12 Downstream Hazards below Treated Water Pond.
