NEW YORK STATE DEPT OF ENVIRONMENTAL CONSERVATION ALBANY F/G 13/13  
NATIONAL DAM SAFETY PROGRAM. LAKE WELCH DAM (INVENTORY NUMBER N--ETC(1))  
SEP 80 E O'BRIEN DACW51-79-C-0001

REPORT DOCUMENTATION PAGE		READ INSTRUCTIONS BEFORE COMPLETING FORM
1. REPORT NUMBER	2. GOVT ACCESSION NO.	3. RECIPIENT'S CATALOG NUMBER
	AD-A091279	
4. TITLE (and Subtitle) Phase I Inspection Report Lake Welch Dam Hudson River Basin, Rockland County, NY Inventory No. 283		5. TYPE OF REPORT & PERIOD COVERED Phase I Inspection Report National Dam Safety Program

PHASE I INSPECTION REPORT  
NATIONAL DAM SAFETY PROGRAM  
LAKE WELCH DAM  
I.D. NO. N.Y. 283  
DEC #196-854  
HUDSON RIVER BASIN  
ROCKLAND COUNTY, NEW YORK

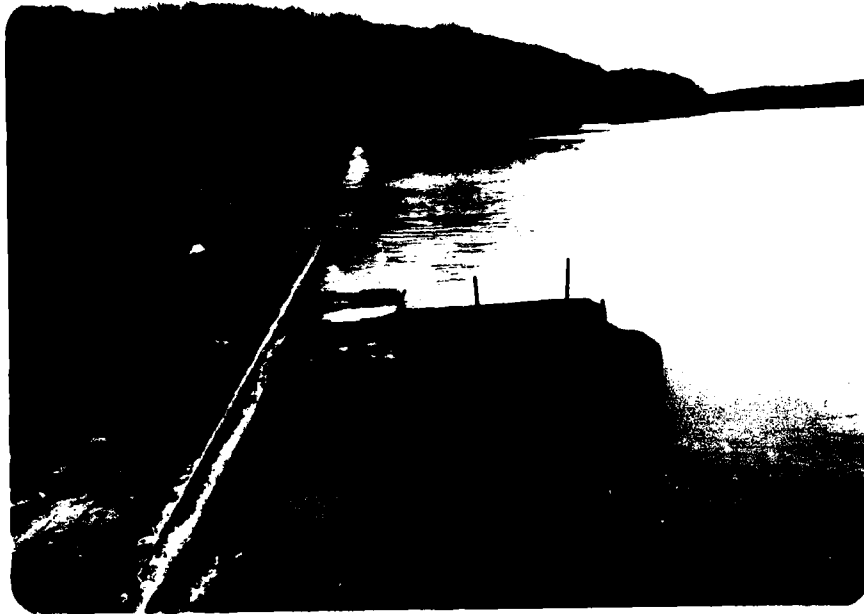
2. VIEW OF CREST OF SPILLWAY AND  
INTAKE STRUCTURE FOR HIGH LEVEL  
OUTLET.
