Name Of Dam: MOORE CREEK

Location: ROCKBRIDGE COUNTY

PHASE I INSPECTION REPORT NATIONAL DAM SAFETY PROGRAM

JUNE 1980

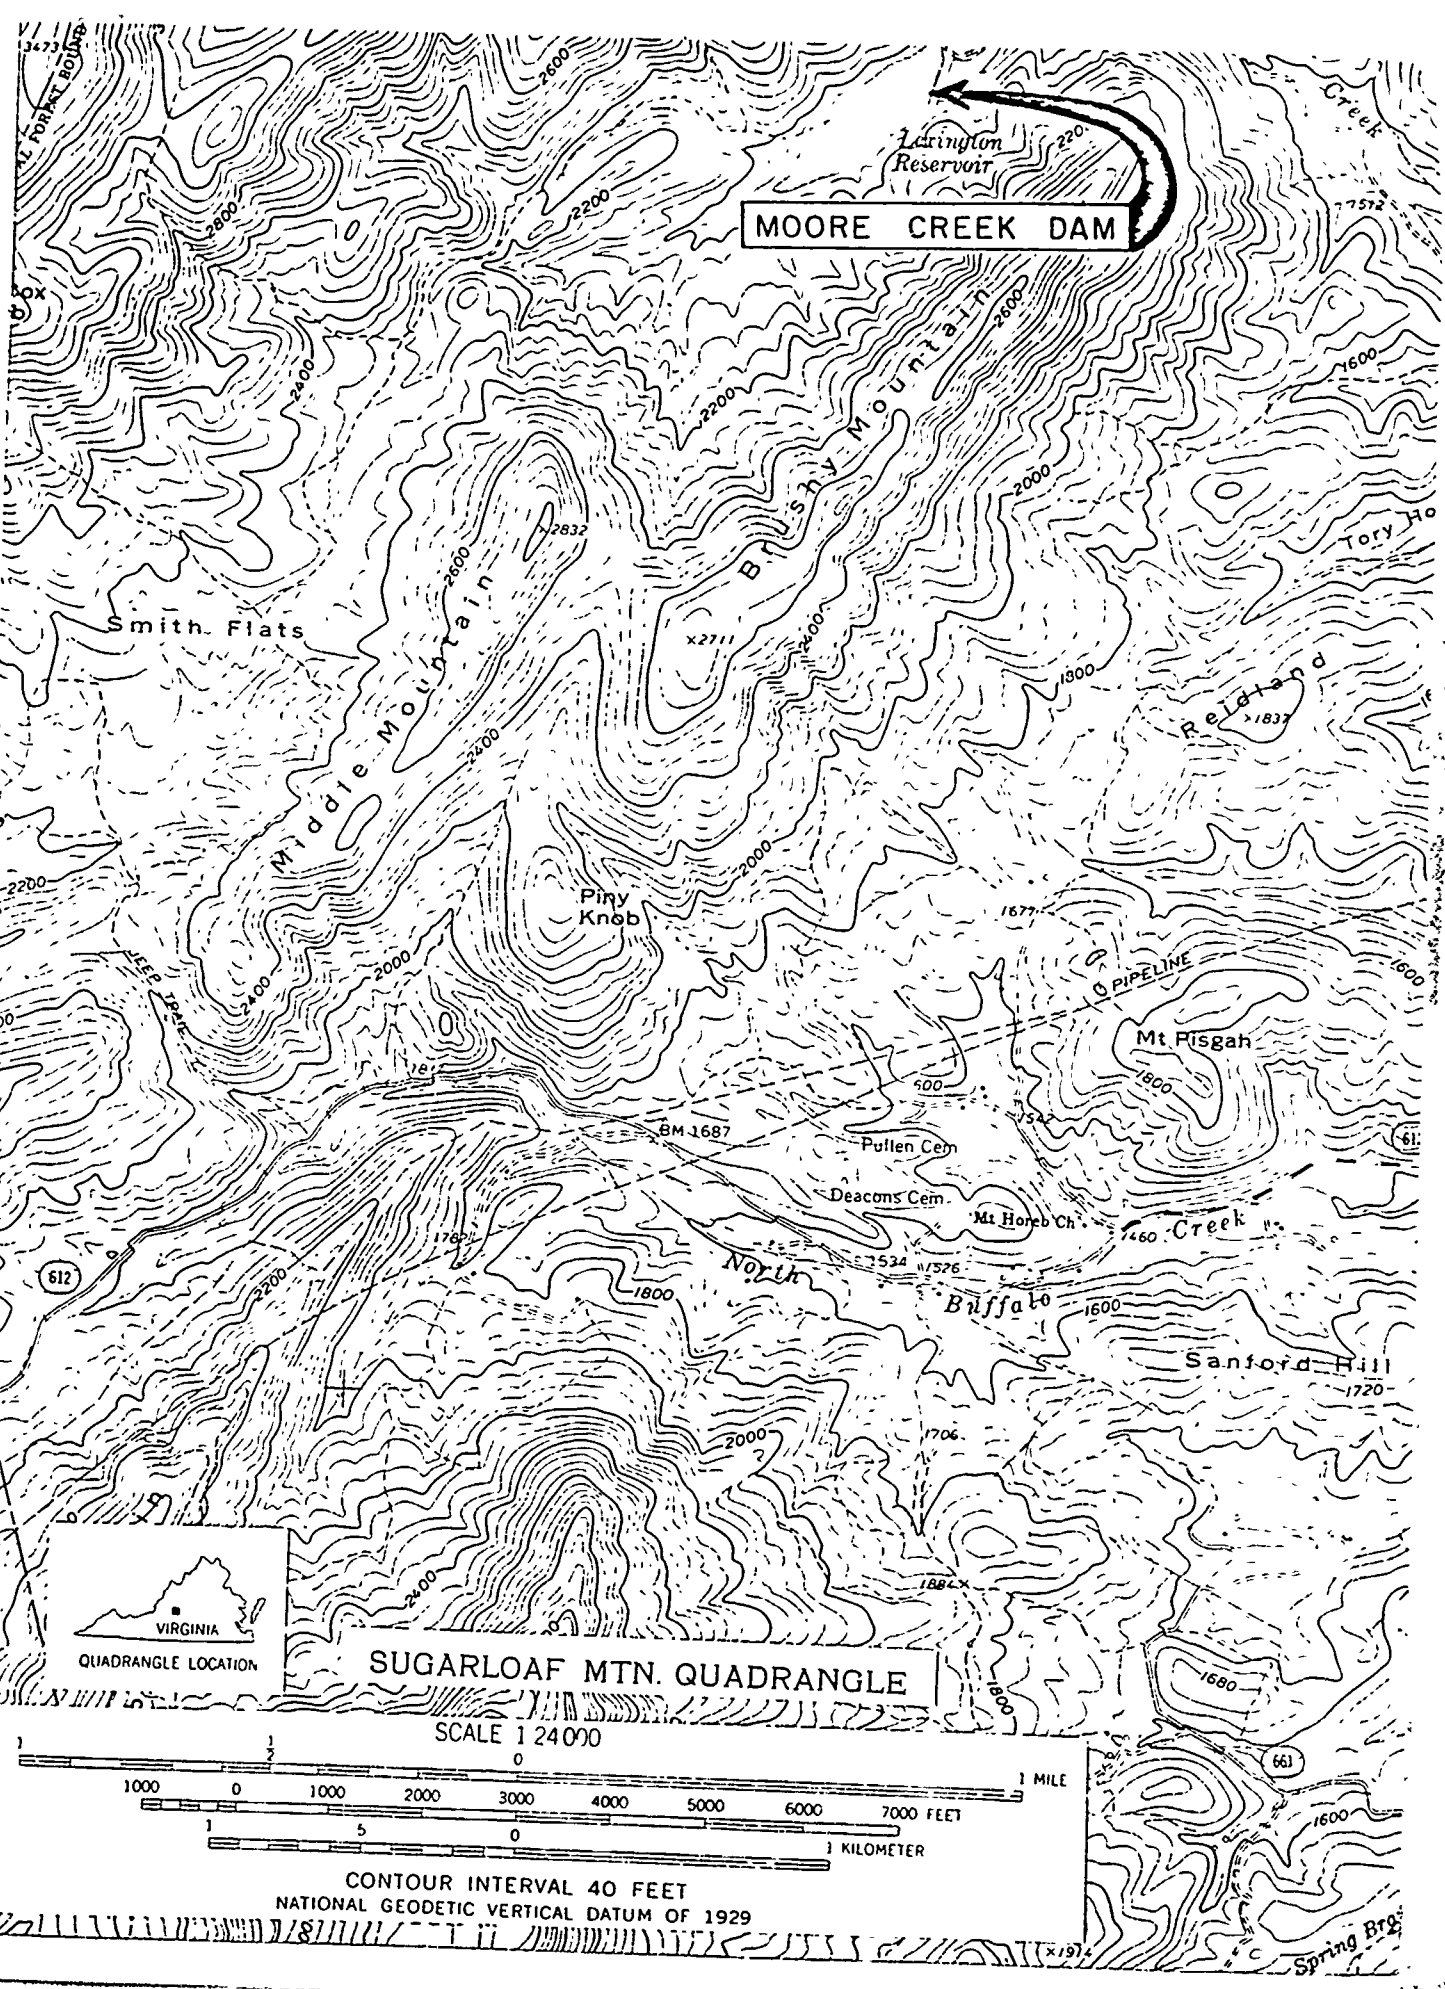
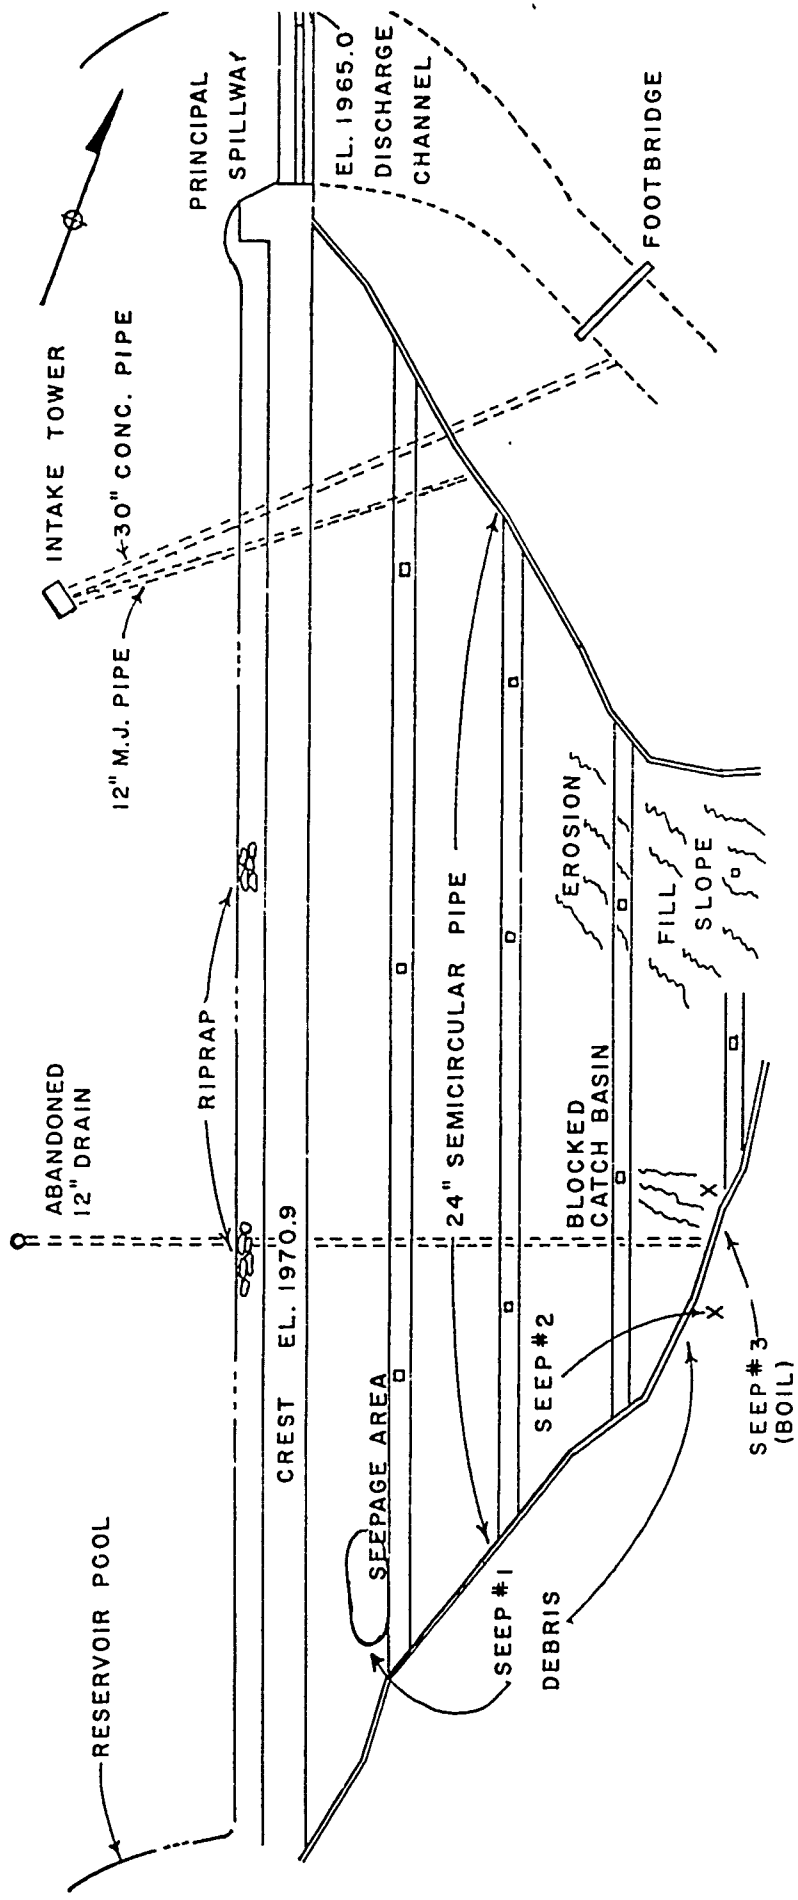
PLAN VIEW

Three seeps were found and are as located on Plate I. Seep 1, shown in Photo 7, is a wet spot. It has created a wet, soggy area about 7 x 25 feet on the downstream slope at the first bench. Seeps 2 and 3 are flowing freely and clearly. No attempt was made to estimate the flow. Seep 3 is a boil and is shown in Photos 9 and 10. It was reported by Wiley and Wilson, that seep 3 is the result of the discharge from a six inch drain tile line which is used to pipe water from an iron water spring which existed in this area.

There are no foundation drains. There is a series of catch basins on the downstream benches. Several were filled with debris. One, as shown on Plate I, is overflowing and there is local ponding surrounding the basin. Also, a gully is developing on the slope just below the basin caused by the overflow. The gully is within the irregular fill.

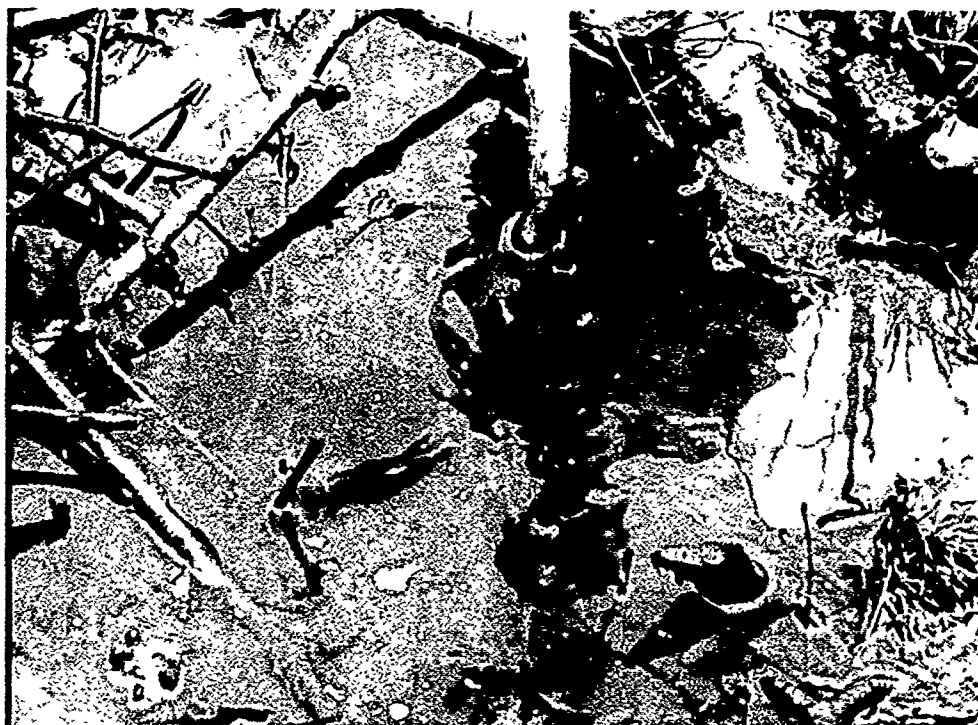
PHOTO #10 CLOSE UP OF "BOIL"
