HUNTINGDON SMITHFIELD DAM

(NDI I.D. PA-00511)

PHASE I INSPECTION REPORT

NAME OF DAM: Huntingdon-Smithfield Dam
STATE LOCATED: Pennsylvania
COUNTY LOCATED: Huntingdon
STREAM: Lily Creek, a Tributary of the Juniata River
SIZE CLASSIFICATION: Intermediate
HAZARD CLASSIFICATION: High
OWNER: Smithfield Township Supervisors
DATE OF INSPECTION: April 29, 1980 and April 30, 1980

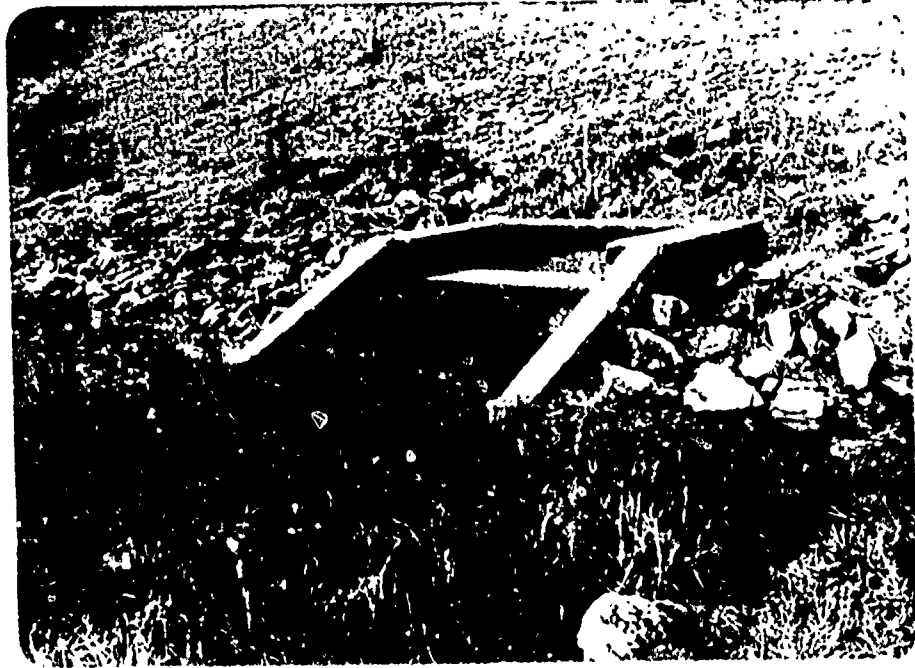
Photograph No. 3
Outlet pipe discharge structure.

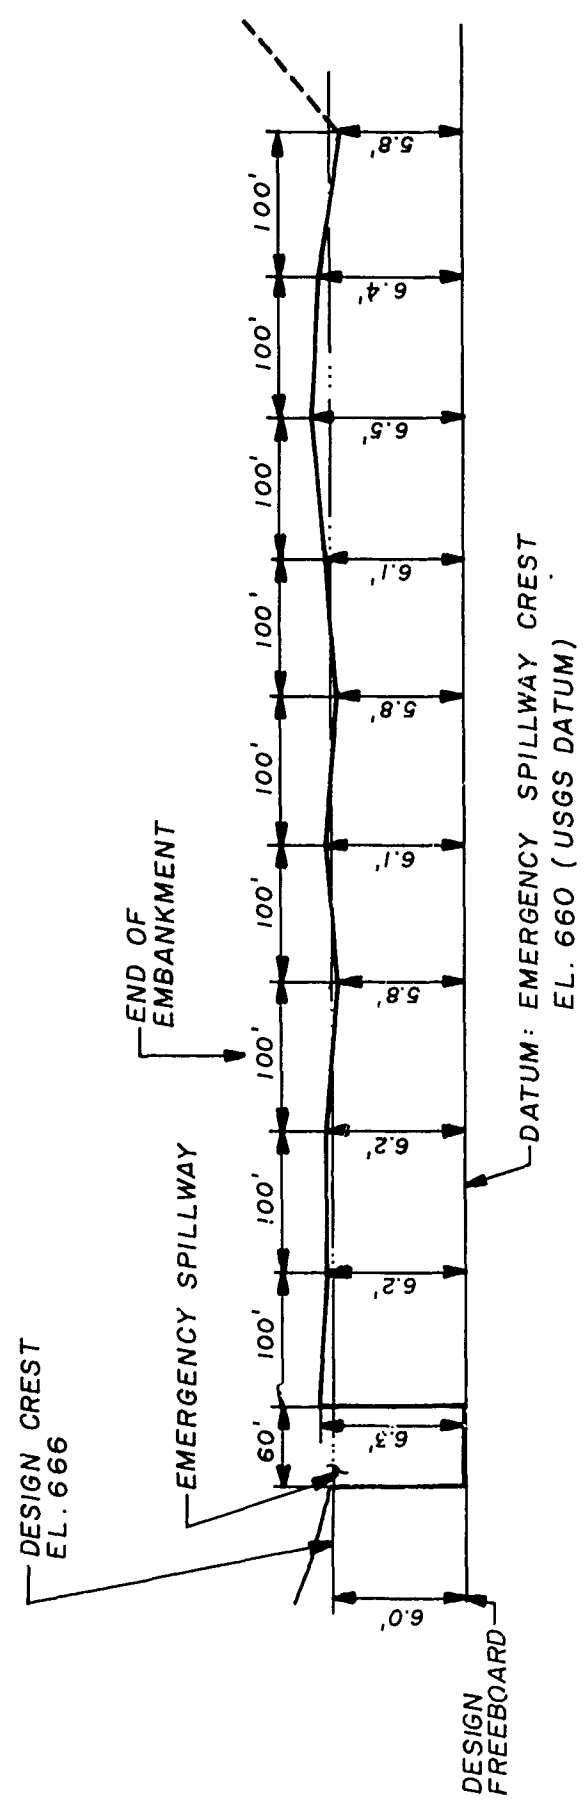
DAM CREST PROFILE
(LOOKING DOWNSTREAM)

In general, the condition of the dam is considered to be good. The crest of the dam was surveyed relative to the emergency spillway crest elevation and it was found to be generally at the design crest elevation. The dam crest profile is illustrated in Plate 7. The downstream and upstream slopes were surveyed and found to be reasonably within the design slopes of 2H to 1V on the upper half of the embankment and 3H to 1V on the lower half of the embankment.
