POTOMAC RIVER BASIN

Name Of Dam: SMITHLEIGH DAM  
Location: AUGUSTA COUNTY, VIRGINIA  
Inventory Number: VA. NO. 01523

# PHASE I INSPECTION REPORT NATIONAL DAM SAFETY PROGRAM

JULY 1980

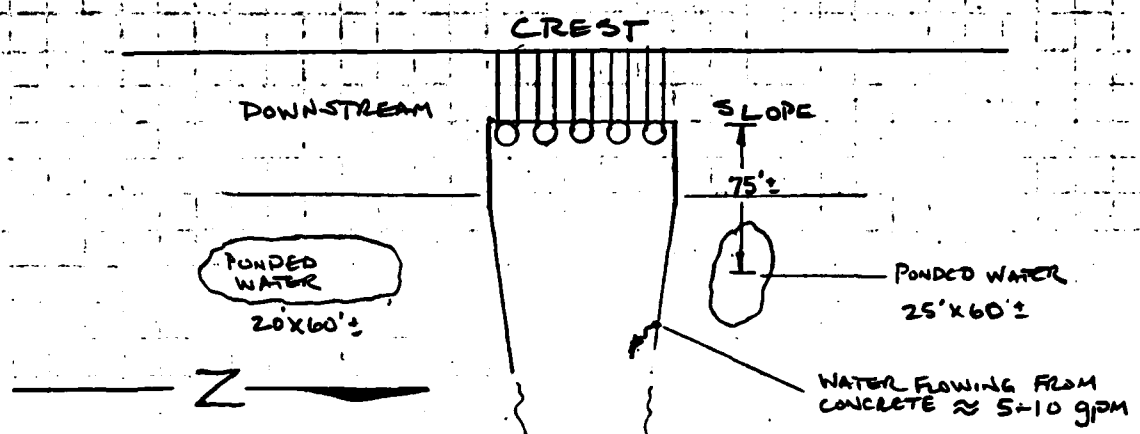
Ponded water was observed in two areas: (1) along the downstream toe, several 100 ft left of the concrete discharge channel and (2) in an area 60 ft x 25 ft + about 75 ft below and to the left of the left edge of the concrete channel. No iron staining was observed and both areas are believed to represent ponded runoff from rainfalls of the preceding day. Just right of area (2) water was flowing through a small opening in the concrete channel at a rate of 5 to 10 gpm. This water is believed to represent water which was flowing beneath and along the side of the spillway. Water also flowing from beneath the concrete channel at rate of 25 to 30 gpm. See accompanying field sketch.

PONDED AREAS ALONG DOWNSTREAM SLOPE

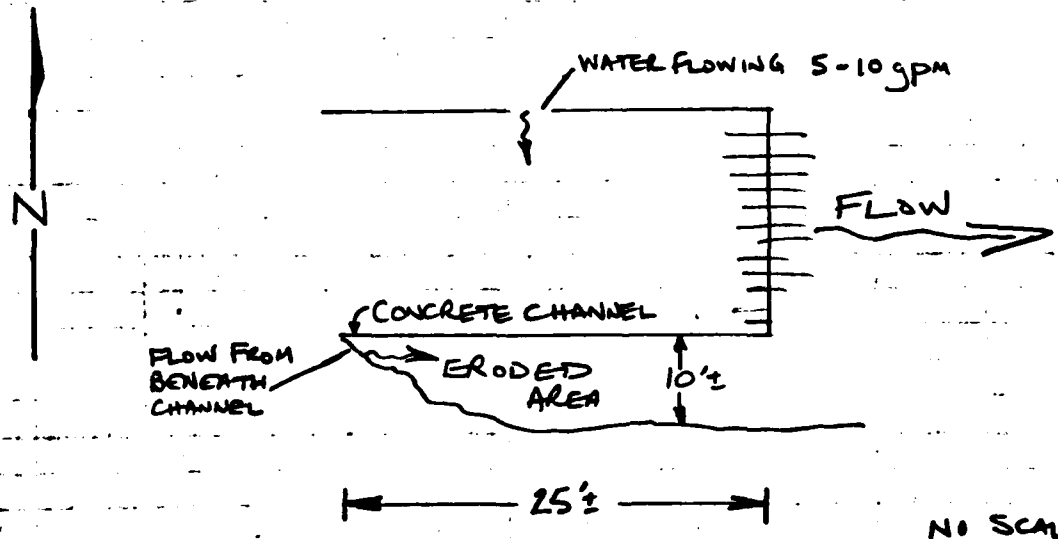
The concrete outlet channel is in need of erosion protection. The downstream channel below the outlet channel is also in need of erosion control. The erosion on the outlet channel and downstream channel is severe enough to cause damage to the outlet channel if left unchecked. This could ultimately be detrimental to the dam performance.

EROSION, CONCRETE DISCHARGE CHANNEL

7.3.1 Repair eroded areas on the outlet channel and downstream channel, and provide erosion control measures such as riprap to prevent future erosion. Areas which are undermining the outlet channel should also be backfilled and protected.
