Name Of Dam: POTOMAC CREEK NO. 1

Location: STAFFORD COUNTY, VIRGINIA

Inventory Number: VA. NO. 17902

PHASE I INSPECTION REPORT NATIONAL DAM SAFETY PROGRAM

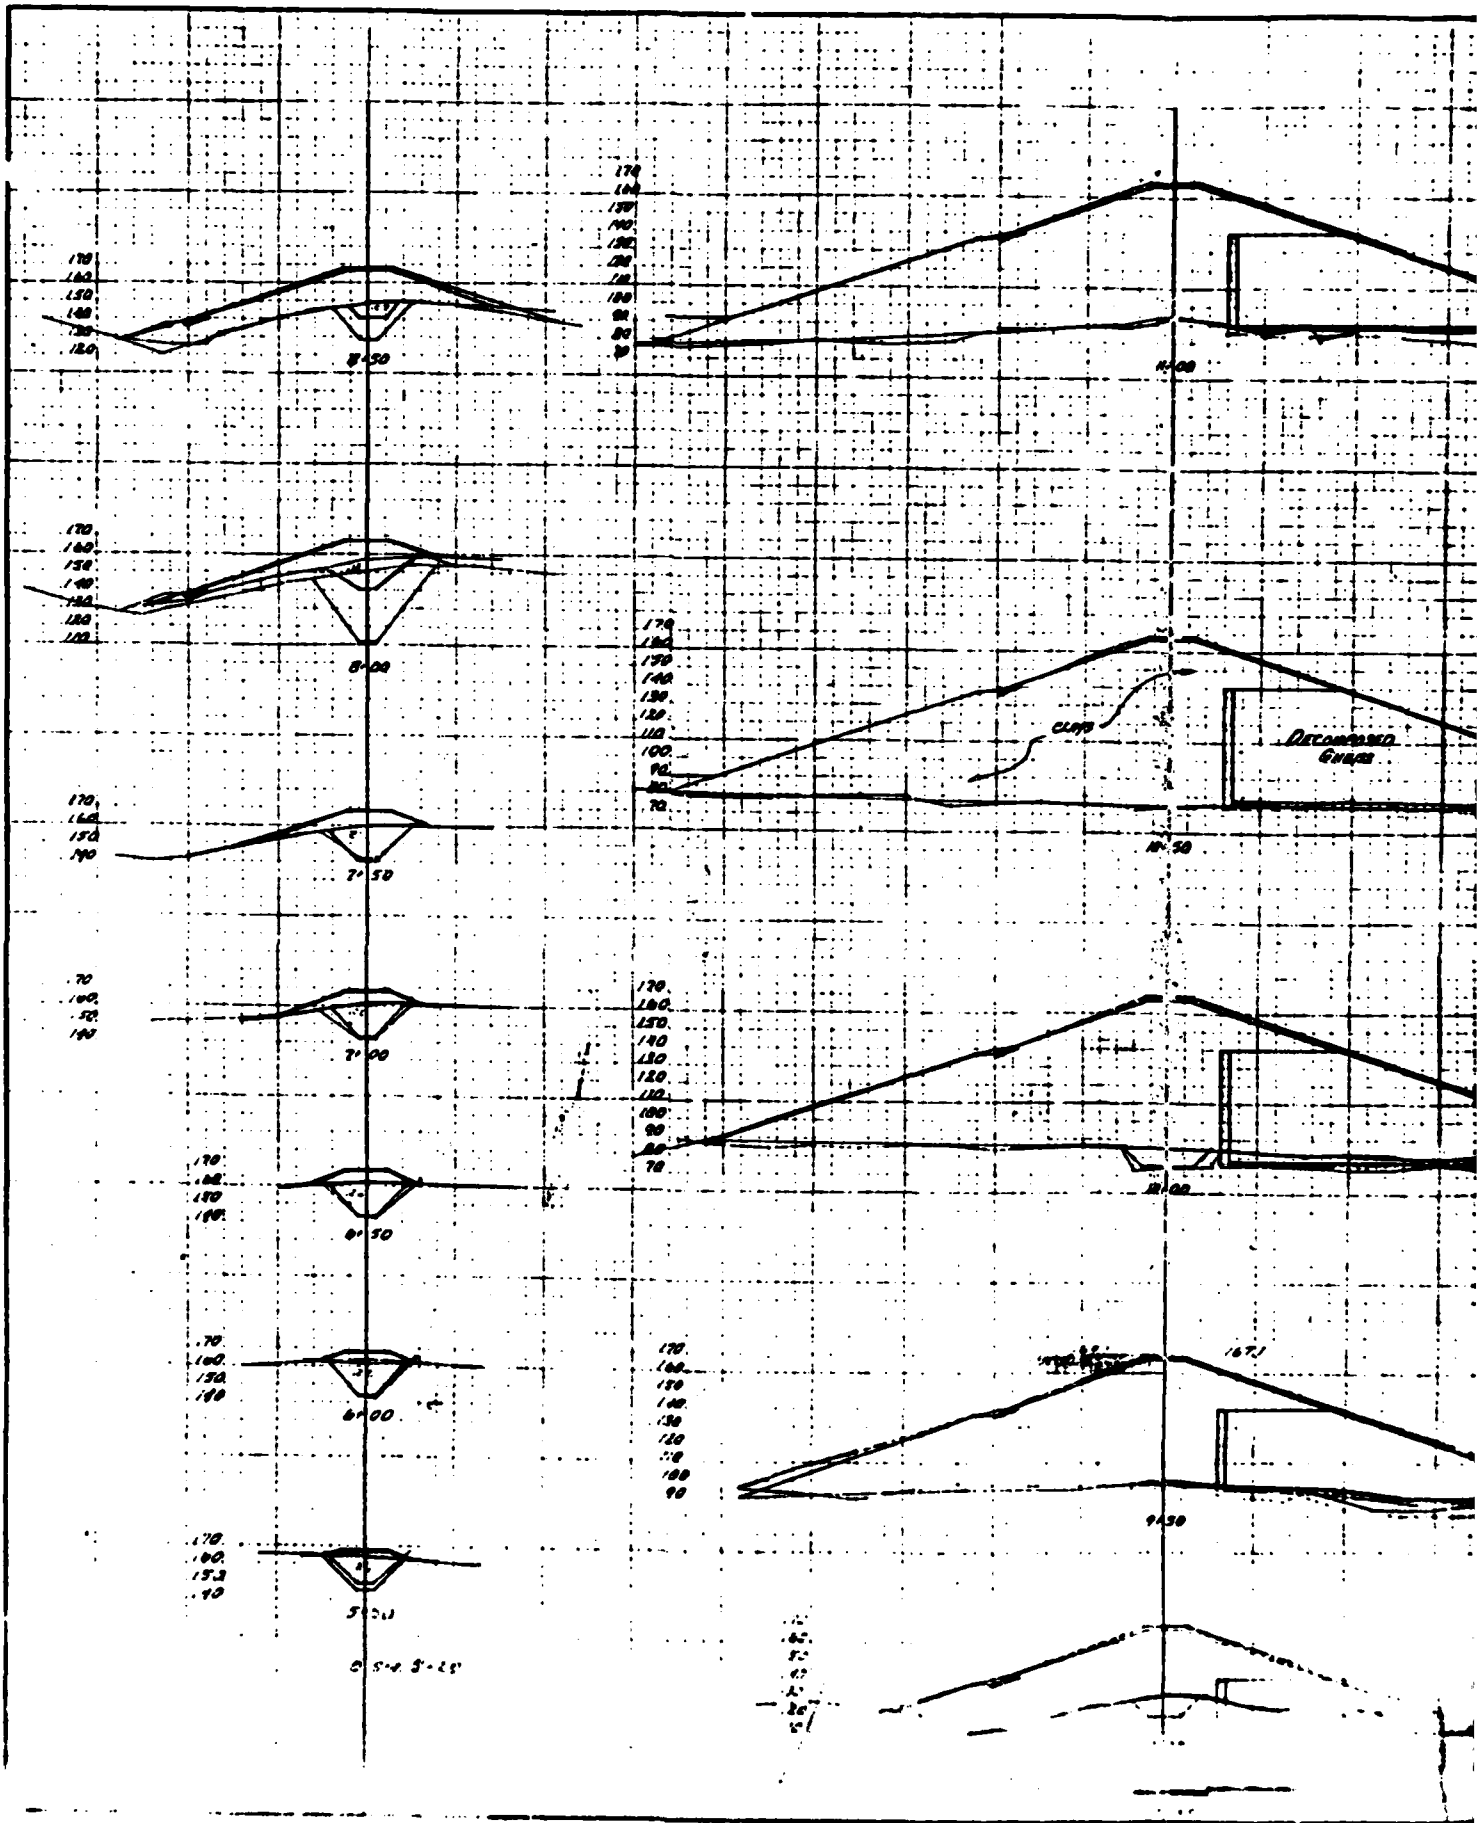
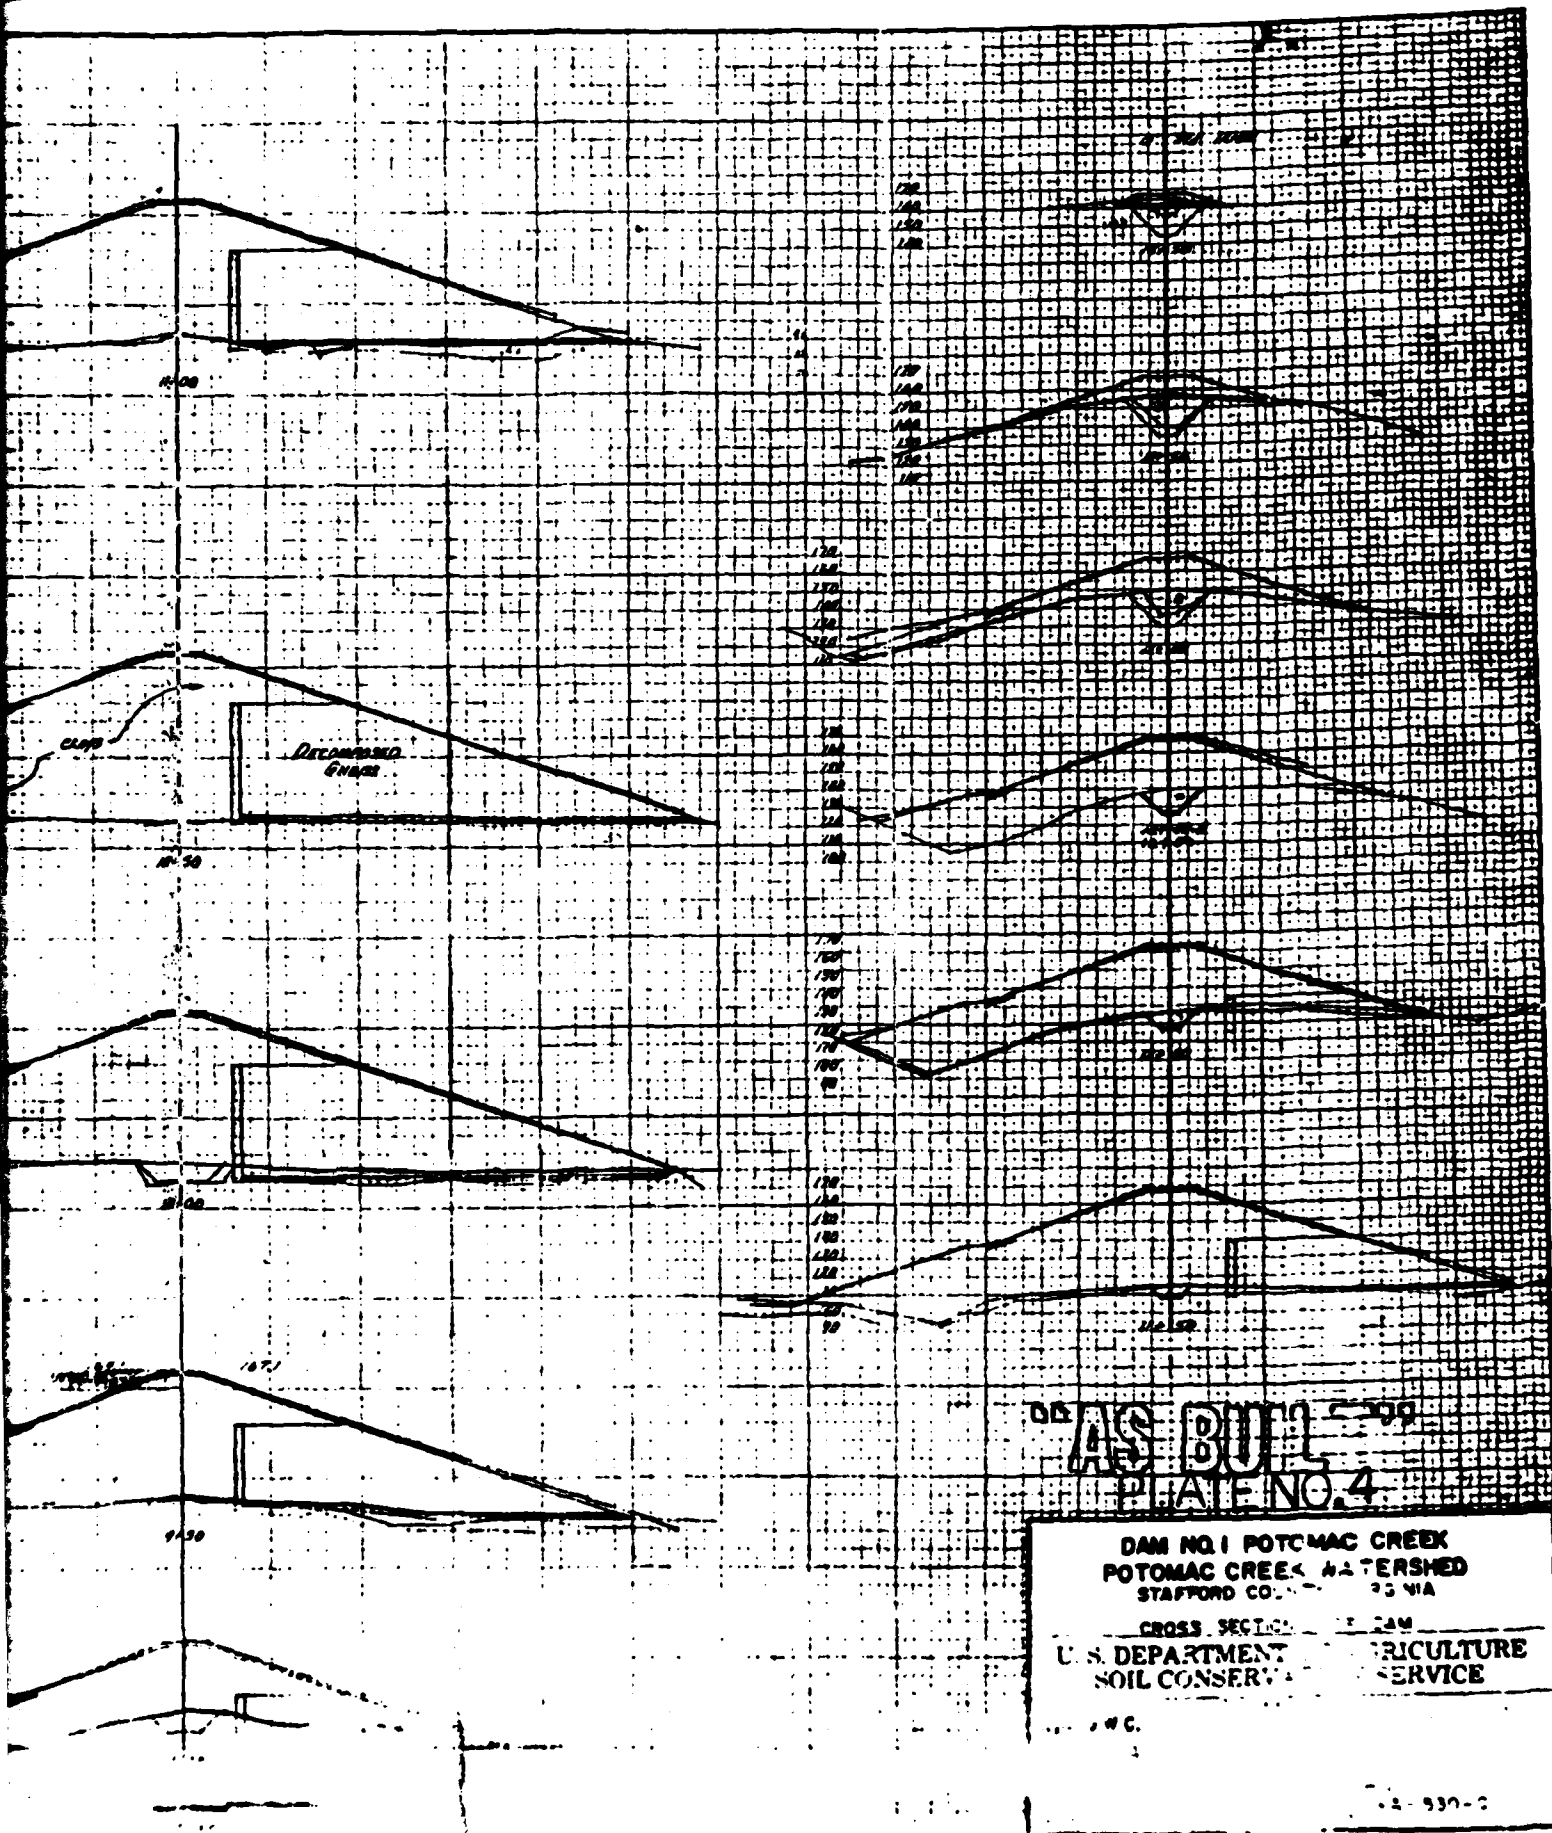
AS BULL
 PLATE NO. 4

A review of design drawings indicates the dam is founded on overburden and includes a cutoff trench which extends into "firm unweathered rock" (See Plate No. 5, Appendix I). Pressure test data developed in Boring B-1 and B-3 show the overburden materials are susceptible to water loss under pressure. However, water loss was negligible below elevation 120± to 115± in the unweathered bedrock. The foundation report indicated that the decomposed gneiss underlying the site would be subject to piping, ravelling and erosion in its natural state and possibly in a compacted state.

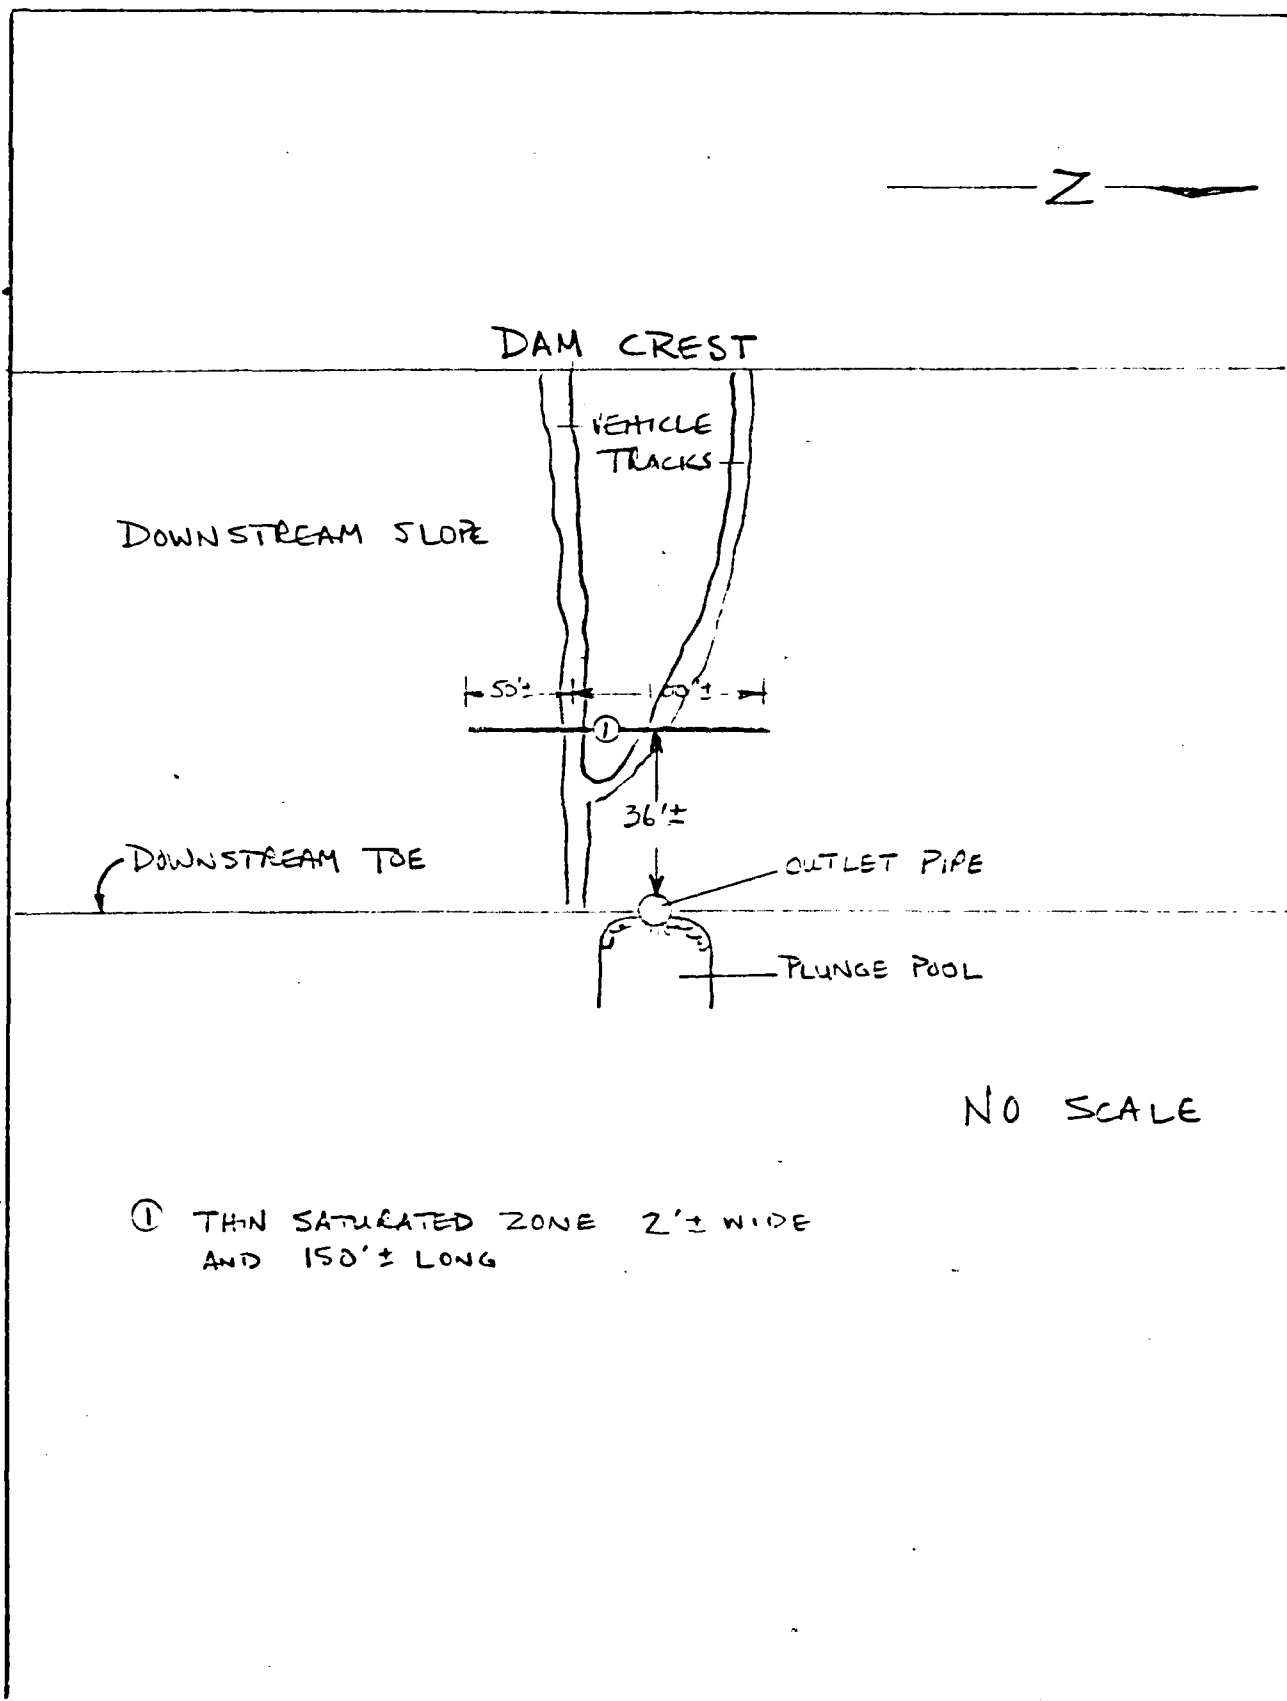
① THIN SATURATED ZONE 2'± WIDE
AND 150'± LONG

g) The thin saturated area present on the downstream slope should be monitored during normal maintenance operations, particularly once normal pool levels are resumed, in order to verify that this condition is not related to seepage passing through the dam. If increased saturation or flow should occur, a professional Geotechnical Engineer should be contacted to evaluate the problem and make recommendations for required corrective measures.
