POTOMAC CREEK NO. 2

STAFFORD COUNTY, VIRGINIA

VA. NO. 17913

# PHASE I INSPECTION REPORT NATIONAL DAM SAFETY PROGRAM

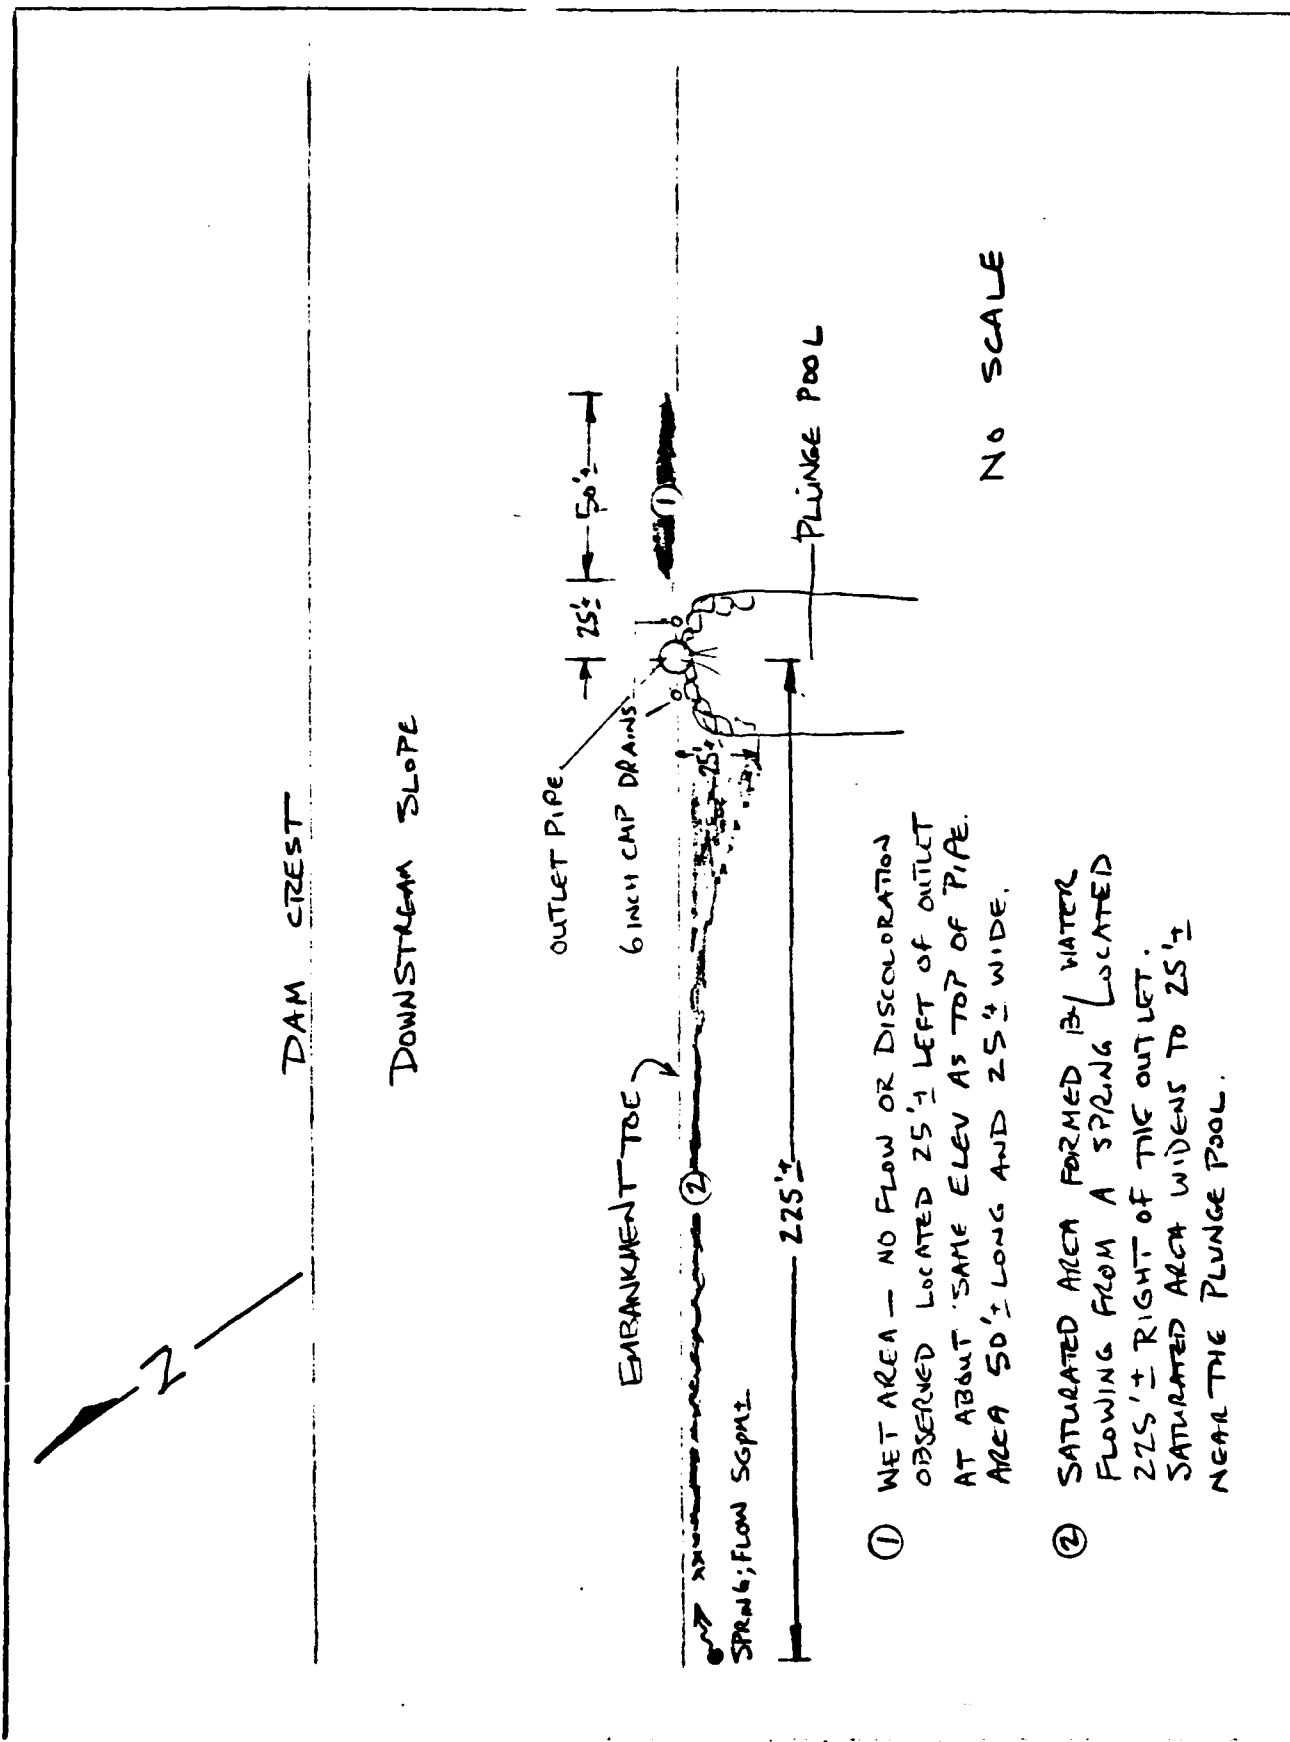
SHEET NO 1 OF 1  
 JOB NO. V80199

is roughly 50 ft long, 25 ft wide and begins 25 ft left of the outlet. No flow or discoloration of water was observed. This area is believed to represent ponded water from recent rains. The second area is a 225 ft<sup>±</sup> long saturated zone, which occurs to the right of the outlet, along the toe of the downstream slope. This saturated condition is the result of water flowing at approximately 5 gpm from a spring located immediately downstream from the embankment toe. This water flows down gradient along the toe of the slope toward the plunge pool. The area of saturation increases to a width of 25 ft<sup>±</sup> near the outlet. Both saturated areas are illustrated on Sheet 1 of Appendix III.

The saturated area located to the left of the outlet pipe is believed to be the result of ponded surface runoff. It is recommended that this area be monitored during routine maintenance operations in attempt to verify that it is not the result of seepage through the embankment. The saturated area located to the right of the outlet is the result of flow from a nearby spring. This saturated condition is not believed a hindrance to normal performance of the dam.

| VISUAL EXAMINATION OF | OBSERVATIONS | REMARKS OR RECOMMENDATIONS |
|---|---|---|
| ANY NOTICEABLE SEEPAGE | A wet or saturated area was encountered 25 ft left of the outlet pipe at the downstream toe. No water flow or discoloration was noted. The ground to the right of the outlet pipe is also saturated as a result of water flowing from a small spring located 225 ft west of the pipe at an estimated rate of 5 gpm. See the accompanying field sketch, Sheet 1. | The wet area to the left of the outlet pipe is believed to represent accumulated surface runoff. This area should be monitored to verify its origin. |

d) The saturated area located to the left of the outlet pipe should be monitored during routine maintenance in attempt to verify that it is not the result of seepage through the embankment. If increased saturation or flow should occur, a professional Geotechnical Engineer should be contacted to evaluate the problem and make recommendations for required corrective measures.
