4. TITLE (and Subtitle) Phase I Inspection Report National Dam Safety Program Edmondson Dam Washington County	5. TYPE OF REPORT & PERIOD COVERED Final

PHASE I INSPECTION REPORT.  
NATIONAL DAM SAFETY PROGRAM

**Name of Dam:** Edmondson Dam  
**State:** Virginia  
**Location:** Washington County  
**USGS Quad Sheet:** Damascus, Va.  
**Stream:** Middle Fork Holston River  
**Date of Inspection:** 5 June 1980

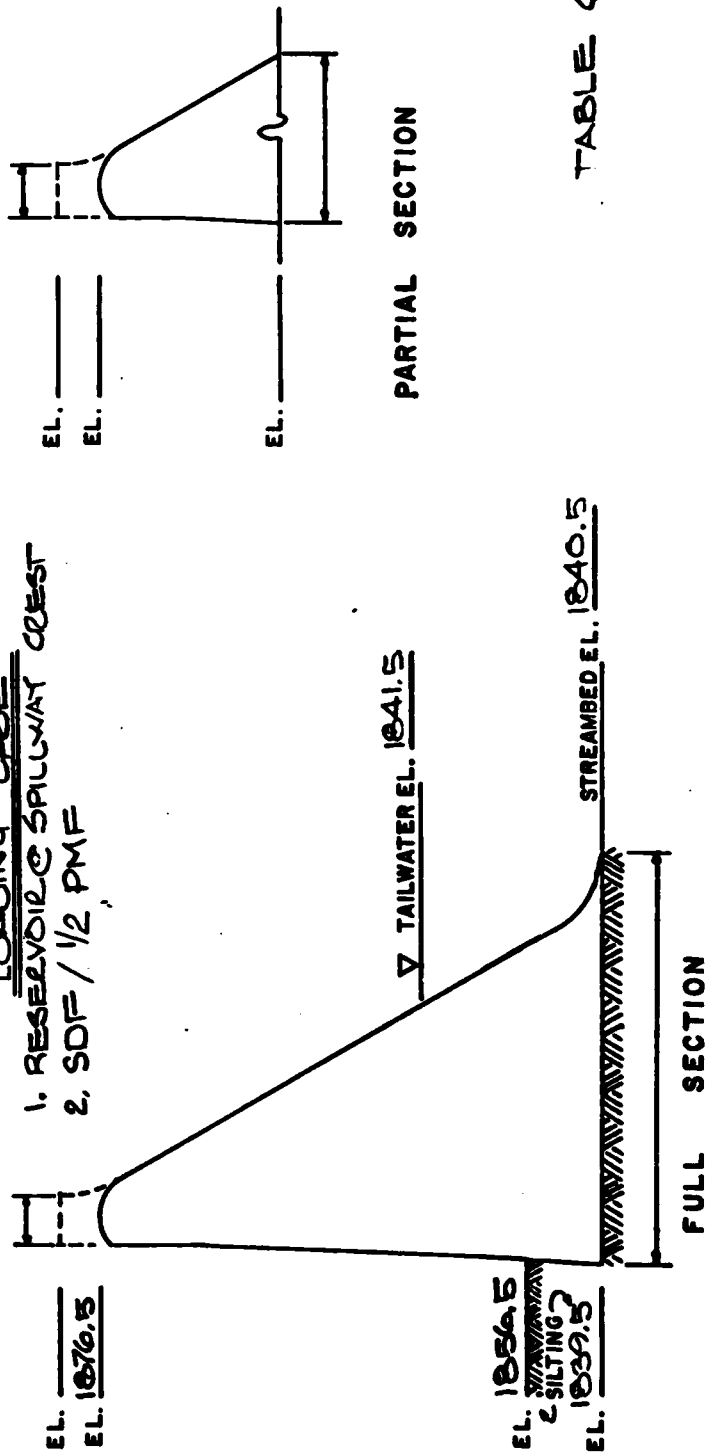
TABLE 6.1

**6.1 Stability Analysis:** A preliminary stability analysis was performed based on a sketch by William C. Whitner & Co., Inc., Cons. Engineers, Richmond, Virginia, dated 2 May 1925. The sketch is titled "Section of Dam, Edmondson Electric Co." (see Plate II). The results of this analysis indicate that the dam is stable under normal conditions with reservoir level at the crest of the dam. When the spillway design flood is applied, however, the dam is on the verge of overturning failure with no margin of safety. Results of the stability analysis are summarized in Table 6.1. The spillway design flood, using present day criteria, is considered to be the 1/2 PMF for this structure (see Section 5.8). Since no original calculations are available, the basis of design is unknown.

LOADING CASE	ELEV. HEAD WATER	ELEV. TAIL WATER	$\Sigma V$	$\Sigma H$	$\frac{\Sigma H}{\Sigma V}$	LOCATION RESULTANT FROM TOE	% BASE IN COMPRESSION	FACTOR SAFETY SLIDING	FOUNDATION PRESSURE	
									TOE	HEEL
1	1876.5	1841.5	79.7 K	47.6 K	0.6	16.4 FT.	100%	2.6	39 PSI	22 PSI
2	1892.5	1865.0	49.9 K	64.3 K	1.3	2.5 FT.	12%	1.5	-	-
