Name Of Dam: SOUTH RIVER NO. 3

PHASE I INSPECTION REPORT
NATIONAL DAM SAFTY PROGRAM

MAY 1980

Name of Dam: South River #3
State: Virginia
Location: Augusta County
USGS Quad Sheet: Vesuvius
Stream: Poor Creek
Date of Inspection: 16 April 1980

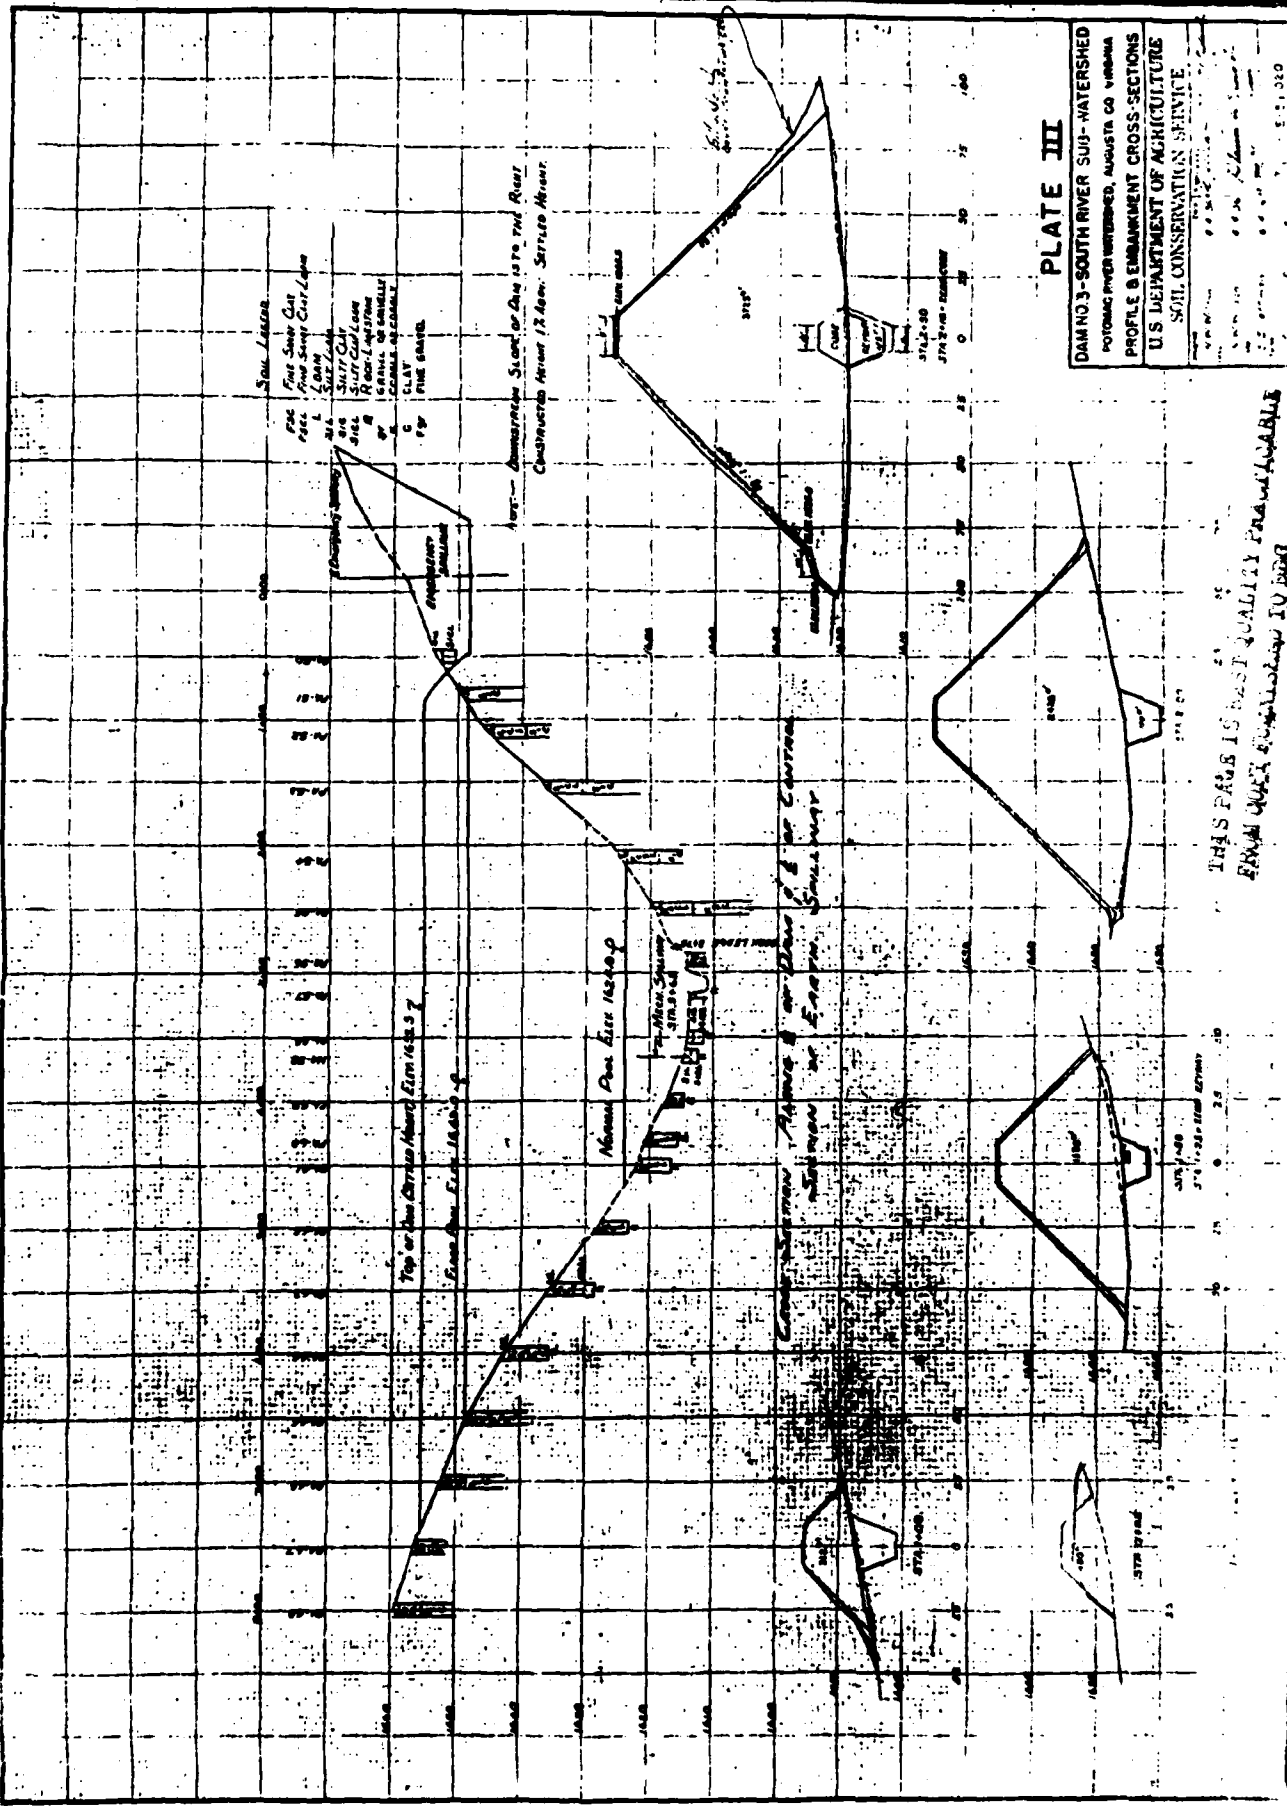
PLATE III

6.1 Foundation and Abutment: Test boring logs on the design drawings indicate the foundation materials to be silty clays with fine sand overlying limestone. (See Plate 3, Appendix I). The dam is located within the valley and ridge physiographic province consisting of undulating hills of low topographic relief. Limestone outcrops in the area strike perpendicular to the dam axis with a rear vertical dip. The rock is thin bedded, fine grained, and has calcite stringers. The foundation material is generally impervious but bedding planes enhance seepage. As noted in the visual inspection there is a wet spot on the downstream right abutment and a spring downstream of the toe. Based on the drawings, the dam is keyed into bedrock and has a toe drain. Overall the foundation is considered stable.
