NAME OF DAM: AVIATION, GOLF AND FARM CLUB DAM
LOCATION: BATH COUNTY, VIRGINIA
INVENTORY NUMBER: VA. NO. 01703

PHASE I INSPECTION REPORT
NATIONAL DAM SAFETY PROGRAM

BY
SCHNABEL ENGINEERING ASSOCIATES, P.C./
J. K. TIMMONS AND ASSOCIATES, INC.

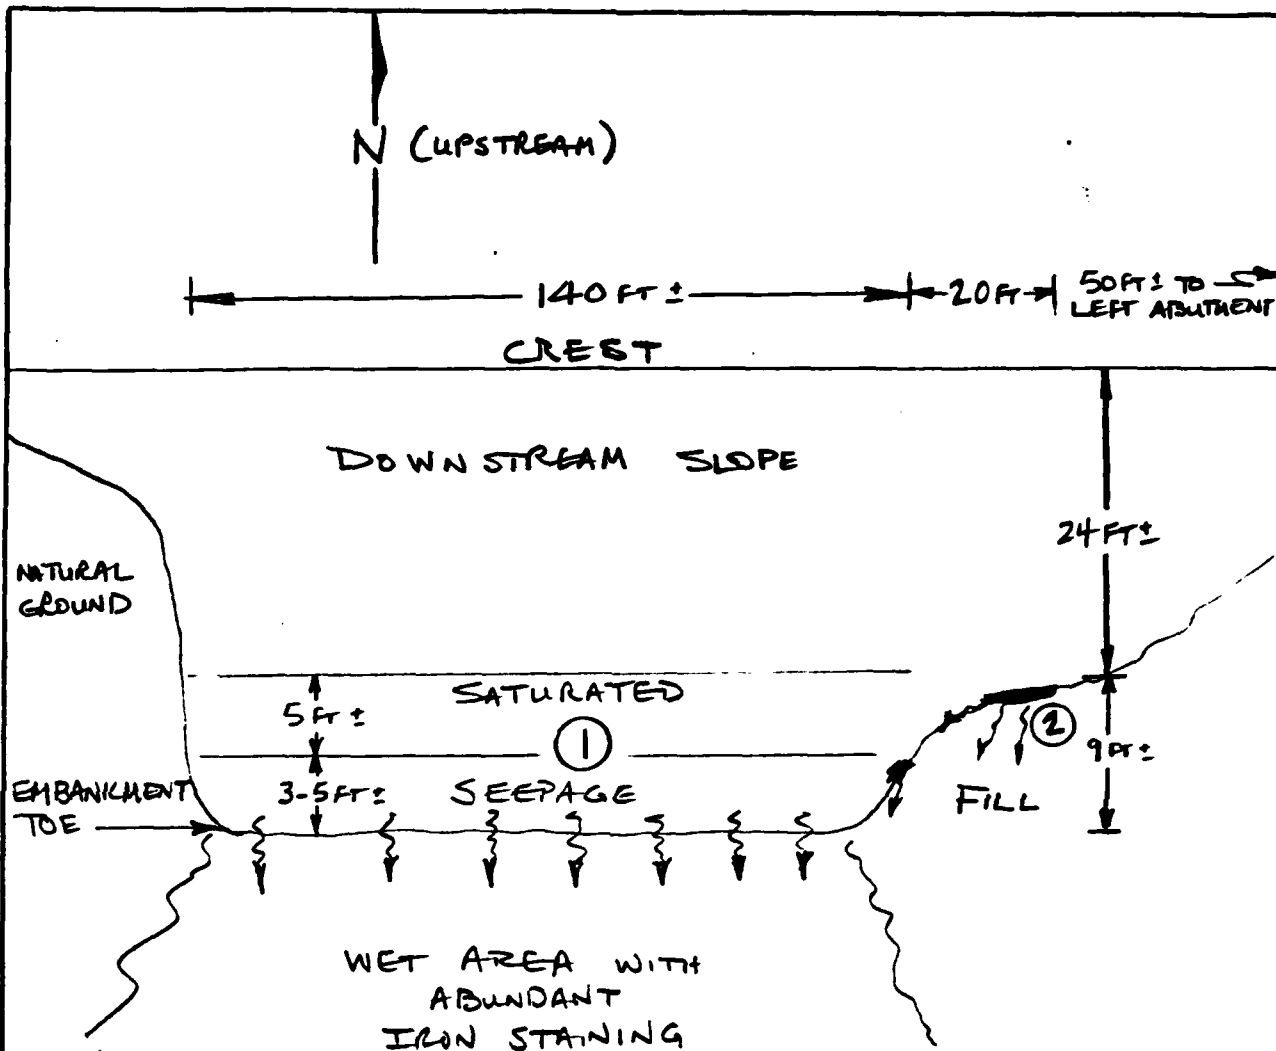
Considerable seepage with accompanying iron staining was observed along the toe of downstream slope. Seepage was present along the basal 3 to 5 ft while saturated conditions existed 5 to 10 ft above the lowest point of the downstream slope. Additional seepage was located along the edge of the left abutment. See the accompanying field sketch, Sheet 1.

- ① SEEPAGE CONCENTRATED IN BASAL 3-5 FT ± WITH SCATTERED FLOW AT LESS THAN 1 GPM. SATURATED SLOPE APPROXIMATELY 5 FT WIDE EXISTS ABOVE THE BASAL AREA.
- ② AREA OF LOCALIZED SEEPAGE ; 20 FT ± LONG AND 5 FT ± WIDE WITH ABUNDANT IRON STAIN. OBSERVED FLOW LESS THAN 1 GPM.

7.3.1 Widespread seepage present along the downstream slope should be monitored quarterly and after periods of high pool levels in the reservoir to detect any increases in flow rates which may cause piping within the embankment.

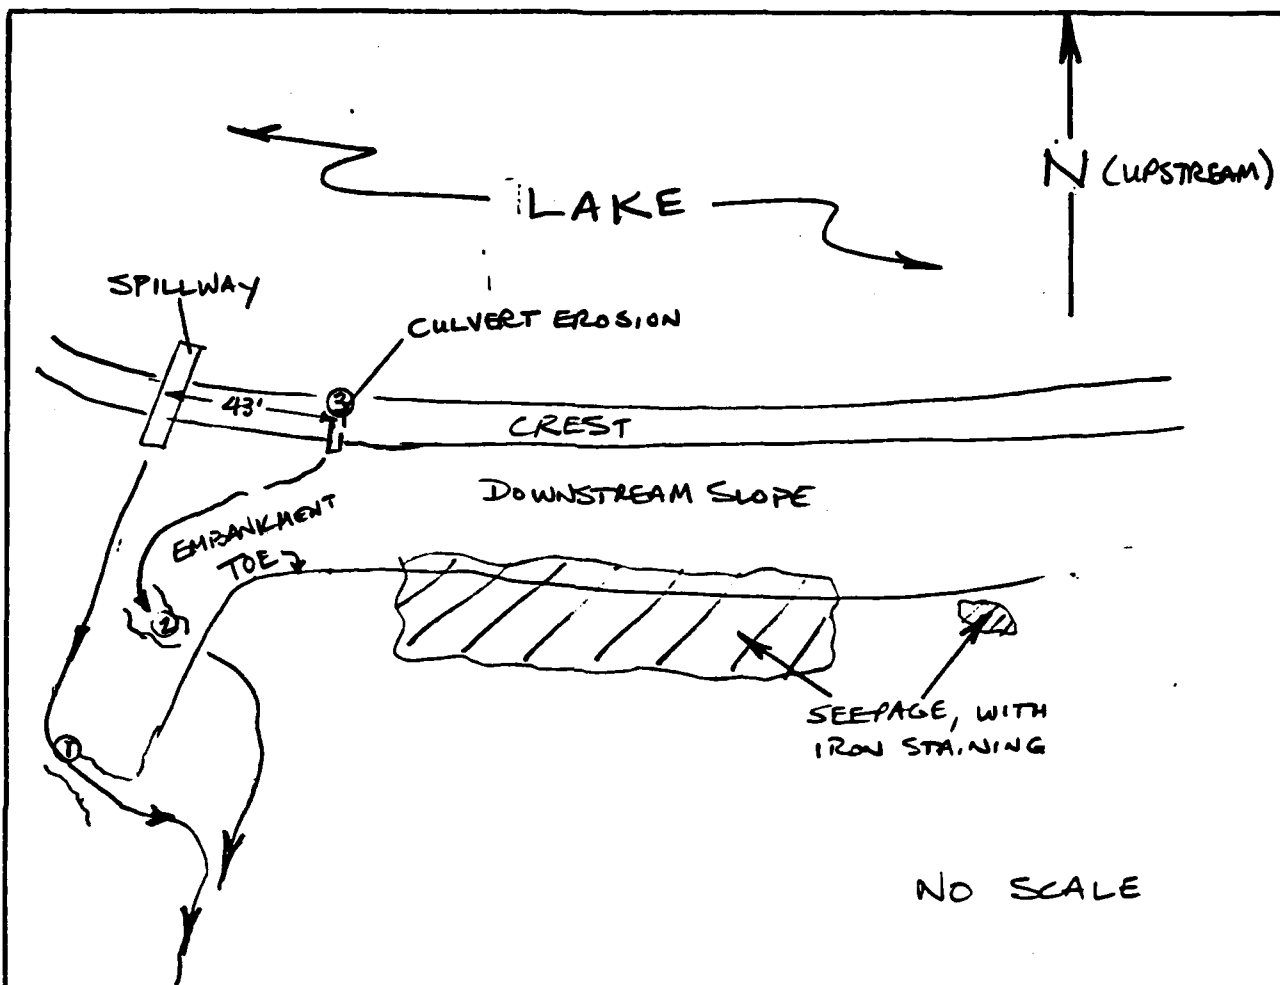
The spillway outlet pipes of the principal spillway showed no signs of deterioration, however, the outlet channels for these pipes were eroded at the plunge pool area due to a lack of riprap. The lower end of the outlet channels were badly eroded and include approximately 20 ft vertical drops in their channels in approximately a 5 ft horizontal distance. See the field sketch, Sheet 2, Appendix III.

- ① ERODED AREA IN MAIN SPILLWAY CHANNEL; 20-25 FT ± WIDE, 15 FT ± DEEP. PRESENTLY UNDERMINING A LARGE TREE BOUNDING THE NORTH SIDE OF CHANNEL.
- ② ERODED AREA OFF MAIN CHANNEL; 10-20 FT ± WIDE AND 15 FT ± DEEP. FILLED IN PART WITH LARGE BLOCKS OF ROCK
- ③ EROSION FROM EDGE OF POOL TO POINT 7 FT ± INWARD. ERODED AREA IS 7 FT ± LONG, 3 FT ± WIDE AND 4 FT ± DEEP. EROSION IS AROUND 16" ± CMP

Repairs needed where outlet channels are eroded.
