4. TITLE (and Subtitle) Phase I Inspection Report National Dam Safety Program Silver Lake Dam Rockingham County, Virginia		5. TYPE OF REPORT & PERIOD COVERED Final

NAME OF DAM: SILVER LAKE DAM  
 LOCATION: ROCKINGHAM COUNTY, VIRGINIA  
 INVENTORY NUMBER: VA. NO. 16508

PHASE I INSPECTION REPORT  
 NATIONAL DAM SAFETY PROGRAM

PHASE I INSPECTION REPORT  
NATIONAL DAM SAFETY PROGRAM  
SILVER LAKE DAM  
VA. NO. 16508

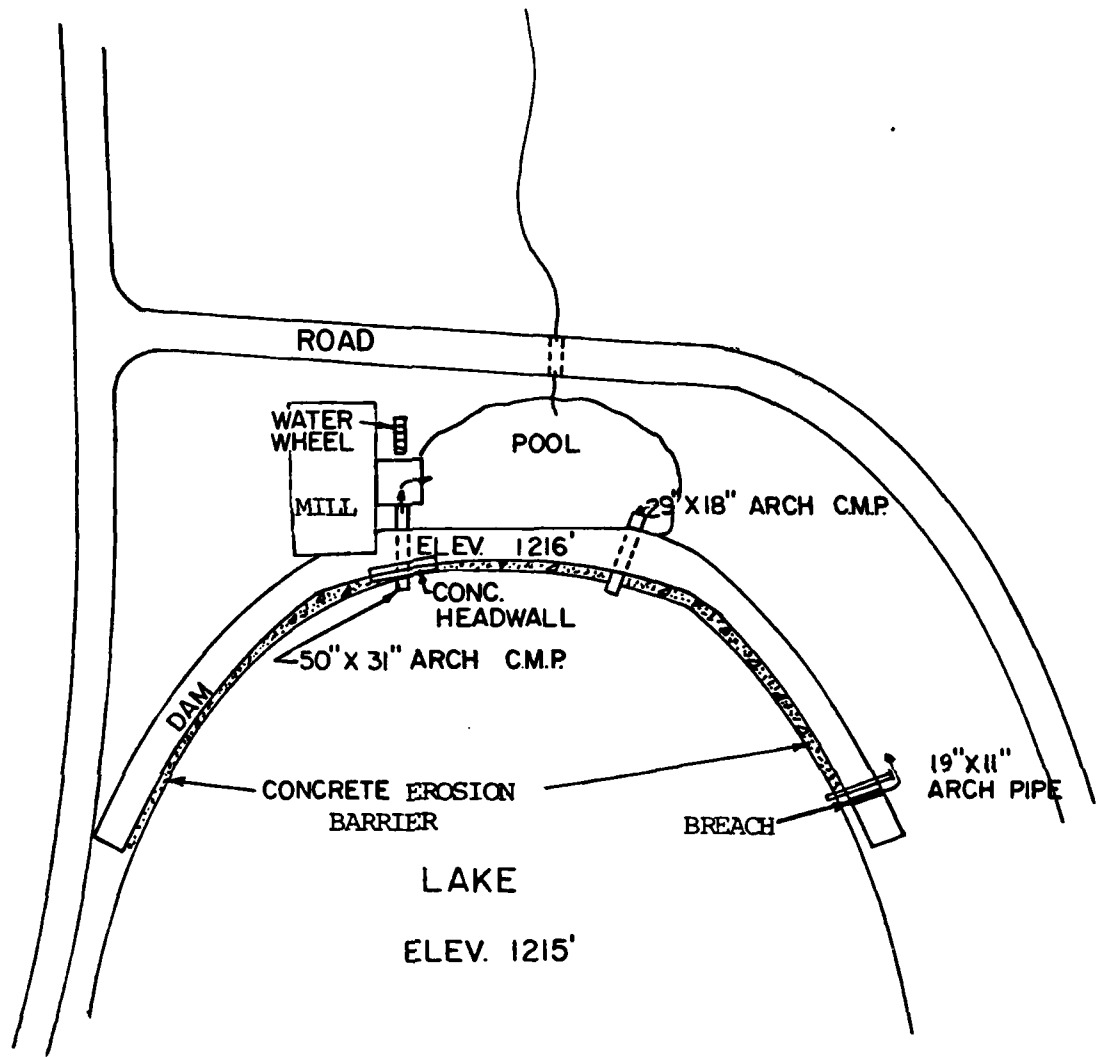
PLATE NO. 2

The 50" x 31" arch pipe empties into a side discharge concrete weir spillway originally used to propel a waterwheel. The side discharge spillway crest elevation is at normal pool (elevation 1215 msl). The 29" x 18" arch pipe discharge is located near the center of the dam with an invert at elevation 1214.5 msl. The 19" x 11" arch pipe is near the right abutment with an invert at elevation 1215 msl (See Plate No. 2, Appendix I).

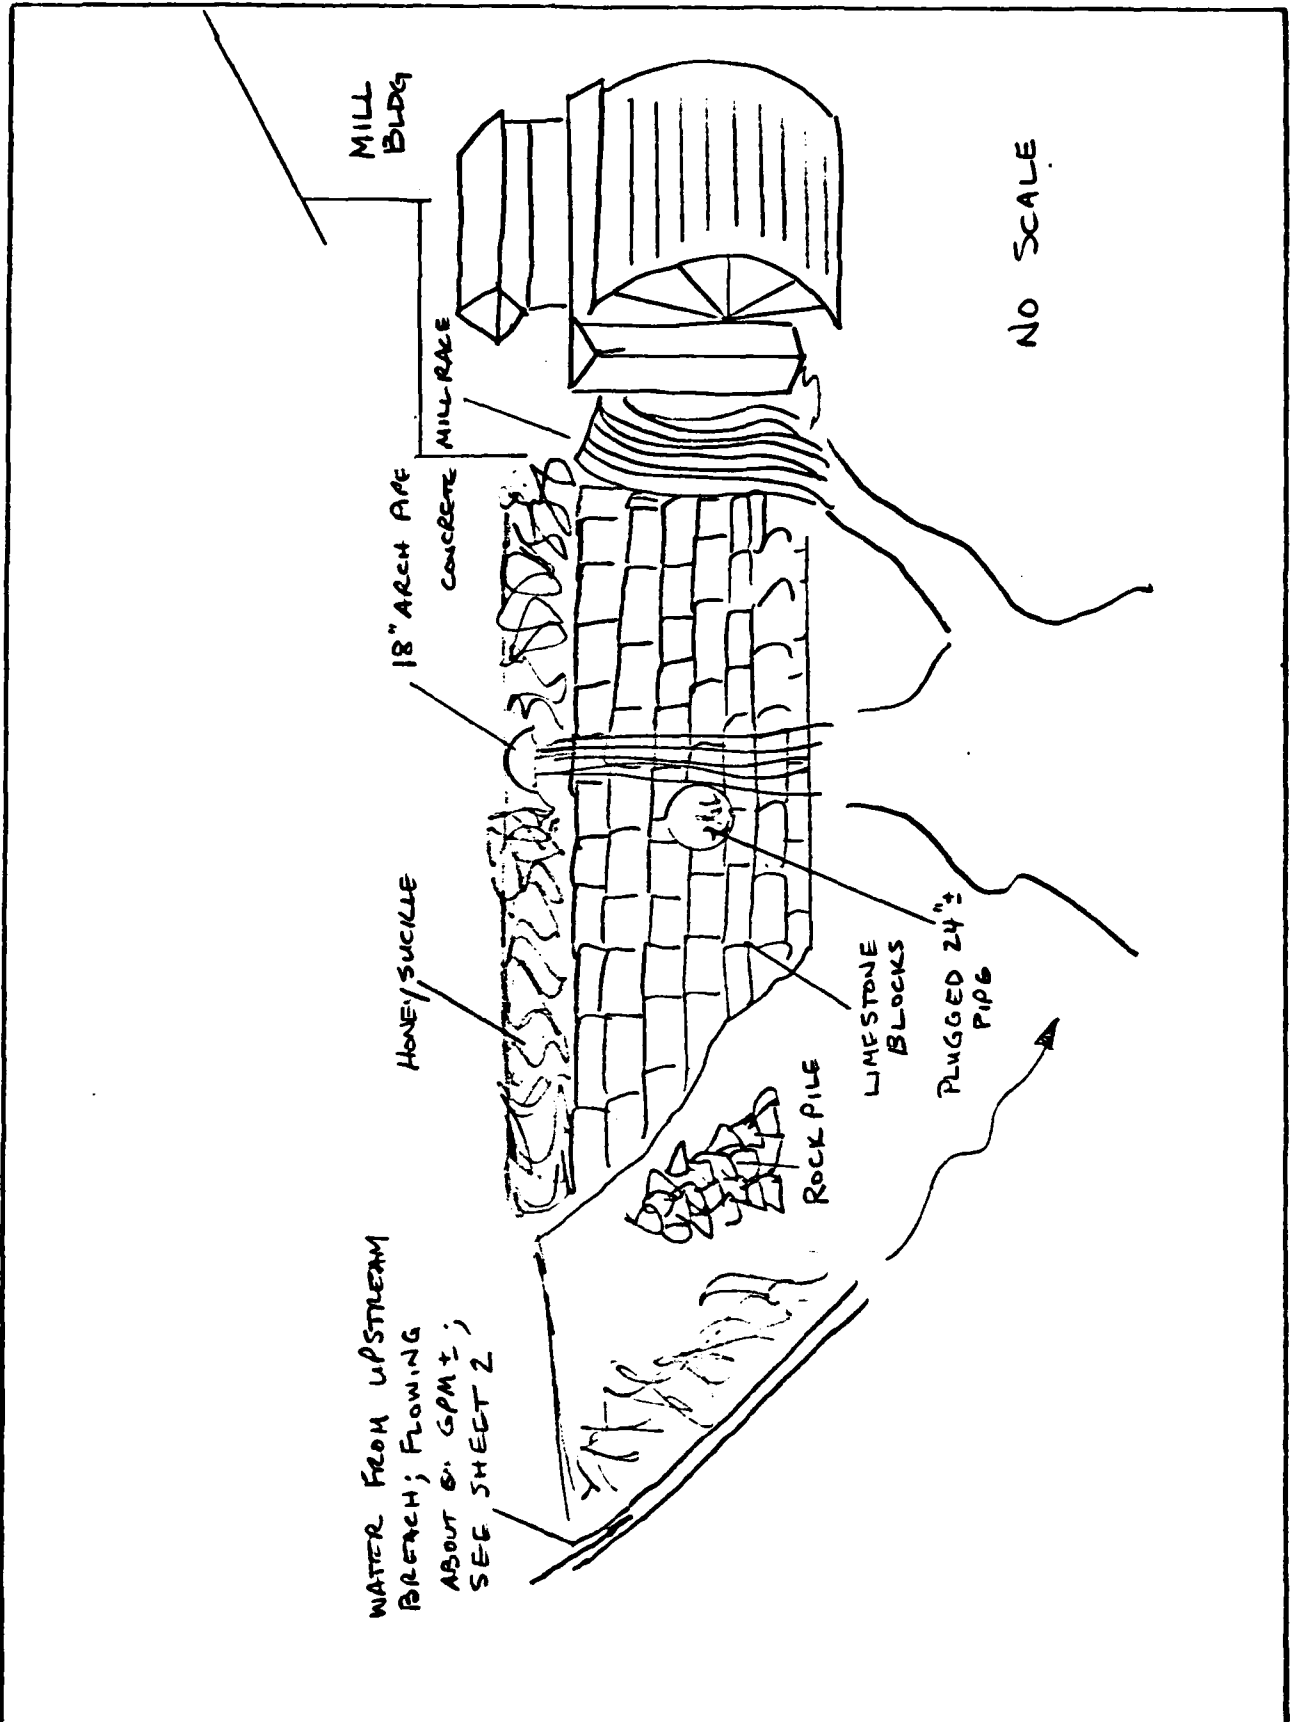
SHEET NO. 1 OF 2  
JOB NO. V80103

WATER FROM UPSTREAM  
BREACH; FLOWING  
ABOUT 60 GPM ±;  
SEE SHEET 2

3) The eroded area located at the right abutment should be corrected in order to prevent continual or increased flow of water and associated erosion in the earthen portion of the dam.
