Name Of Dam: NEWMAN LAKE DAM

Location: HARRISONBURG, VIRGINIA

Inventory Number: VA. NO. 66001

PHASE I INSPECTION REPORT NATIONAL DAM SAFETY PROGRAM

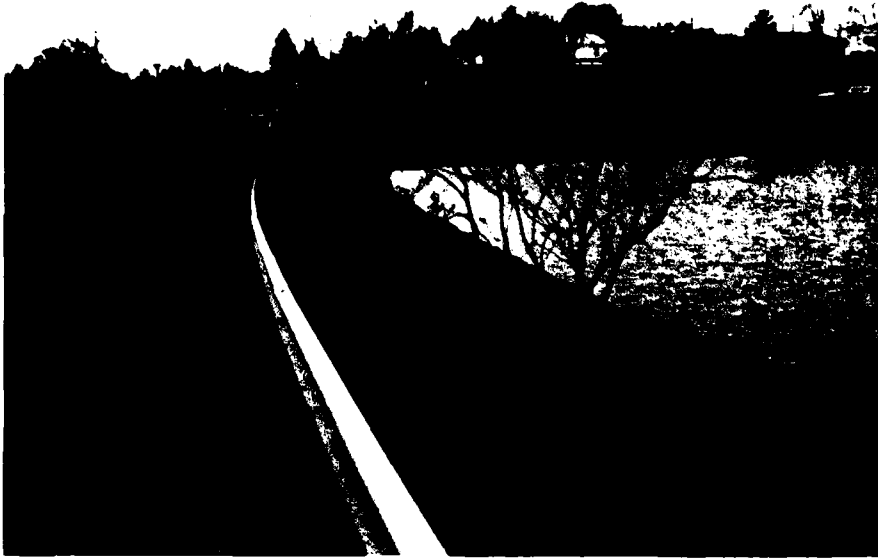
Photograph No. 1

The shallow washes described on the upstream slope do not present any problem. The presence of a good vegetative cover at wave level on the upstream slopes appears to be controlling wave erosion, consequently corrective measures are not believed necessary. The muskrat holes do not presently create an unsafe condition, however, future burrowing could result in numerous voids in the embankment which could be potentially hazardous under certain conditions. It is recommended that the existing holes be backfilled and that any future burrows be backfilled as they appear.

Upstream Face of Dam

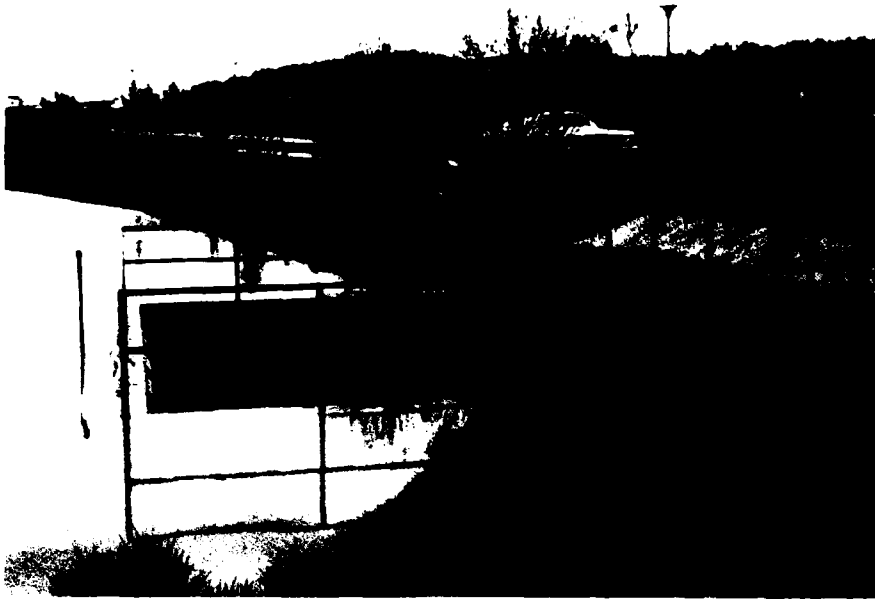
Photograph No. 4

The intake structure showed no signs of deterioration and the drain gate was reportedly in operational condition. The double 10 ft x 12 ft

Intake Structure

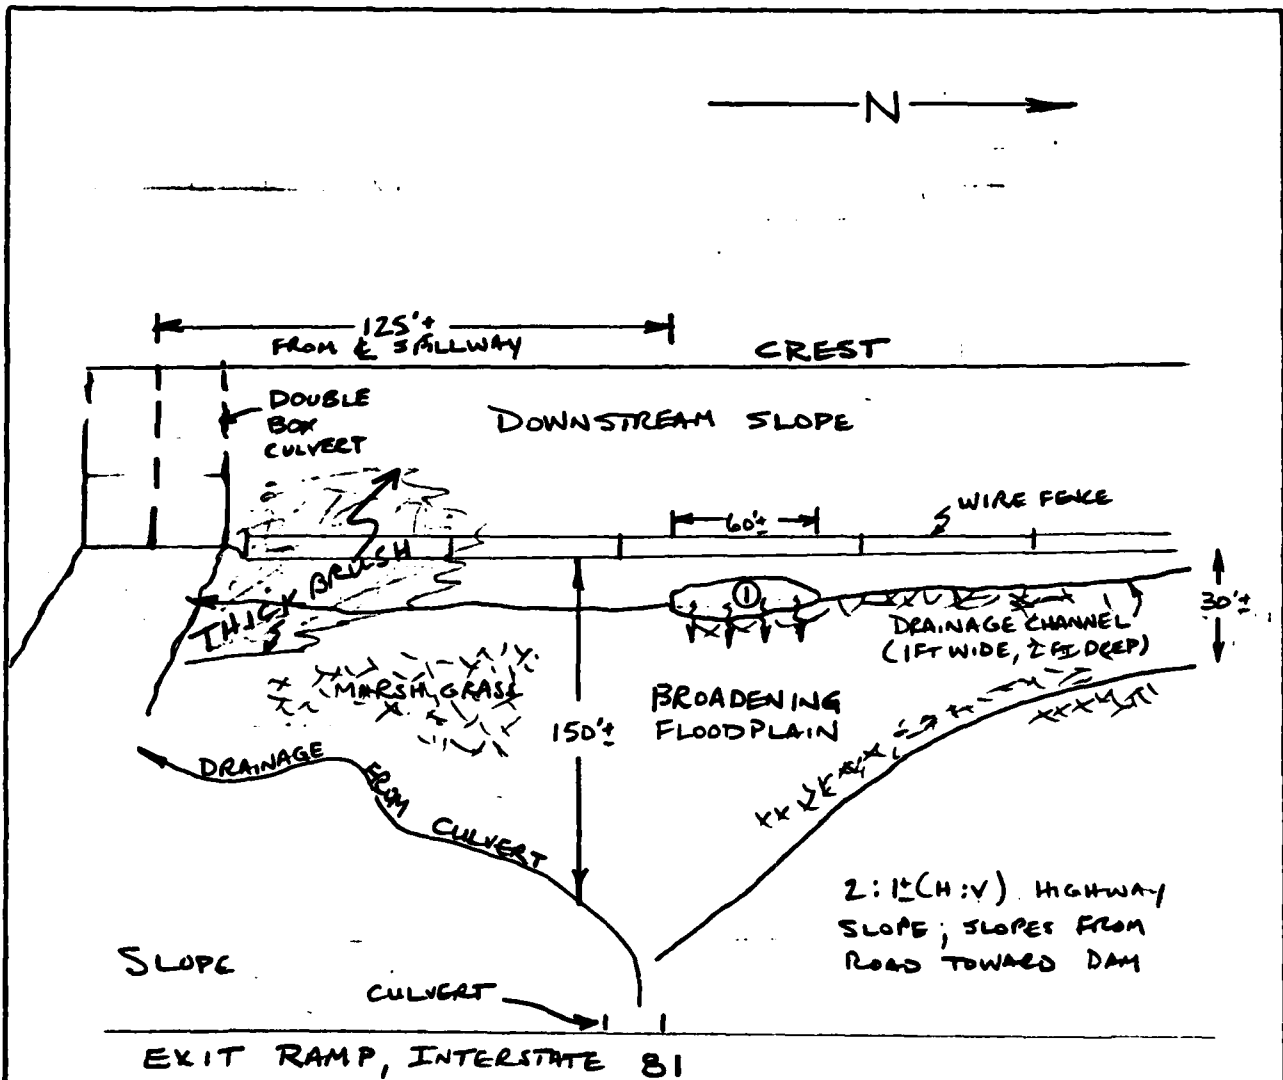
SHEET NO. 1 OF 2
JOB NO. V.80106

Seepage was observed in an area approximately 60 ft long and 20 ft wide along the toe of the downstream slope at a point roughly 125 ft left of the spillway centerline. Although no flow or turbidity was observed, the area did include iron staining. Much of the area below the downstream slope was water saturated as a result of previous rainfall. Only those areas exhibiting iron staining were identified as seepage. It is likely that the wet marshy area near the box culvert is also the result of seepage through the dam. A field sketch is provided as Sheet 1 of Appendix III.

A single area of seepage approximately 60 ft long and 20 ft wide was encountered along the toe of the downstream slope at a point 125 ft± left of the spillway centerline. Although no flow or turbidity was observed, the area did include iron staining. Rainfalls from the previous night resulted in the presence of scattered wet areas. Only areas exhibiting iron staining were positively identified as seepage. It is likely that the wet marshy area near the box culvert is also the result of seepage through the dam. A field sketch is provided as Sheet 1.

- ① SEEPAGE AREA APPROXIMATELY 20 FT WIDE. NO FLOW OR TURBIDITY OBSERVED, BUT DOES INCLUDE IRON STAINING.

7.3.1 Seepage present along the downstream toe should be monitored quarterly to detect any increase in flow rates which may cause piping within the embankment.

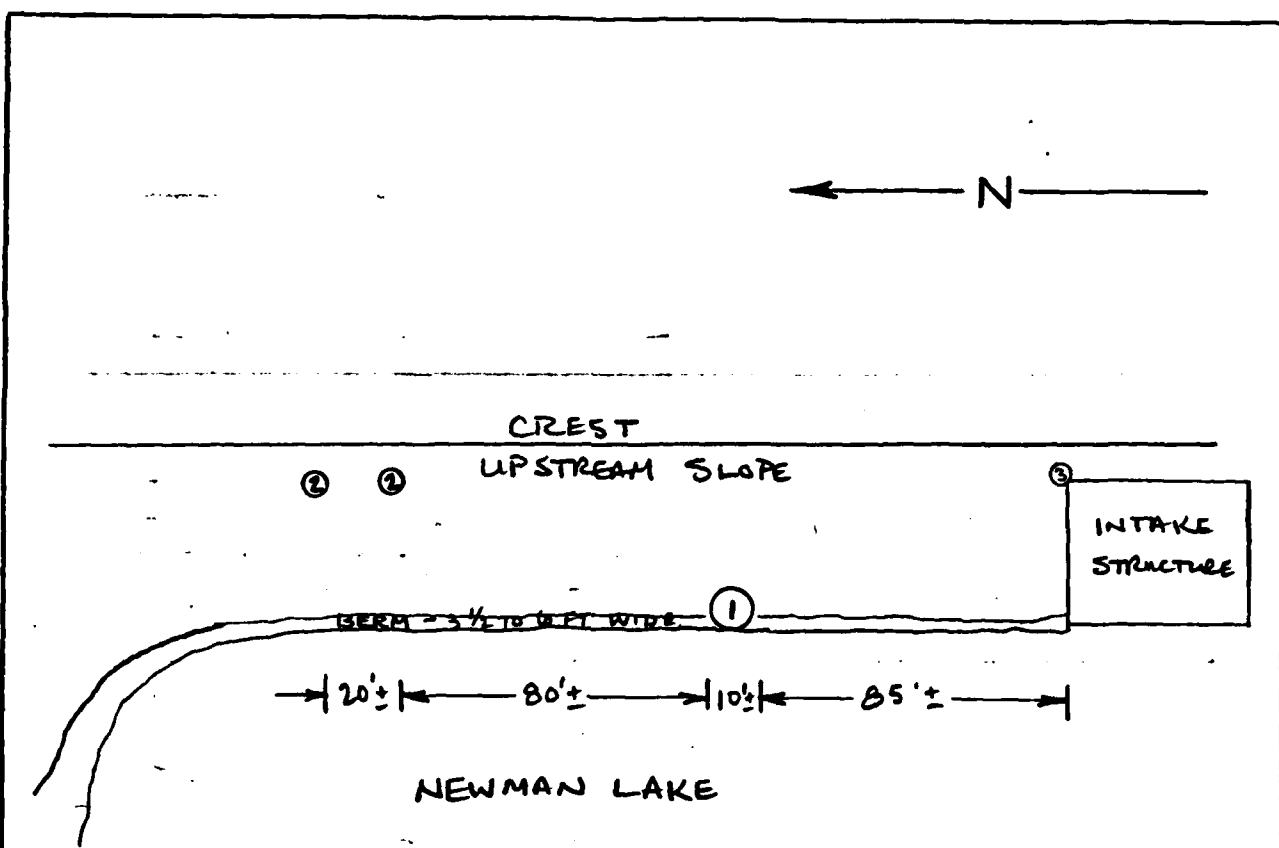
SHEET NO. 2 OF 2
JOB NO. V90106

- ① 10 FT ± WIDE AREA, NUMEROUS MUSKRAT (?) HOLES
- ② MINOR SURFACE EROSION; 6" DEEP, 1' WIDE, 2' LONG
- ③ MUSKRAT BURROW
