⑥ National Dam Inspection Program,
Number
DOVERSPIKE NO. 2 DAM
(NDI I.D. PA-00810,
DER I.D. 33-57), Ohio River Basin,
Caylor Run, Jefferson County,
Pennsylvania.
PHASE I INSPECTION REPORT,
NATIONAL DAM INSPECTION PROGRAM

NAME OF DAM: Doverspike No. 2 Dam
STATE LOCATED: Pennsylvania
COUNTY LOCATED: Jefferson
STREAM: Caylor Run, Tertiary Tributary of Mahoning Creek
SIZE CLASSIFICATION: Intermediate
HAZARD CLASSIFICATION: Significant
OWNER: J. C. Enterprises
DATE OF INSPECTION: April 24, 1980 and May 1, 1980

PHASE I REPORT
NATIONAL DAM INSPECTION PROGRAM
DOVERSPIKE NO. 2. DAM
NDI I.D. PA-810
DER I.D. 33-57

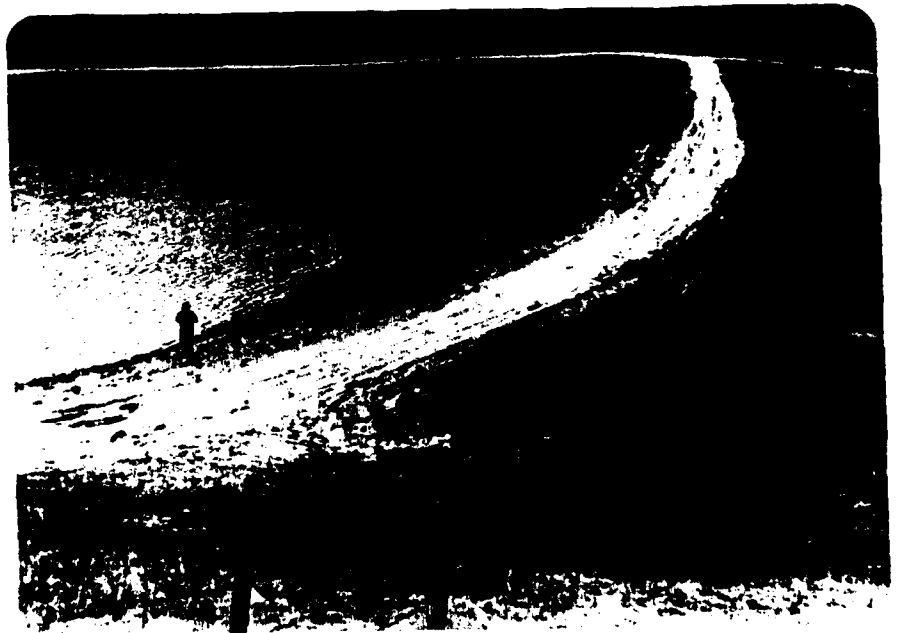
A low spot on the crest of the dam at the junction of the embankment and right abutment appears to be the intended spillway for the reservoir. This low area on the crest of the dam is approximately triangular in cross section with a top width of about 60 feet at the dam crest level and a depth of 2 to 2-1/2 feet from the mean dam crest elevation. No defined discharge channel exists below this low spot on the crest of the dam.

The crest of the dam was surveyed relative to the pool elevation on the date of inspection, and the crest profile is illustrated in Plate 4. A low area found on the crest of the dam near the right abutment appears to be the intended spillway overflow section for the reservoir. The downstream and upstream slopes of the dam were surveyed and found to be approximately 9H to 1V and 3H to 1V, respectively.

VISUAL EXAMINATION OF	OBSERVATIONS	REMARKS OR RECOMMENDATIONS
CONCRETE WEIR	A low spot on the crest of the dam near the right abutment appears to be the intended emergency overflow section for the dam.	
APPROACH CHANNEL	Lake	
DISCHARGE CHANNEL	None	
BRIDGE AND PIERS	None

Photograph No. 2
Crest (looking southeast). For ground: low area
on crest, possible emergency spillway.

3.2 Evaluation. The overall condition of the embankment is considered to be good. Installation of an overflow spillway with adequate discharge capacity, erosion protection and discharge channel is considered to be required.

In view of the above conditions, it is recommended that hydrologic and hydraulic features of the dam be evaluated by an experienced professional engineer to prepare plans to provide adequate spillway facilities to maintain a prescribed normal pool elevation and to have adequate flood discharge capacity.

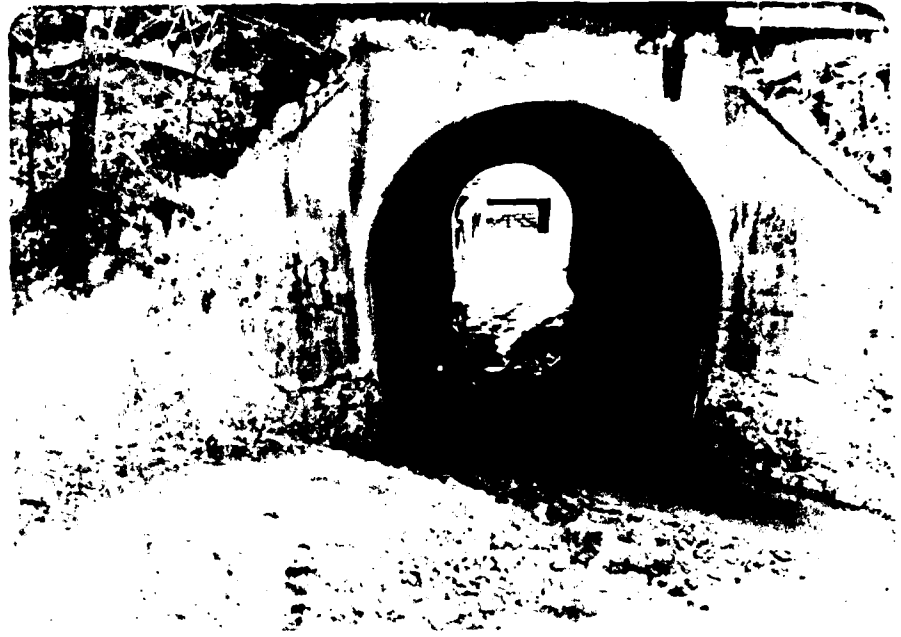
Photograph No. 3

A culvert under railroad embankment (approximately one mile downstream).

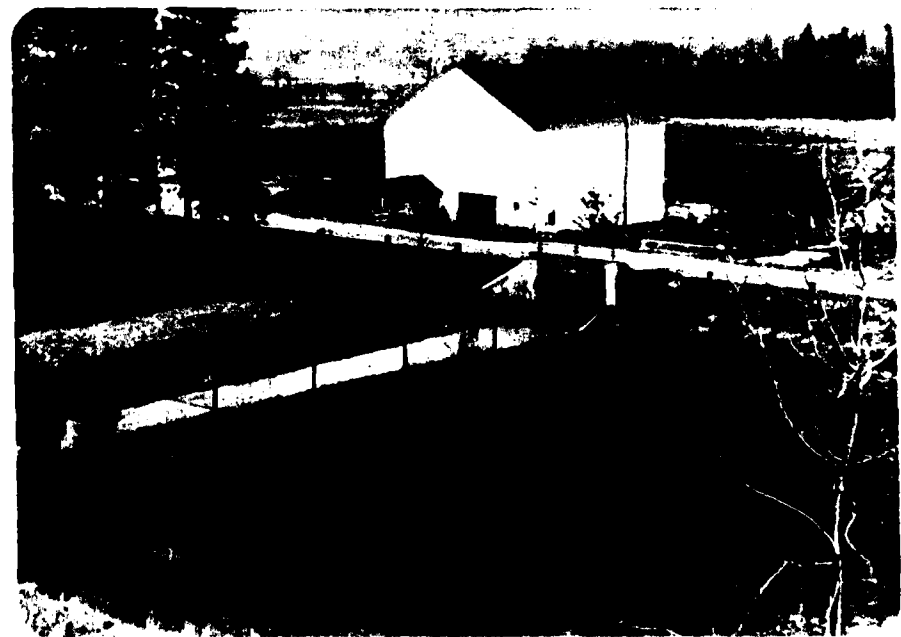
Photograph No. 4

d. Hazard Classification. The dam is classified to be in the significant hazard category. Below the dam, the valley is approximately 400 to 500 feet wide with gentle side slopes. A small stream originates approximately 500 to 600 feet downstream from the dam. The stream flows under a railroad embankment approximately one mile downstream from the dam and then joins Pine Run, a secondary tributary of Mahoning Creek. Rural residential areas are located downstream of the railroad embankment underpass. It is estimated that failure of the dam may cause loss of a few lives and property damage in the farms in the vicinity of the confluence of Caylor Run and Pine Run.

Farm, immediately downstream from railroad embankment.

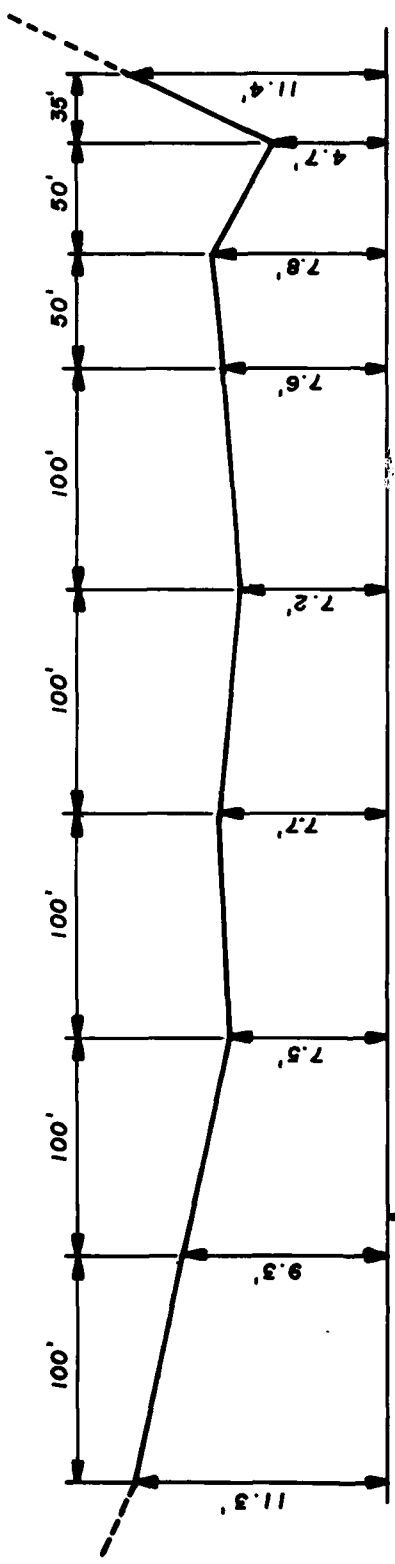
DAM CREST PROFILE
(LOOKING DOWNSTREAM)

d. Overtopping Potential. Various percentages of the PMF inflow hydrograph were routed through the reservoir, and it was found that the dam can impound less than 20 percent of the PMF without overtopping the low spot on the crest (Elevation 1404.7). For 40 percent of the PMF, it was found that only the low spot on the crest of the dam near the right abutment would be overtopped, and for 50 percent of the PMF, most of the crest would be overtopped for a duration of 4.8 hours with a maximum depth of about 0.5 foot.
