DEER LAKE DAM
FAYETTE COUNTY, COMMONWEALTH OF PENNSYLVANIA
NDI No. PA 01139
PennDER No. 26-53

(6) PHASE I INSPECTION REPORT,
NATIONAL DAM SAFETY PROGRAM.

Deer Lake Dam, Fayette County, Pennsylvania
NDI No. PA 01139, PennDER No. 26-53
Meadow Run
Inspected 22 July 1980

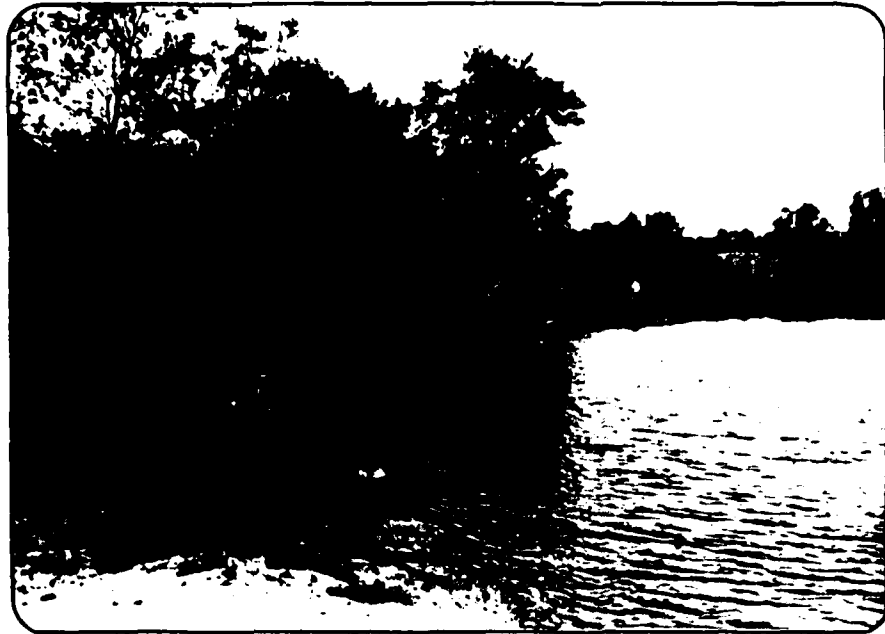
VISUAL EXAMINATION OF		OBSERVATIONS	REMARKS OR RECOMMENDATIONS
CONCRETE WEIR		The spillway consists of a concrete bottom with sides of rough stone mortared together.	The concrete weir shows signs of crumbling and should be repaired.
APPROACH CHANNEL		The reservoir serves as the approach channel.	
DISCHARGE CHANNEL		The discharge channel consists of stone steps mortared together. Some erosion has occurred on the right side of the spillway.	The area of erosion should be repaired.
BRIDGE AND PIERS		A wooden footbridge spans the discharge channel. The bridge appears to be in good condition.

PHOTO 1. View of Upstream Side of Central Spillway

- 10) Repoint the stone training walls of the left spillway.
- 11) Repair the concrete weir of the central spillway.
- 12) Repoint the stone training walls of the right spillway.

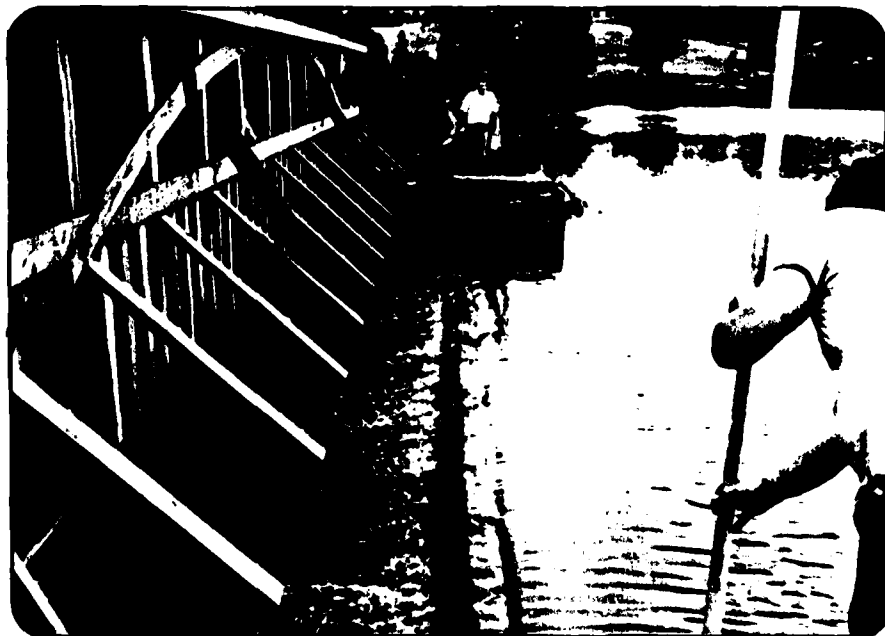
- a) The concrete weir is cracked and leaking and should be repaired.
- b) Some erosion has occurred in the discharge channel to the right of the right training wall. This erosion should be repaired.

**PHOTO 2. View from Left Training Wall of Central Spillway
Looking across Weir**
