BERGER ASSOCIATES INC HARRISBURG PA
NATIONAL DAM INSPECTION PROGRAM. LAKE HAMILTON DAM (NDI-ID NUMB--ETC(U)
AUG 80 H JONGSMA

PHASE I REPORT
NATIONAL DAM INSPECTION PROGRAM

LAKE HAMILTON DAM

NDI-ID PA-01031
DER-ID 64-157

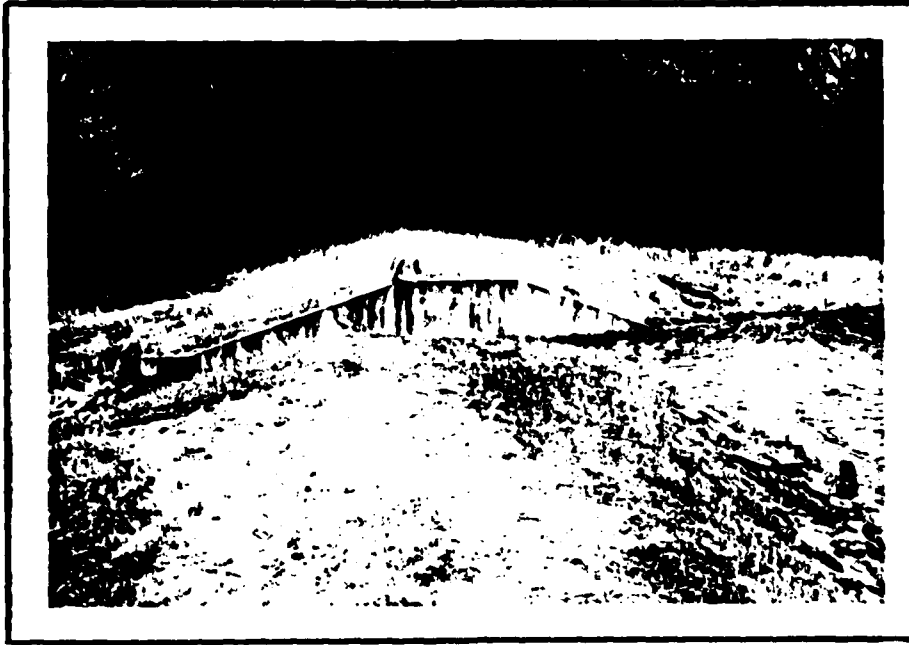
OVERVIEW FROM LEFT ABUTMENT - NO. 2

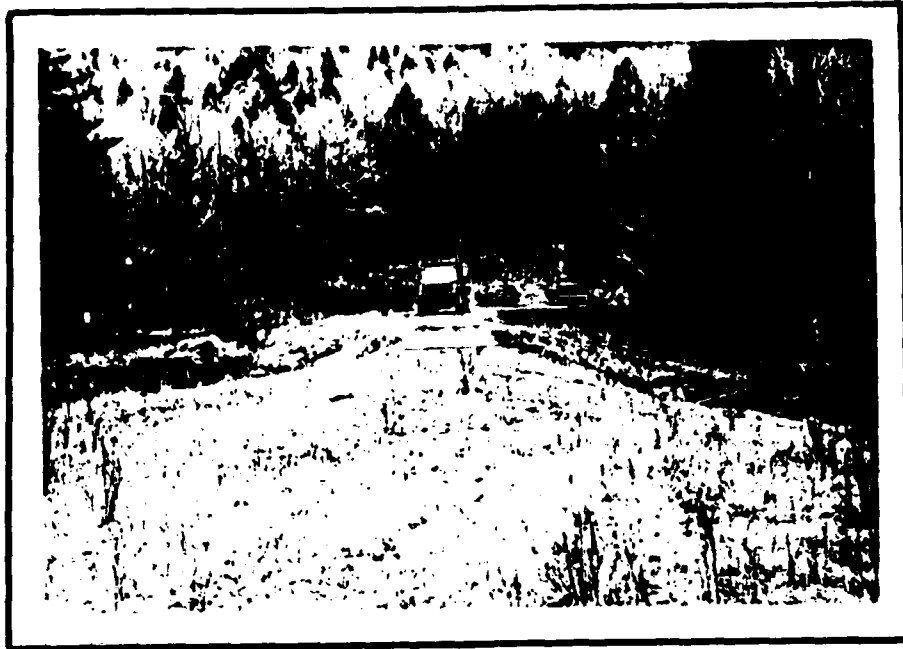
OVERVIEW FROM RIGHT ABUTMENT - NO. 4

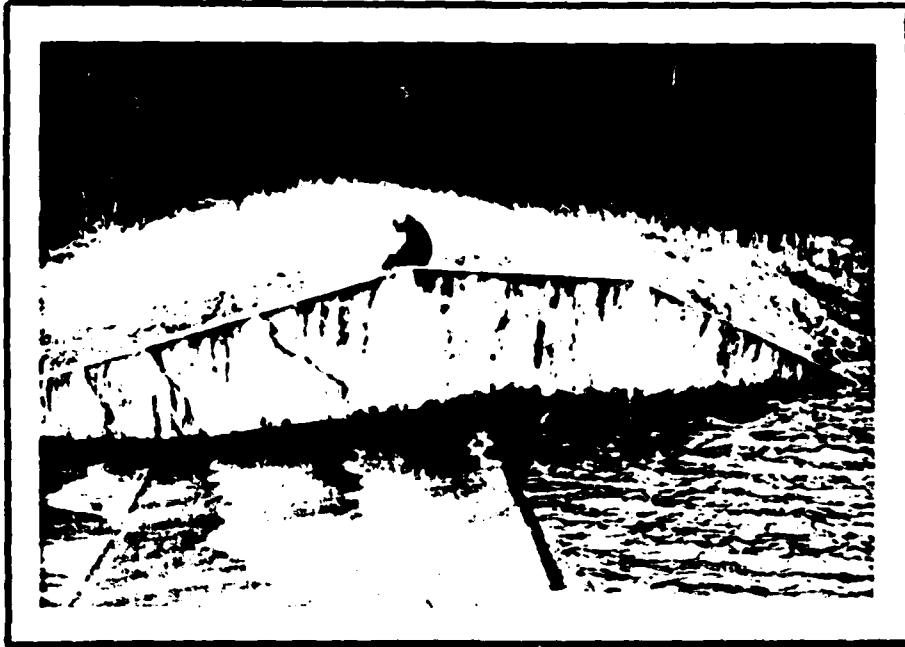
The left spillway wall is deteriorated and has several cracks (Photograph No. 5). The right spillway wall (Photographs No. 6 and No. 7) also has many cracks. A 1/4-inch displacement was noticed at one of the cracks. It is recommended that regular close observations be made of the wall to detect if further movement is occurring.

RIGHT SPILLWAY WALL - NO. 6

1. That the spillway walls be closely observed. If further deterioration or wall movement occurs, steps should be taken to replace or repair these walls.
2. That all brush and cuttings be removed from the embankment. Trees within ten feet of the toe should be removed. This area and the embankment should be maintained on a regular basis.
3. That the scarred areas be reseeded to provide an adequate cover against erosion.
4. That additional riprap be placed at the downstream wingwalls to prevent scour.

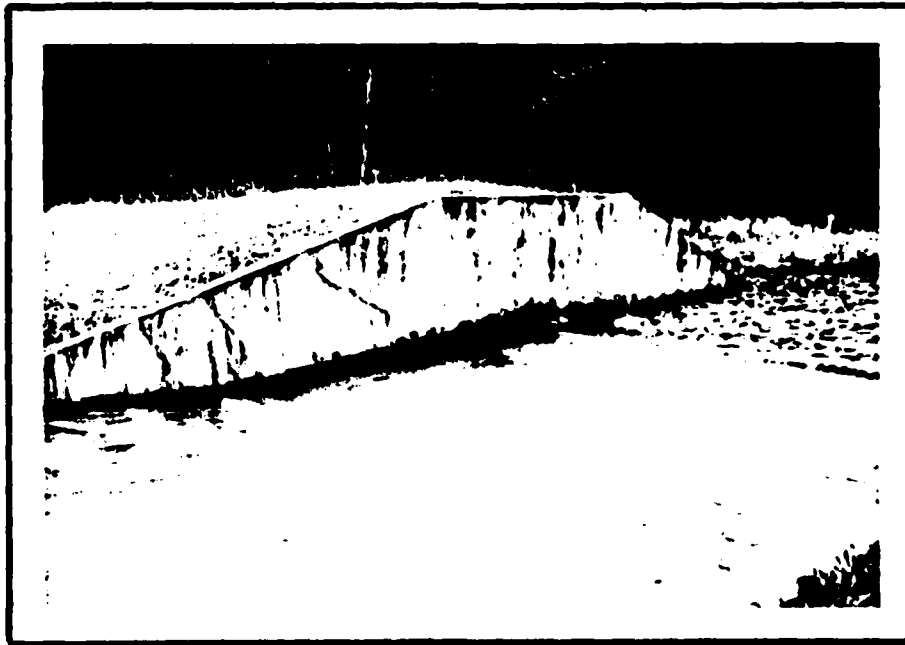
DOWNSTREAM SLAB OF SPILLWAY - NO. 7

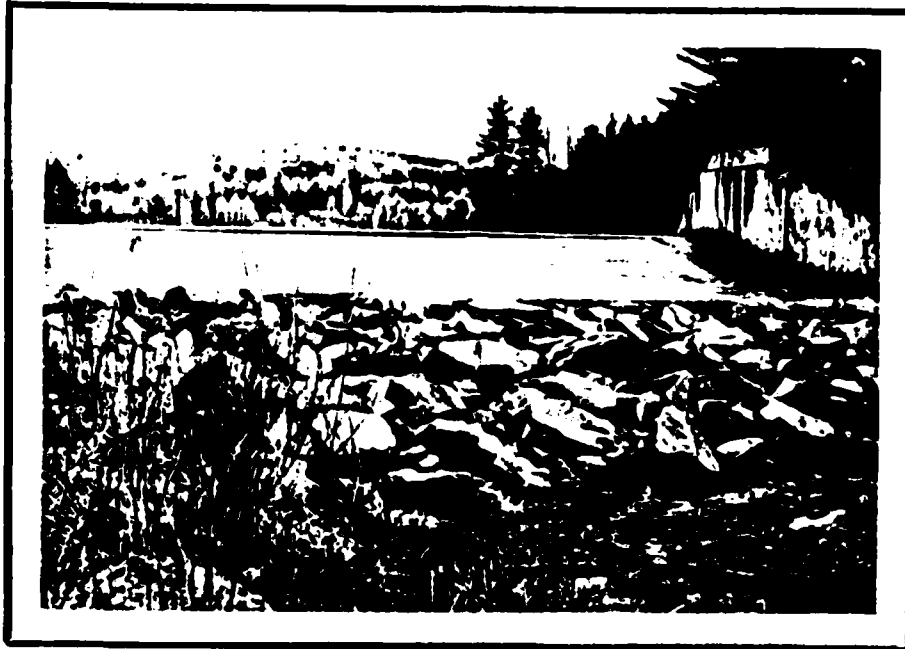
RIPRAP PROTECTION AT END OF SPILLWAY SLAB - NO. 8

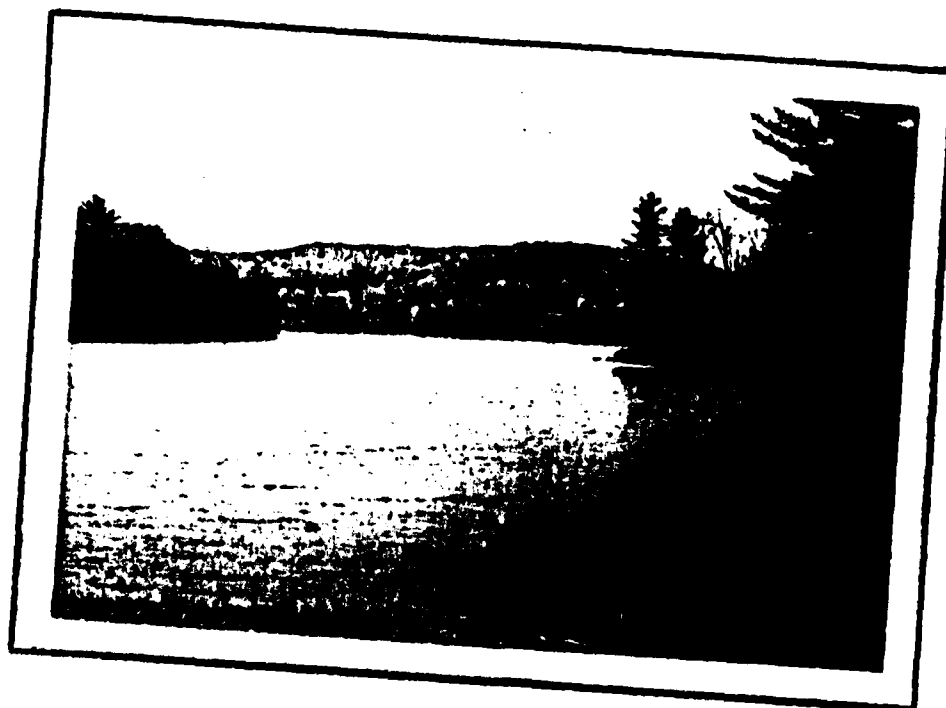
RESERVOIR AREA - NO. 11

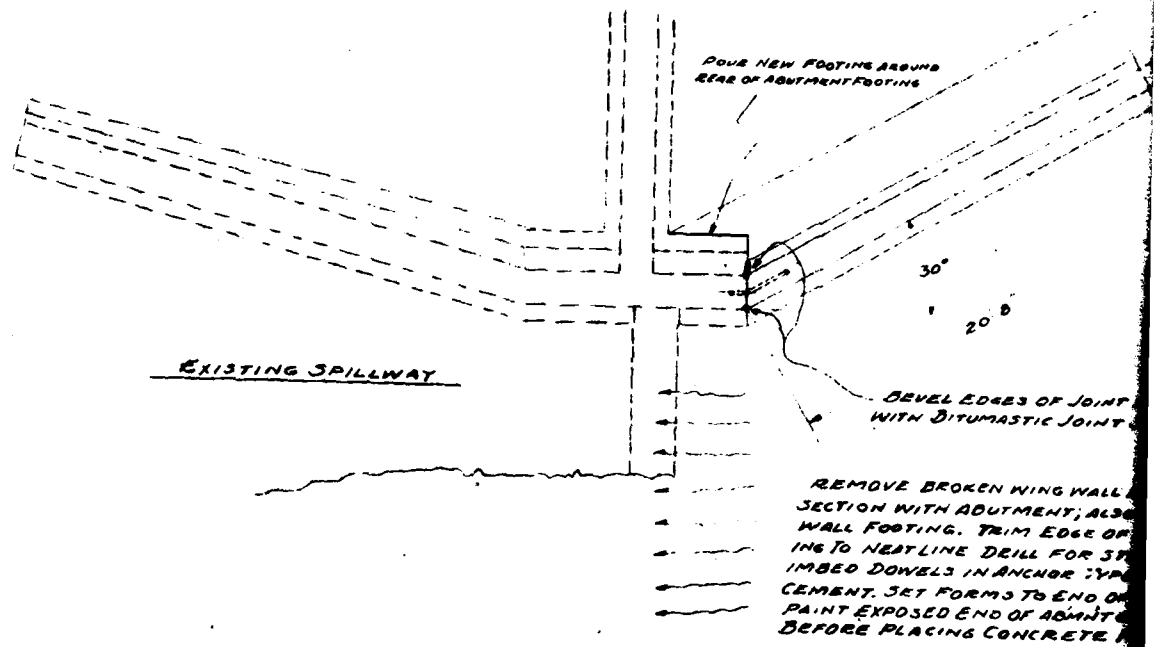
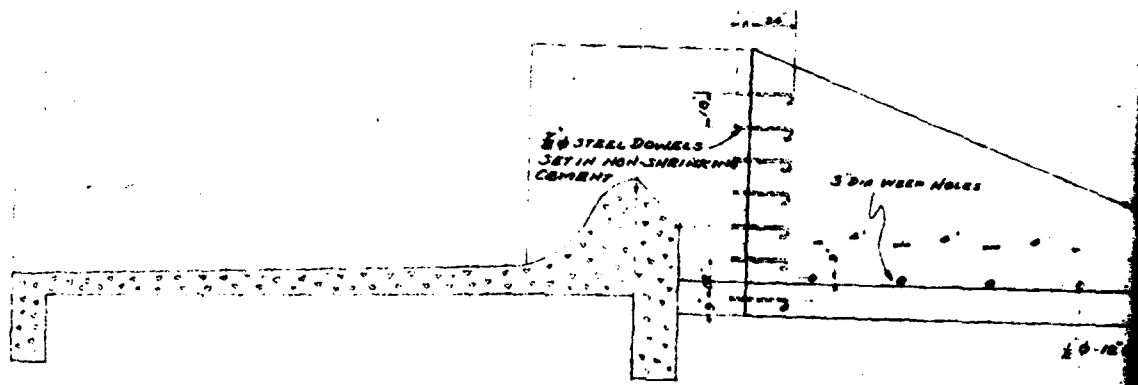
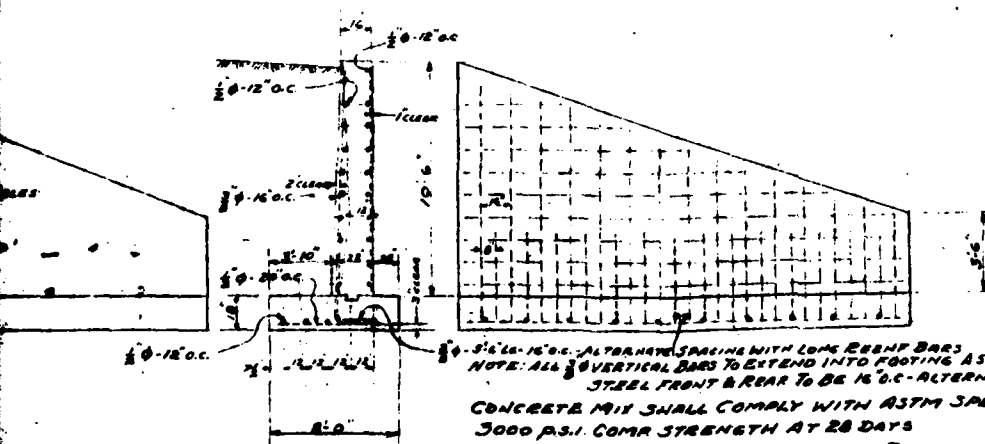
REPAIR TO
WAY-LAKE
MAY 1968

The right forebay wall was replaced with a new wall in 1968 (Plate VI, Appendix E). Although the footing width design appears adequate, cracks have occurred, indicating possible settlement.

BROKEN WING WALL AT POINT OF INTER-
SECTION ADJUTMENT; ALSO REMOVE WING
WALL. TRIM EDGE OF ABUTMENT & FOOT-
ING. DRILL FOR STEEL DOWELS AND
INSTALL IN ANCHOR TYPE NON-SHRINKING
EPOXY RESIN FORMS TO END OF ABUTMENT.
POUR END OF ABUTMENT & FOOTING WITH EPOXY RESIN
AND SETTING CONCRETE FOR NEW WALL
