COMET LAKE DAM

(NDI ID. No. PA-00796, ^{Number}
PENNDER ID. No. 28-103) ^{Number}

Potomac River Basin,
Spring Run, Franklin County, Pennsylvania

~~DATE: 11-10-80~~
PHASE I INSPECTION REPORT,
NATIONAL DAM INSPECTION PROGRAM

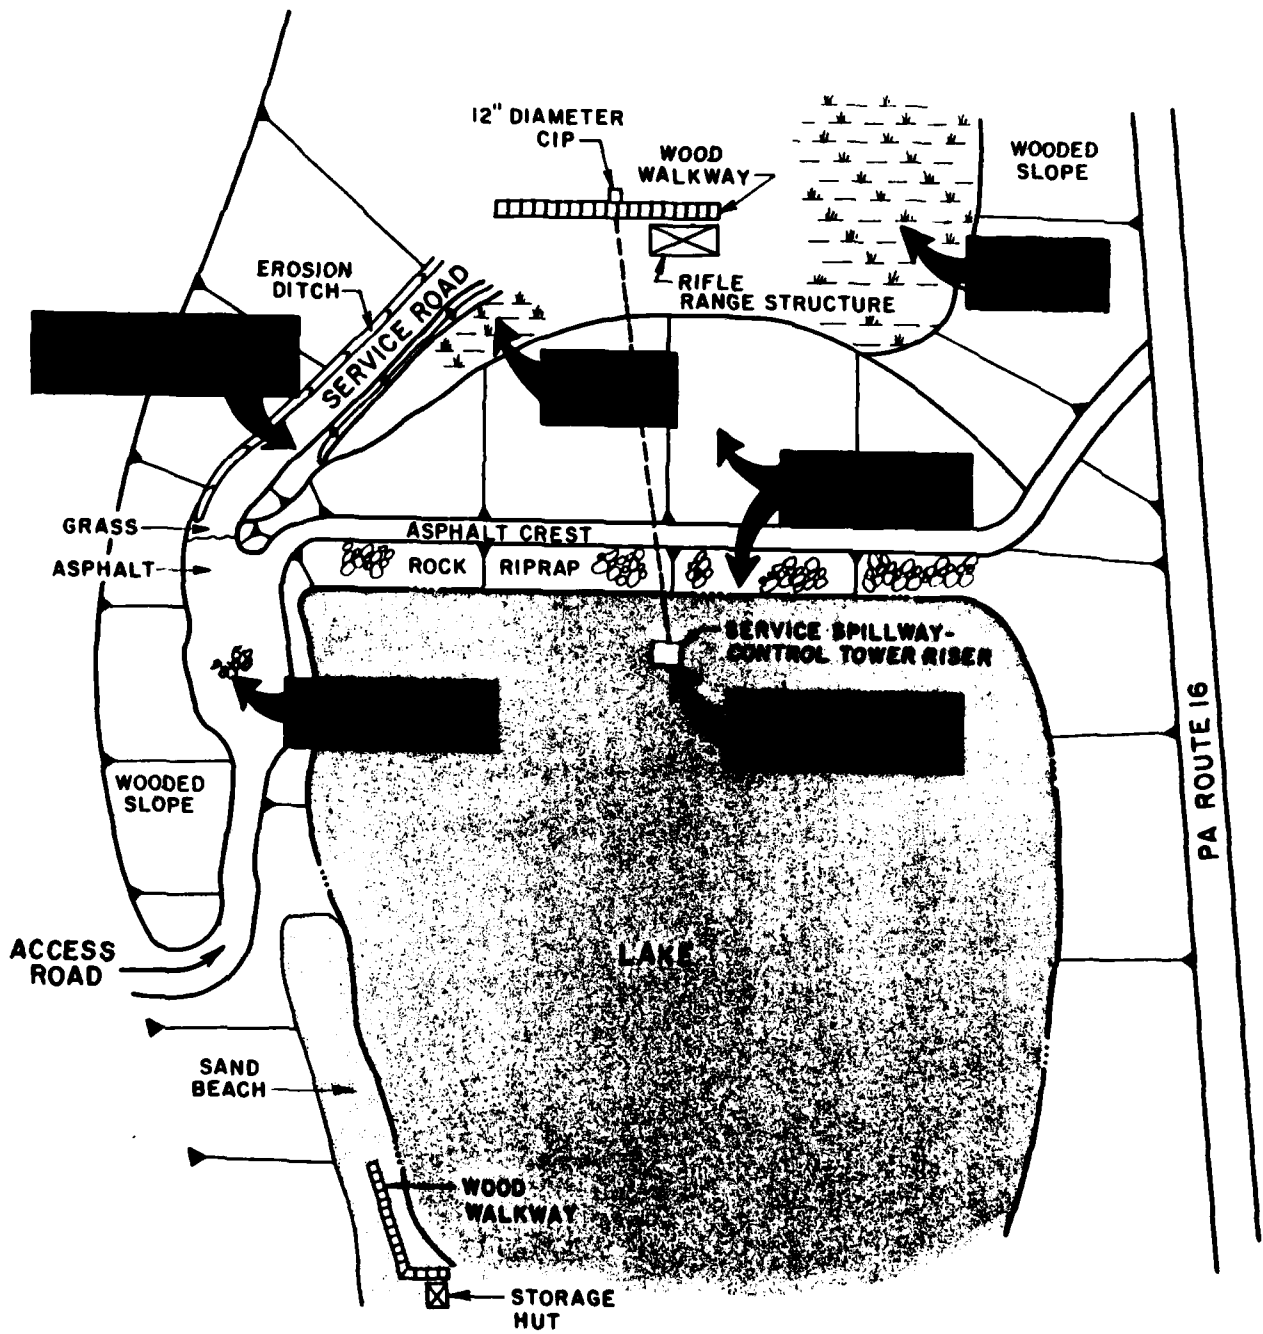
COMET LAKE DAM
 GENERAL PLAN - FIELD INSPECTION NOTES

ITEM	OBSERVATIONS/REMARKS/RECOMMENDATIONS	NDI# PA. 00796
DAMP AREAS IRREGULAR VEGETATION (LUSH OR DEAD PLANTS)	<p>Two areas (see "General Plan-Field Inspection Notes," Appendix A).</p> <ol style="list-style-type: none"> 1. Area several feet to the right of the emergency spillway. 2. Area immediately downstream of toe along right abutment (≈ 30 feet wide). 	
ANY NOTICEABLE SEEPAGE	None through face of dam; however, both areas listed above are saturated and exhibit noticeable seepage.	
STAFF GAGE AND RECORDER	None.	
DRAINS	None observed.

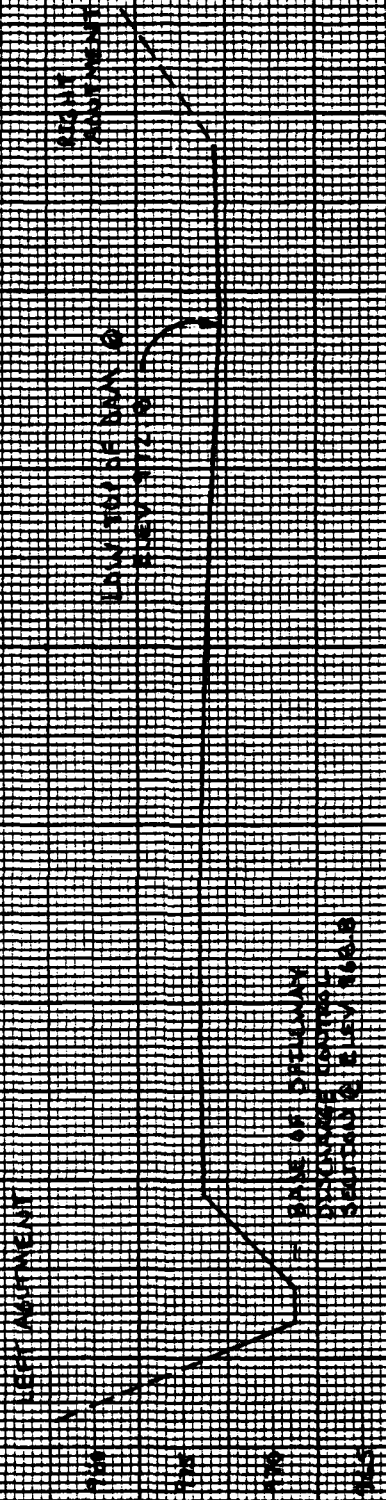
PROFILE OF DAM CREST
FROM FIELD SURVEY

b. Embankment. Observations made during the visual inspection indicate the embankment is in fair condition. No evidence of sloughing, erosion, seepage through the embankment face, or animal burrows were observed. The embankment slopes are heavily overgrown with thick brush indicating a lack of regular, routine maintenance (see Photographs 1, 3 and 4). Two distinct swampy areas were observed as indicated on the field sketch (see "General Plan, Field Inspection Notes", Appendix A). Both swampy areas are located beyond the limits of the downstream embankment toe (see Photograph 8). No measurable seepage flow was observed. The embankment crest is well protected with a cover of asphalt paving; however, field measurements indicate differential settlements in excess of 1-foot (see "Profile of Dam Crest", Appendix A).

a. Embankment. Observations made during the visual inspection indicate the embankment is currently in fair condition. Lack of adequate maintenance has resulted in overgrown slopes and a generally poor appearance; nevertheless, no evidence of excess embankment stresses, slope instability, or seepage through the downstream embankment face was observed. Heavy overgrowth across the embankment slopes and along the downstream toe hamper visual observation of critical conditions and should be removed. Field measurements indicate differential settlement across the embankment crest in excess of 1-foot. Large settlements such as this effectively reduce the available freeboard and spillway capacity. Moreover, in the event the embankment should be overtopped, they create channels that concentrate flows and induce breaching. Consequently, it is recommended the embankment crest be regraded to its design elevation.
