OHIO RIVER BASIN  
ROWES RUN  
FAYETTE COUNTY

NDI No. PA 00220  
PENN DER No. 26-41

ROYAL RESERVOIR DAM

PHASE I INSPECTION REPORT  
NATIONAL DAM INSPECTION PROGRAM

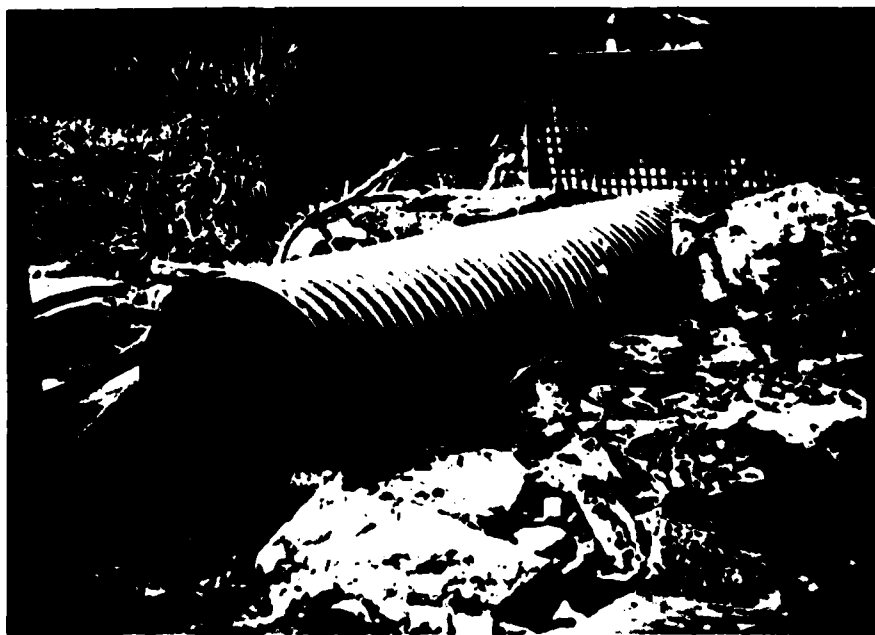
The lower portion of the discharge channel is seriously deteriorated to the extent that the right training wall has collapsed and erosion of the lower portion of the embankment has begun. The condition presents a potential for significant erosion of the downstream portion of the embankment.

Concrete deterioration is also significant in this reach, with erosion through the slab joints revealing subgrade materials below.

PHOTO 2. DISCHARGE CHANNEL

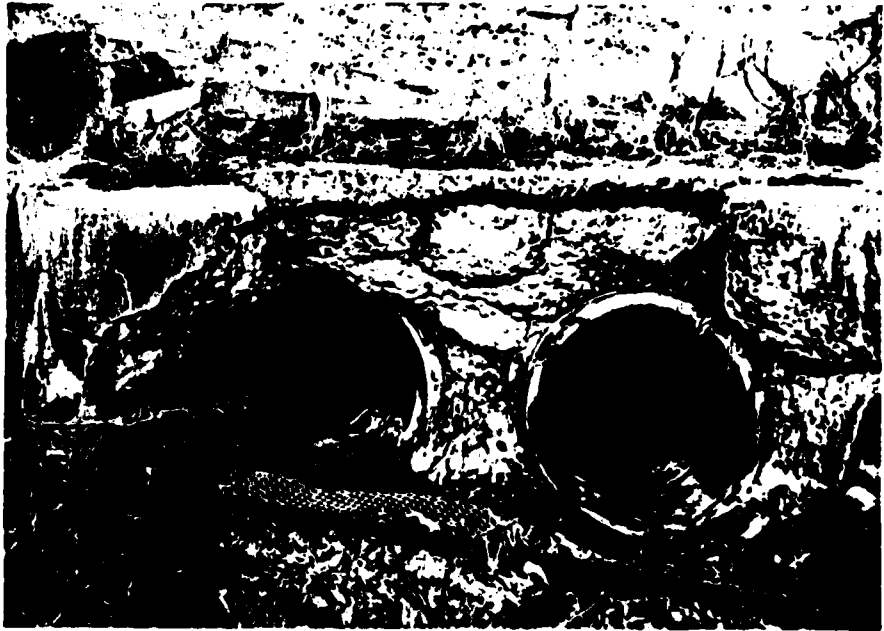
c. Principal Spillway: The principal spillway for Royal Reservoir Dam is considered to be in poor condition. This is based on the observed lack of a trash rack or trash boom to control clogging of the inlet.

PHOTO 5. PRINCIPAL SPILLWAY INLET
