OHIO RIVER BASIN
FOURMILE RUN
WESTMORELAND COUNTY

PENNSYLVANIA
NDI No. PA 00485
PENN DER No. 65-134

BRESKIN DAM No. 2

PHASE I INSPECTION REPORT
NATIONAL DAM INSPECTION PROGRAM

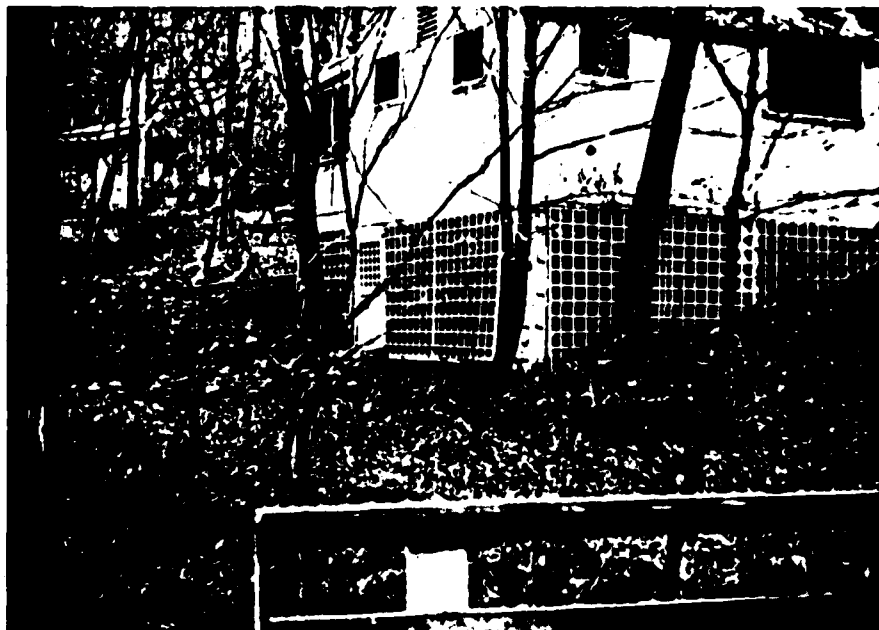
PHOTO 13. DOWNSTREAM HAZARD

d. Hazard Classification: Breskin Dam No. 2 is classified as a "high" hazard dam. In the event of a dam failure, at least five inhabited dwellings within the first one half mile downstream would be subjected to substantial damage and loss of life could occur.
