NDI No. PA 00907

CRABAPPLE DAM

PHASE I INSPECTION REPORT NATIONAL DAM INSPECTION PROGRAM

JULY 1980

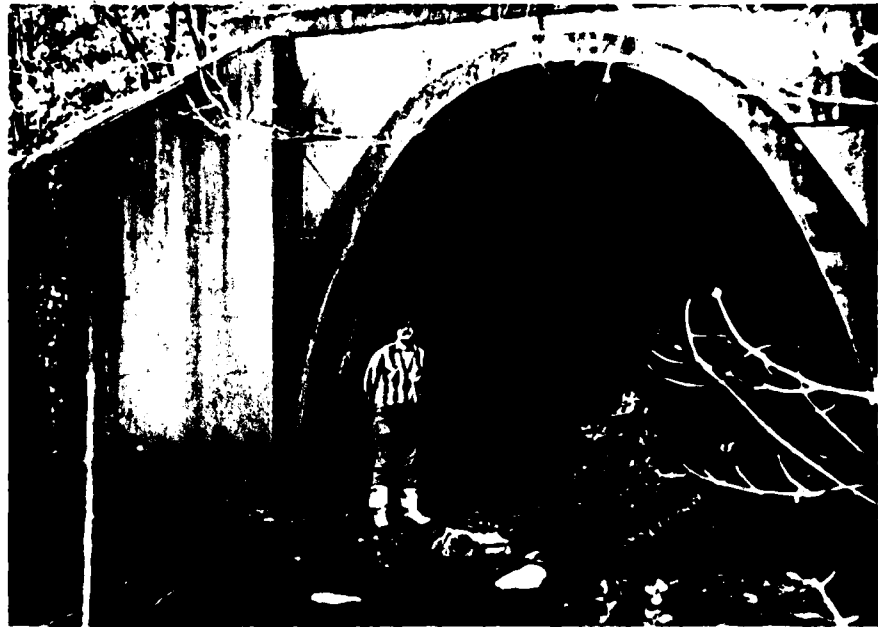
PHOTO 11. ROUTE 51 CULVERT

(2) Floodplain Development: In the first 2000 feet below the dam, two inhabited dwellings lie on the floodplain at an elevation low enough to be imperiled by a dam failure. Also, State Route 51, a major north-south highway, crosses Crabapple Run approximately 100 feet downstream of the dam. The elevation of the highway embankment is generally higher than the elevation of the dam. In the event of a failure of Crabapple Dam, a failure of the highway embankment would be unlikely, but damage could occur to the large, reinforced concrete culvert beneath the roadway.
