PARKER DAM

NDI No. PA 01126
PennDER No. 17-87

PHASE I INSPECTION REPORT
~~NATIONAL DAM SAFETY PROGRAM~~

Parker Dam, Clearfield County, Pennsylvania
NDI No. PA 01126, PennDER No. 17-87
Laurel Run
Inspected 25 June 1980

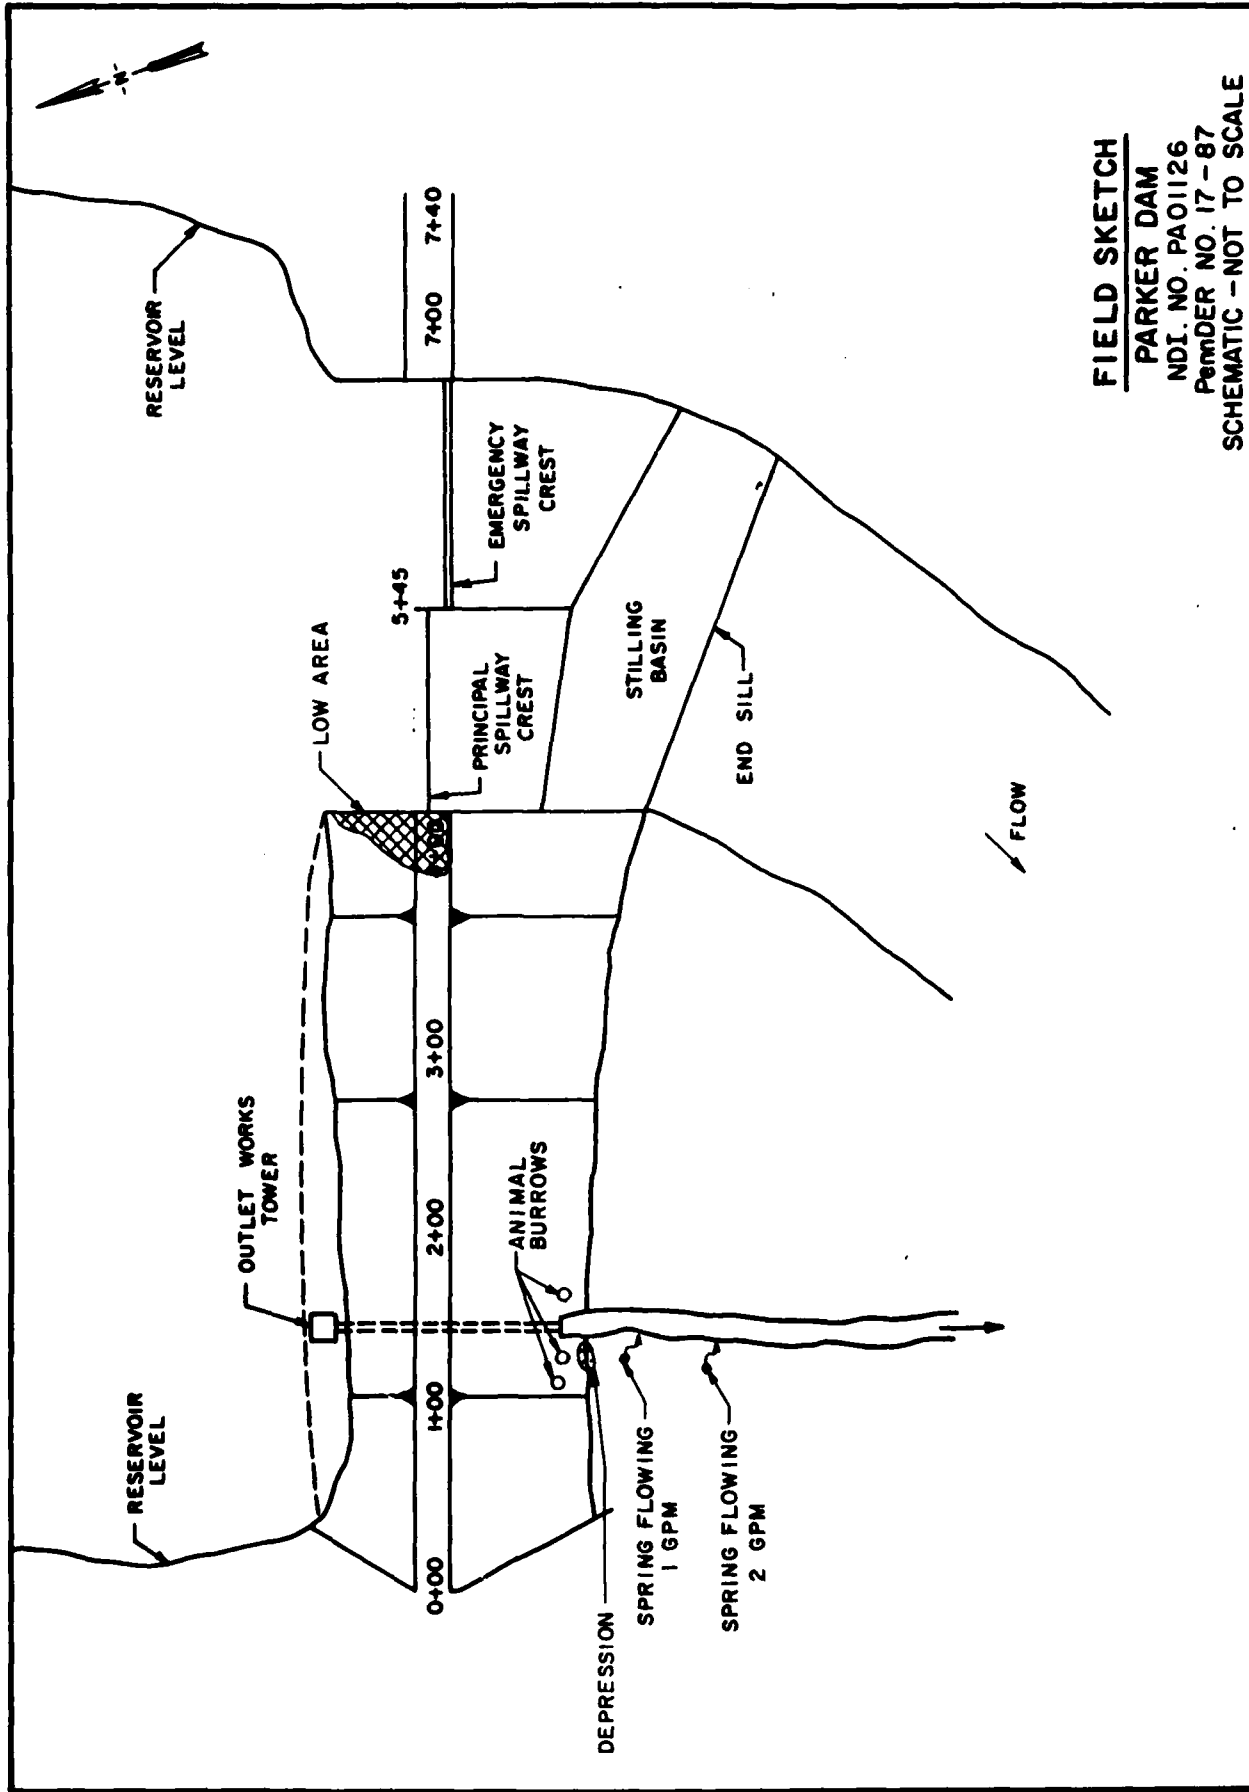
FIELD SKETCH

None were observed. The embankment and abutment slopes were in good condition. There is an animal burrow on the downstream face of the embankment immediately to the left of the outlet structure. There are also several other animal burrows approximately 10 ft. to the right of the outlet structure.

VISUAL EXAMINATION OF	OBSERVATIONS	REMARKS OR RECOMMENDATIONS
VERTICAL AND HORIZONTAL ALIGNMENT OF THE CREST	There is a low area on the crest and upstream slope of the dam adjacent to the right spillway training wall.	This area should be filled.
RIPRAP FAILURES	None were observed. The riprap on the upstream face of the dam and in the spillway discharge channel was in good condition.	
VEGETATION	A well-maintained cover of grass is growing on the entire embankment.

- 1) Fill the depression in the downstream toe of the embankment immediately to the right of the outlet works.
- 2) Fill the animal burrows on the downstream face of the embankment immediately to the left of the outlet works and approximately 10 feet to the right of the outlet works.
- 3) Fill the low area on the crest and upstream face of the dam adjacent to the right spillway training wall and reseed with grass.
