Name of Dam: Brisentine's Dam

Inventory Number: VA 14720

PHASE I INSPECTION REPORT

Brisentine's Dam (Inventory Number VA 14720)
James River Basin, Prince Edward
County,
Commonwealth of
Virginia.

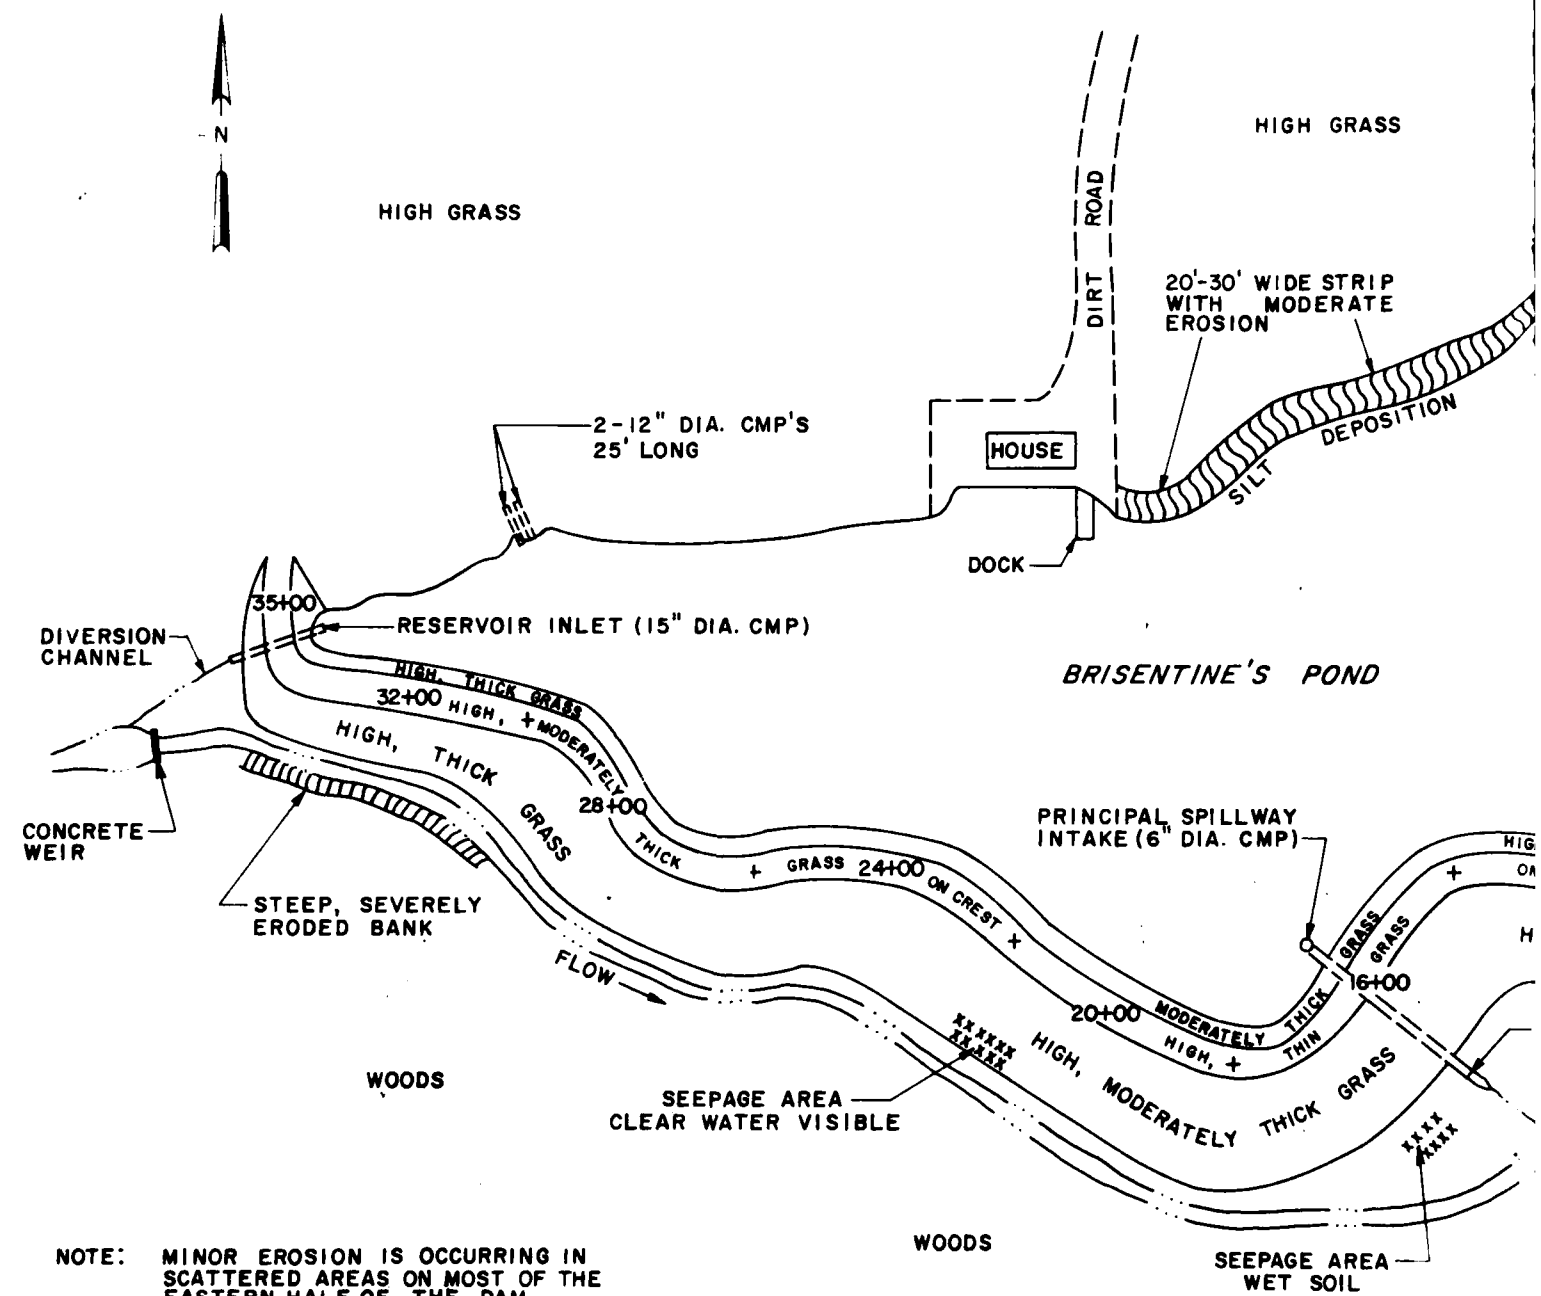
PLATE 1

**NOTE: MINOR EROSION IS OCCURRING IN
SCATTERED AREAS ON MOST OF THE
EASTERN HALF OF THE DAM.**
