PHASE I REPORT
NATIONAL DAM INSPECTION PROGRAM

Name of Dam: WALKER LAKE DAM
State & State No.: PENNSYLVANIA, 52-127
County: PIKE
Stream: WALKER CREEK
Date of Inspection: April 3, 1980

PHASE I INSPECTION REPORT
NATIONAL DAM INSPECTION PROGRAM.

NDI-ID No. PA-00317,
DER-ID No. 52-127

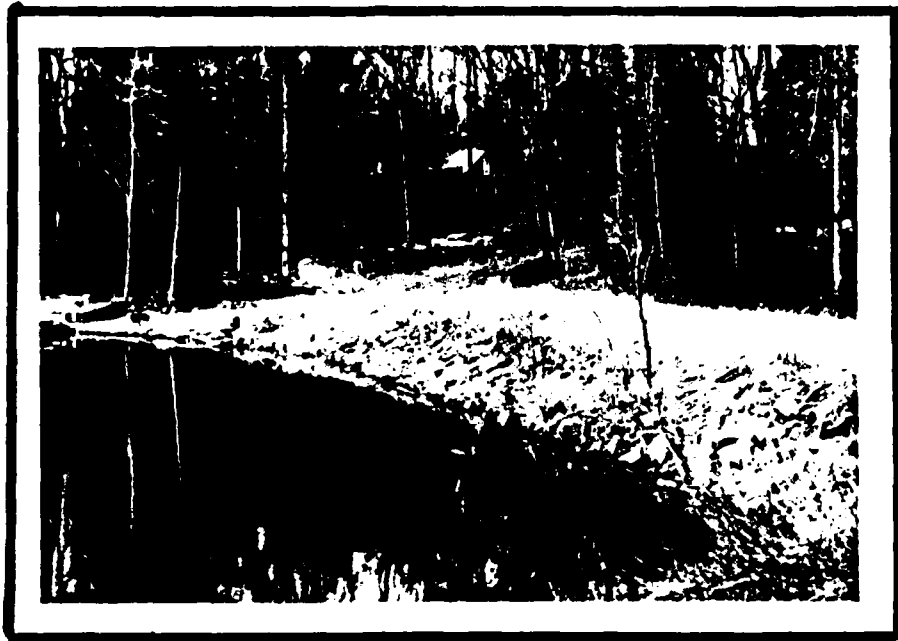
LEFT END UPSTREAM SLOPE - NO. 2

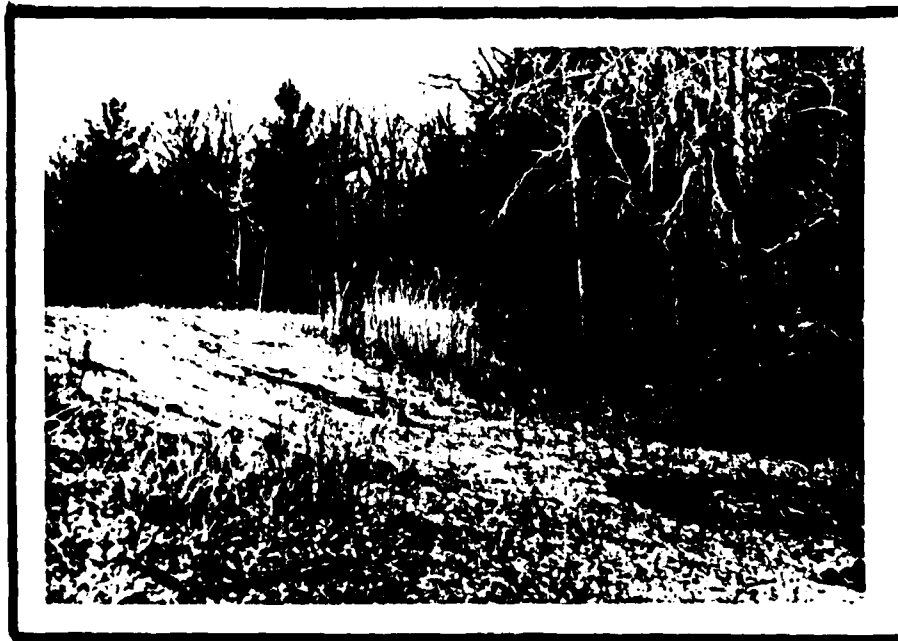
LEFT END DOWNSTREAM SLOPE - NO. 3

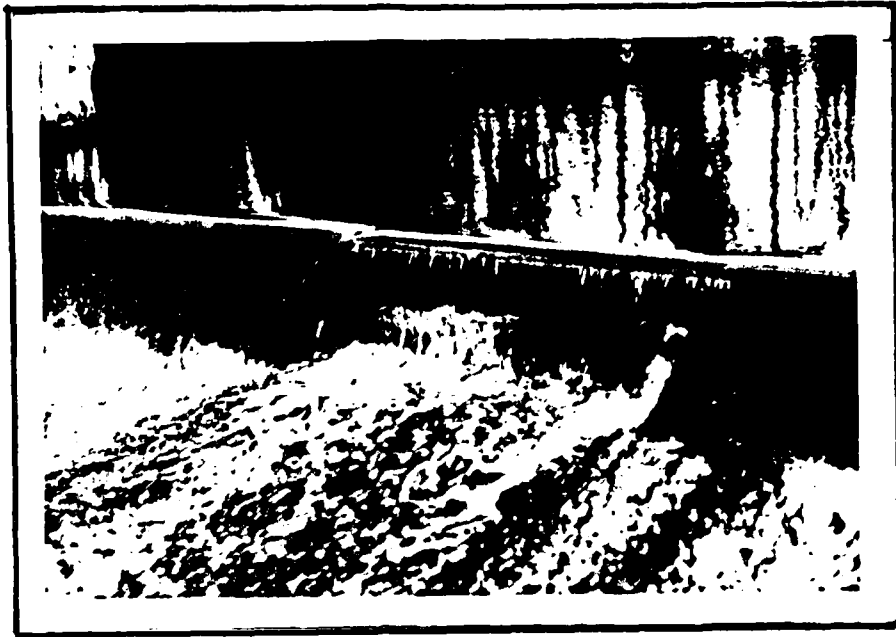
LOW FLOW NOTCH - NO. 6

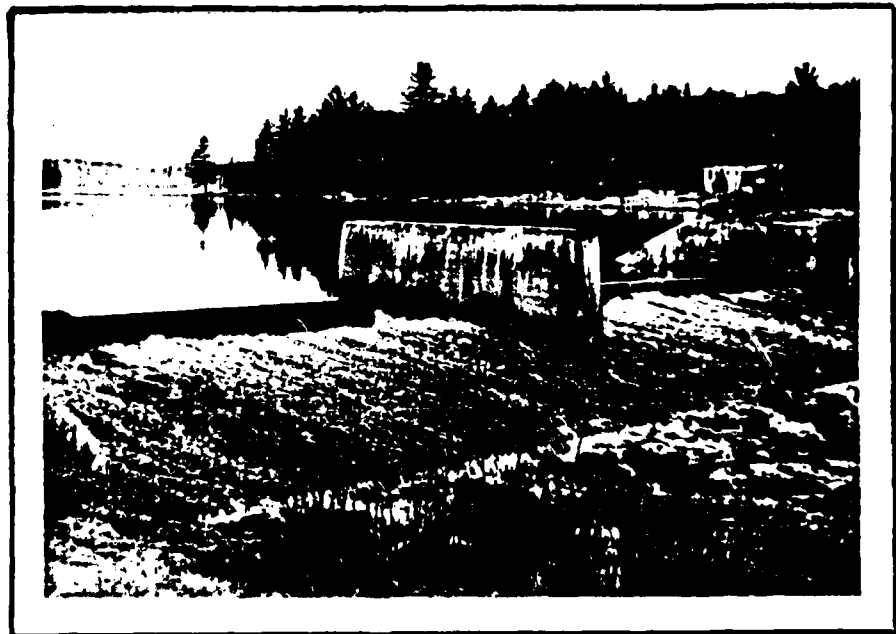
The apron immediately downstream of the spillway has been constructed with grouted handlaid stone. Several cracks and holes have formed in this apron. The immediate streambed below the apron is protected with loose riprap. The concrete of the ogee section and spillway walls show signs of deterioration (Photographs No. 5 and No. 7).

The spillway weir, downstream apron and spillway walls show signs of some deterioration. Holes and cracks in the apron should be repaired to prevent serious damage. Maintenance on the walls and weir is recommended at this time to prevent further deterioration and more costly repairs at a later date. The walls appeared to be stable at the time of inspection. There were no signs of tilting or unusual movement.

SPILLWAY APRON - NO. 7

1. That the headwall on the outlet pipe be replaced and that holes and cracks in the spillway weir and apron be repaired.
2. That the gate on the outlet pipe be maintained and operated at least once a year.
3. That all brush and high weeds be removed from the embankment on an annual basis.

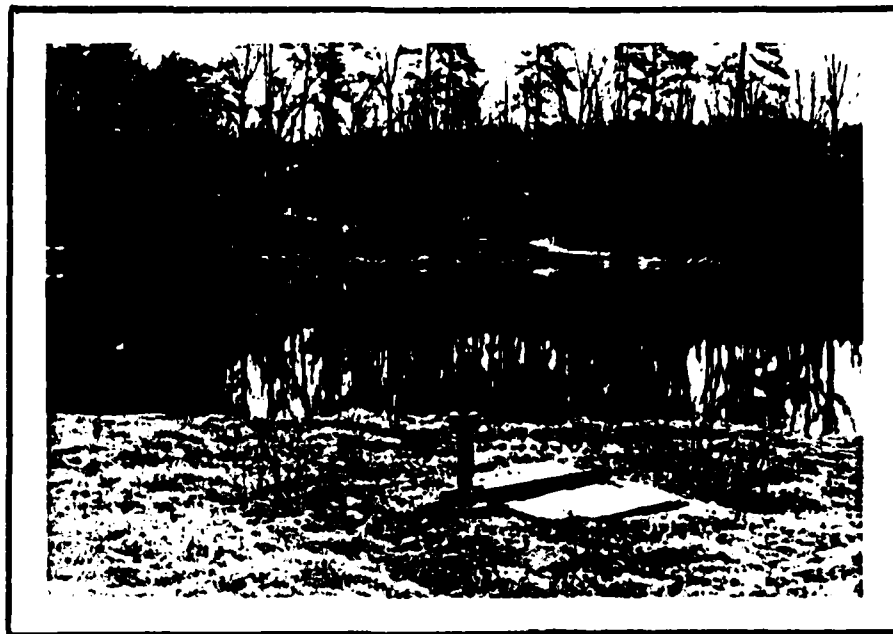
The intake structure is a wet well and was not inspected. The concrete exposed above the embankment is deteriorating on the outside face (Photograph No. 8). The headwall of the outlet pipe has collapsed and should be replaced. This will require removal of a part of the existing stone wall (Photograph No. 9).

BLOWOFF - WETWELL & VALVE STEM - NO. 8

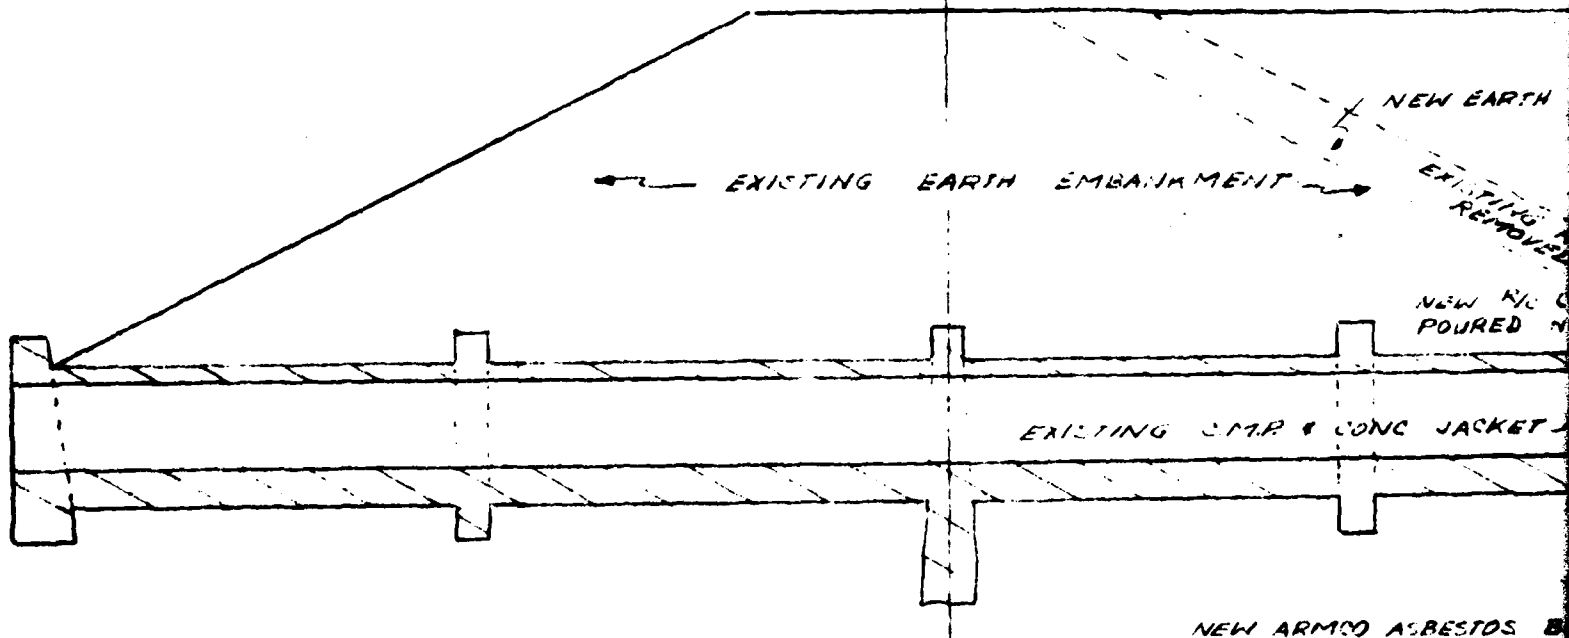
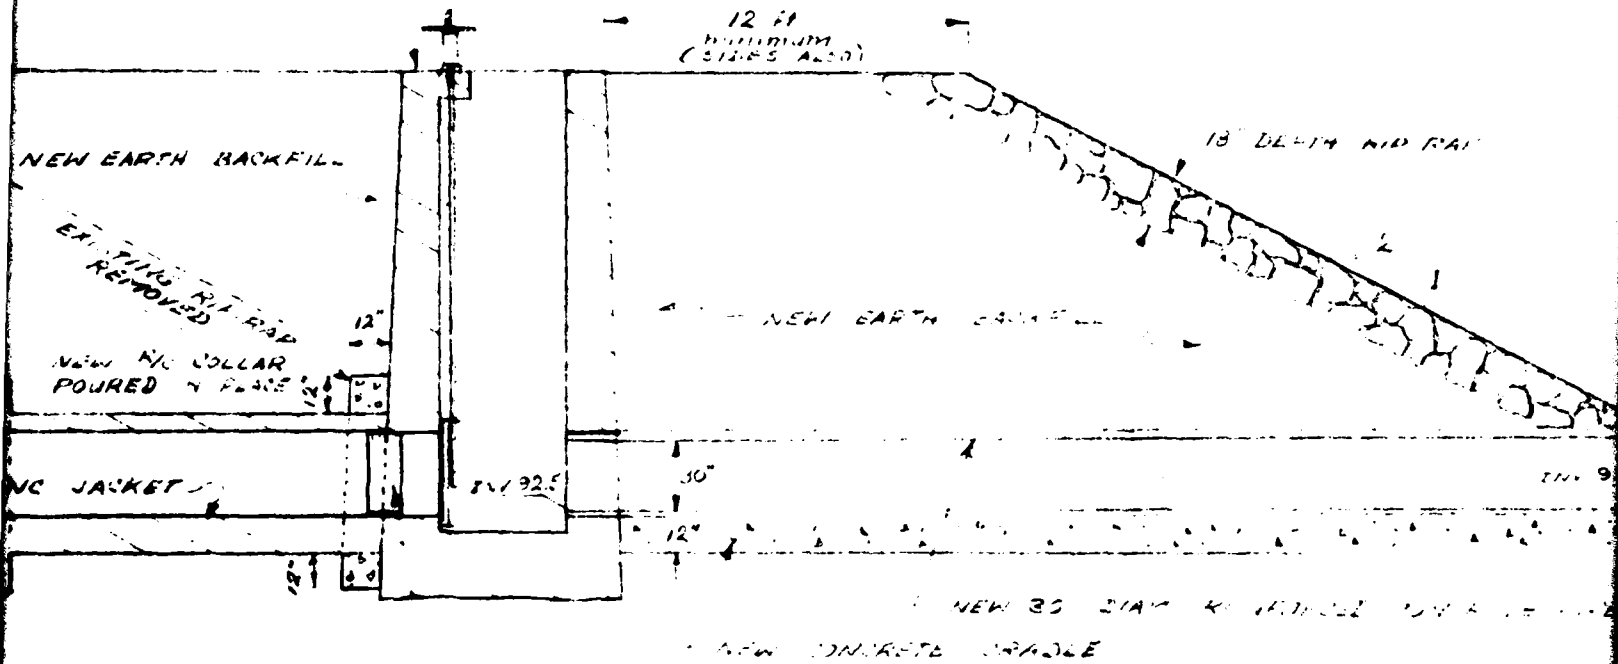
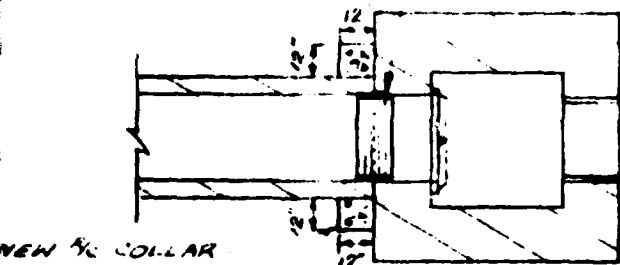
SHOWING METHOD OF REPAIR OF FAILURE AT
GATE TOWER AND OUTLET PIPE

In the winter of 1967-1968, ice pressure caused a small tilt of the intake structure, opening the joint between this structure and the outlet pipe. The joint was repaired in the fall of 1968 (Plate IV, Appendix E), and embankment fill was placed around the structure to prevent a reoccurrence of this damage.

Letters in the files of PennDER indicate that the wet well intake structure was pushed over slightly by ice in the winter of 1967-1968. This movement caused a crack to develop in the joint between the wet well and the outlet pipe. The joint was repaired in 1968 (Plate IV, Appendix E) and embankment fill was placed around the wet well structure to prevent future damage.

FAILURE OCCURRED AT JUNCT
OF GATE TOWER AND OUTLET

← FAILURE WAS APPARENTLY CAUSED BY TIPPING OF THE GATE TOWER DUE TO ICE PRESSURE DURING WINTER OF 1967-68.

NEW ARMED ASBESTOS B
INTERNAL EXPANDING
1/8" NEOPRENE GASKET
OPENING BETWEEN TO
OUTLET PIPE.

ASBESTOS BONDED JMF EXPANDING BAND WITH NEW GASKET TO SEAL BETWEEN TOWER AND PIPE.

ANNULAR SPACE BETWEEN NEW PIPE AND TOWER OPENING OFFICERED WITH CEMENT MORTAR.

NEW 1/2" COLLAR
AND AT JUNCTION
AND OUTLET PIPE
