1. REPORT NUMBER VA 01516		2. GOVT ACCESSION NO.		3. RECIPIENT'S CATALOG NUMBER	
4. TITLE (and Subtitle) Phase I Inspection Report National Dam Safety Program Upper Wallace Dam Augusta County, Virginia			5. TYPE OF REPORT & PERIOD COVERED Final

UPPER WALLACE DAM

VA. NO. 01516

# PHASE I INSPECTION REPORT

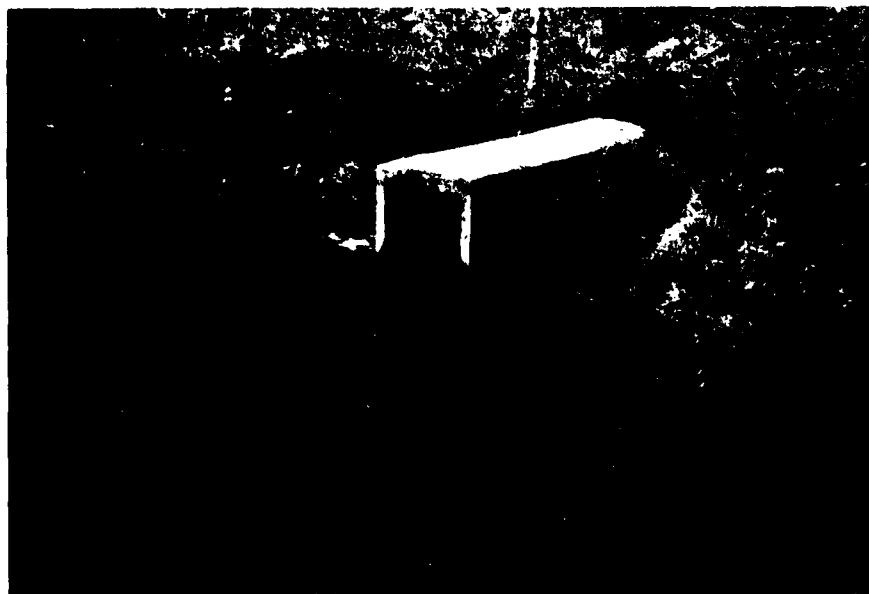
Photograph No. 2

Some erosion was observed around the outlet pipe (principal spillway). The downstream slope (1.7H:1V to 2H:1V) was well vegetated and essentially free of erosion. The steeper upstream slope (1.5H:1V) was not as well vegetated and included numerous steeply eroded gullies up to 2 ft in depth. These gullies generally occurred from 3 to 5 ft above pool level down to the lake. One groundhog hole was observed approximately 10 ft below dam crest and 100 ft<sup>±</sup> left of the right abutment.

Outlet Pipe (Note Erosion Around Plunge Pool and Pipe)

The outlet pipe and intake structure are in good structural condition. Erosion at the outlet pipe plunge pool should be corrected. The drain on the intake structure is in need of repair. The emergency spillway should be reseeded to establish a good vegetative cover and the roadway across the emergency spillway should receive a surface which will inhibit erosion.

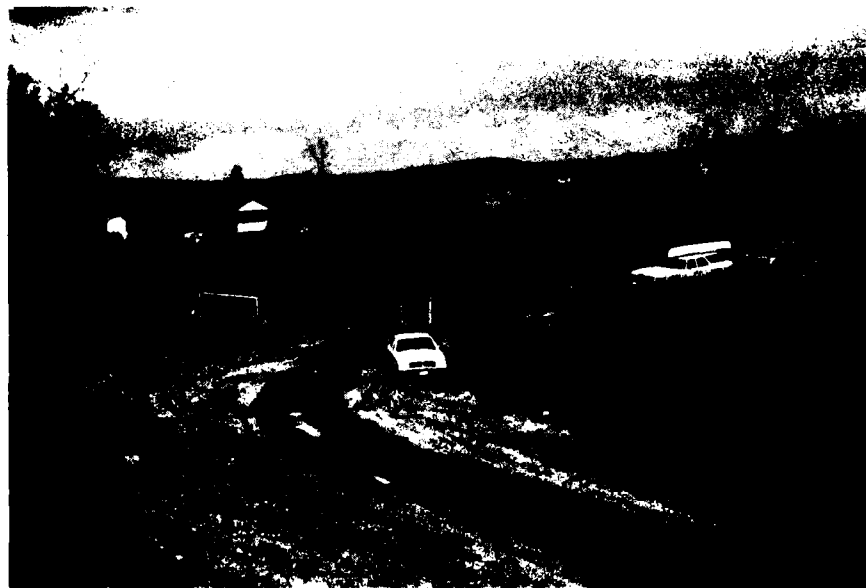
Photograph No. 4

Emergency Spillway (Note Lack of Vegetation)

3) The emergency spillway should also be reseeded to establish a good vegetative cover.

4) The roadway across the emergency spillway should receive a surface which will inhibit erosion during overflow conditions.

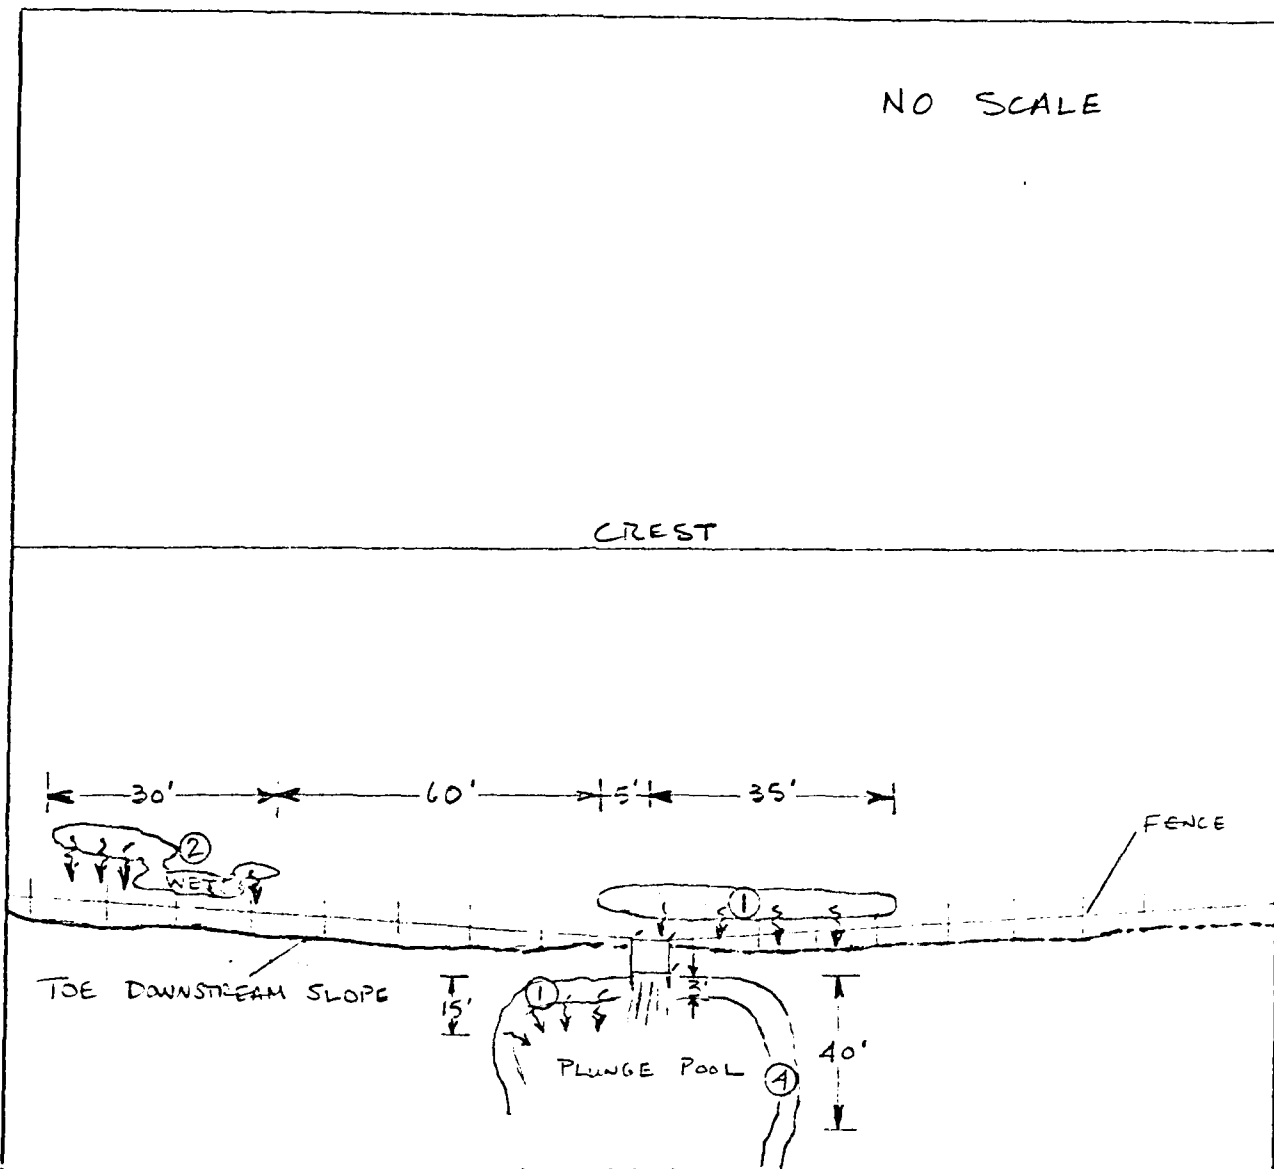
- ① SEEPAGE 2 TO 5 FT ± ABOVE TOP OF OUTLET PIPE, SOME IRON STAINING, NO FLOW OBSERVED. GROUND SURFACE ON DOWNSTREAM SIDE OF FENCE ALSO INCLUDES SATURATED AREAS.
- ② THIS AREA CONSISTS OF TWO WET SPOTS WHICH COALESCE AT TOE OF SLOPE. THE LOWER SATURATED AREAS EXTEND 3 TO 5 FT ± ABOVE THE TOP OF OUTLET PIPE, WHILE UPPER AREA IS ABOUT 9 FT ± ABOVE. NO IRON STAINING OR FLOW OBSERVED.
- ③ SCATTERED SEEPAGE IN 15 FT ± WIDE AREA ALONG VERTICAL SLOPE, IRON STAINING, FLOW UP TO 1 GPM ±
- ④ INTERMITTENT IRON STAINING ALONG EDGE OF PLUNGE POOL
