This report was prepared by the TRW Defense and Space Systems Group, Redondo Beach, CA 90278, under Contract F04701-80-C-0022 with the Headquarters, Air Force Space Division, Deputy for Space Communications Systems, P.O. Box 92960, Worldway Postal Center, Los Angeles, CA 90009. It was reviewed and approved for TRW Defense and Space Systems Group by R. H. Alborn, Manager, DSCS II Orbital Operations. Capt. Gerald D. Nordley was the project engineer.

IISCSII SATELLITE 9444 TELEMETRY TRANSMITTER

ANOMALY REPORT.

o. 36060-AR-022-01

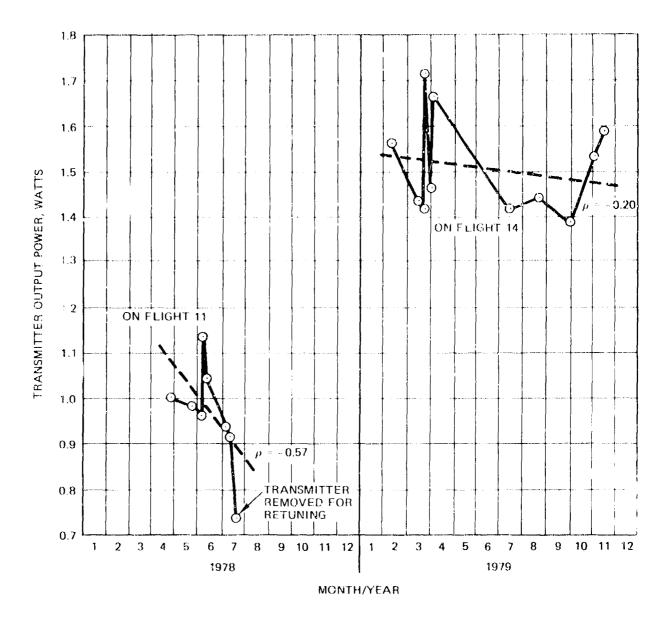
Figure 2-3. Transmitter S/N 3-25 Output Power During Integration and Tost

No anomalies were observed during reacceptance testing, subsequent integration testing or prelaunch checkout at Cape Kennedy. The results of integration testing on both F-11 and F-14 are shown in Table 2-1. Transmitter output power versus calendar time are shown plotted in Figure 2-3 together with least squares trend lines. Note the significant improvement in output power after retuning. The effect of temperature on output power is shown in Figure 2-4. There was very little correlation on Flight 11; somewhat more on Flight 14, but not enough to be considered significant.

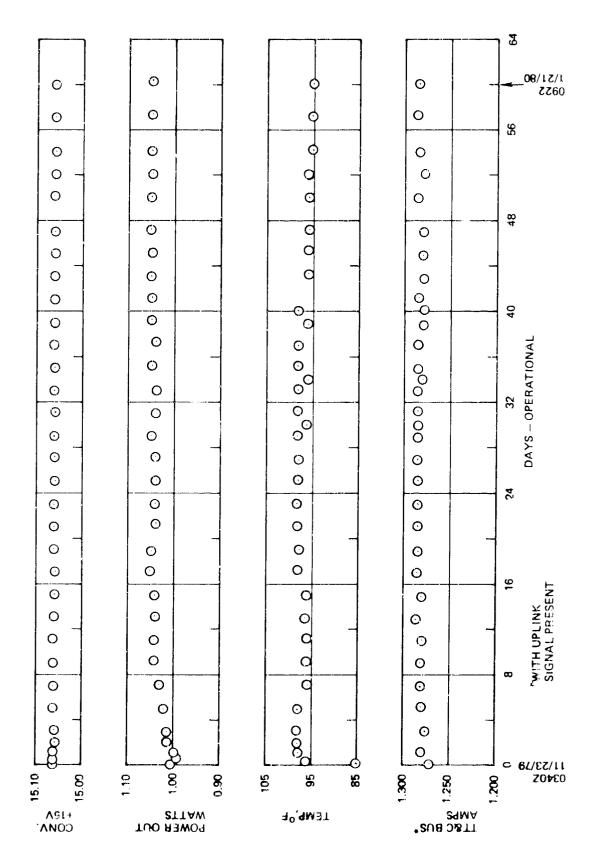
During its two months of orbital operation, transmitter 3-25 performed normally. A graph of serveral operating parameters is shown in Figure 2-5. Converter output voltage was steady at 15.06 V. Transmitter output power increased slightly during the first few days of operation and became steady at 1.05 W, a nominal value. Transmitter internal temperature increased initially when the transmitter was turned-on, then stabilized at a normal value, varying by only 2 to 3 degrees. TT&C bus current also was steady and normal. Thus, there was no evidence of degradation or anomalous behavior of the transmitter prior to the failure.

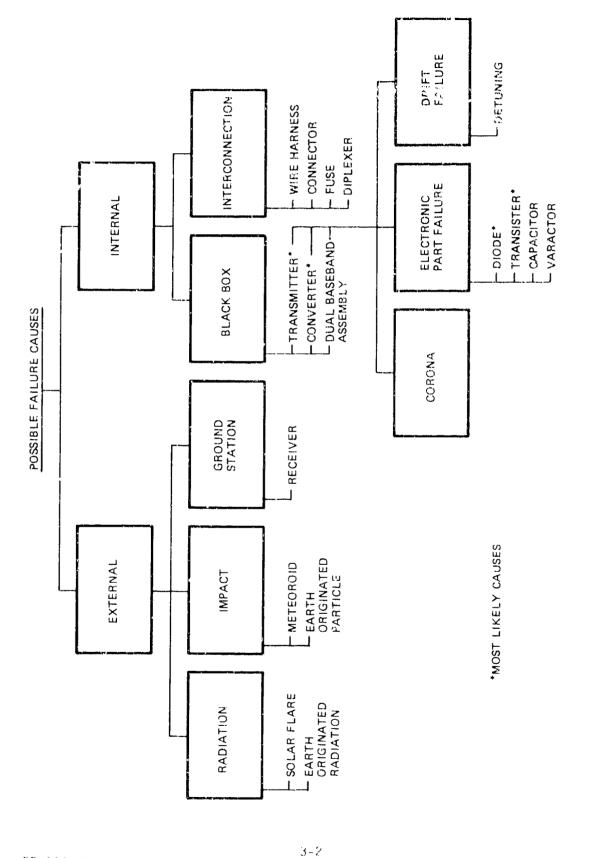
Figure 3-1. Diagram of Possible Failure Causes

Two general categories of possible failure causes exist: external and internal. These are diagrammed in Figure 3-1. Although there is no evidence to suggest any particular external failure cause, they were considered by the anomaly investigation team and are shown here for completeness. Radiation and particle impact were ruled out early as failure causes because they are remote and shielding is provided by the satellite structure and unit housings. The possibility of ground station failure was eliminated because the loss signal from the satellite was verified by a second ground station.

Based on past experience with electronic assemblies, it is more likely that the failure cause is internal. Of these, the transmitter itself, or its power converter, have the highest likelihood. Hence, efforts of the investigation team were concentrated in this area. Drift failure was ruled out quickly because, as seen in Figure 2-5, there was no indication of drift in any of the transmitter parameters. Drift from 1.05 W output power to less than 0.1 W would have had to occur in the 20.5 hours between telemetry samples.

An interconnection failure, such as a broken wire, open printed circuit board trace or improperly mating connector, would fit the observed sudden loss of signal; however, it is highly unlikely that these would not have been detected during ground testing if they existed prior to launch, and are unlikely to occur while the spacecraft is operating normally under relatively benign orbital conditions. Fuse failure is unlikely as there was no indication of any unusual power consumption in the TT&C subsystem. The possibility of corona, as was observed during F-15 thermal-vac testing, was discussed but considered unlikely since the transmitter would have vented completely long before two months in orbit. A diplexer failure is considered unlikely as this would be reflected on the redundant downlink.

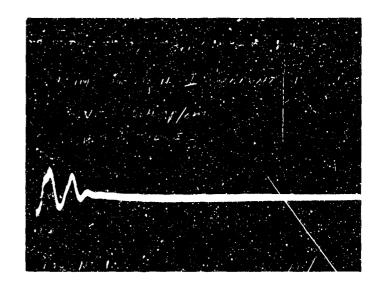
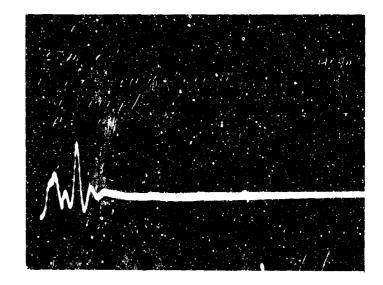
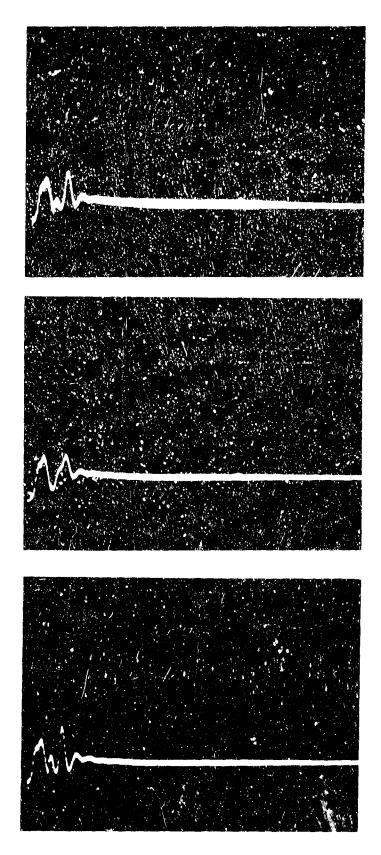
Eigure 3-2. Output Oscilloscope inaces from Converter Overload lests

A possible failure mode investigated by the team is damage to the transmitter or dual baseband unit due to converter fold-back.

It was concluded that as the output load is increased, the input current increases until the input bus fuse blows, thus precluding damage to the transmitter or dual baseband unit.

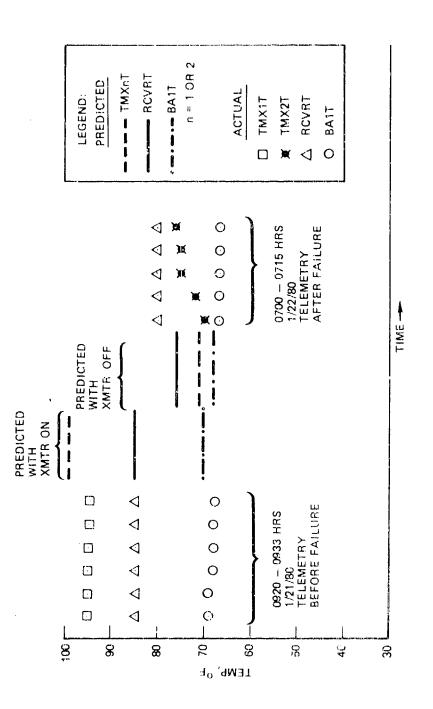
Telemetered temperature measurements for transmitters No. 1 and 2, the receiver and battery No. 1 are shown plotted in Figure 3-3 for several minutes before and after the failure. This figure clearly shows the warm-up of transmitter No. 2.

A thermal analysis was performed using the DSCS II F13-16 spun platform analytical thermal model to predict the effect of transmitter operation on adjacent flight sensor temperatures. The condition analyzed was Winter Soltice, beginning of life in orbit. Table 3-5 tabulates the predicted flight sensor temperatures. In the analytical thermal model, both transmitter No. 1 and transmitter No. 2 are lumped into one isothermal node, therefore, only one temperature is predicted and applied to both transmitters. These temperature predictions are shown plotted as horizontal lines in Figure 3-3.

Before the failure, transmitter No. 1 was operating at 95°F, 4°F below the predicted 99°F. This was not considered significant since it is within the accuracy of the measurements and analytical predictions. The receiver and battery were operating very close to the predicted values.

After the failure, transmitter No. 2 temperature was very close (within $1^{\circ}F$) to its predicted value in the off condition. This indicated that neither the transmitter nor its converter was dissipating power. However, this does not necessarily infer that the converter failed causing loss of power to the transmitter, because failure of the transmitter could also reduce power output of the converter causing it to coel down. The receiver temperature dropped to within 4°F of predicted. Battery number one temperature changed only 1-2°F as predicted. Thus, nothing unusual could be inferred from this temperature data.

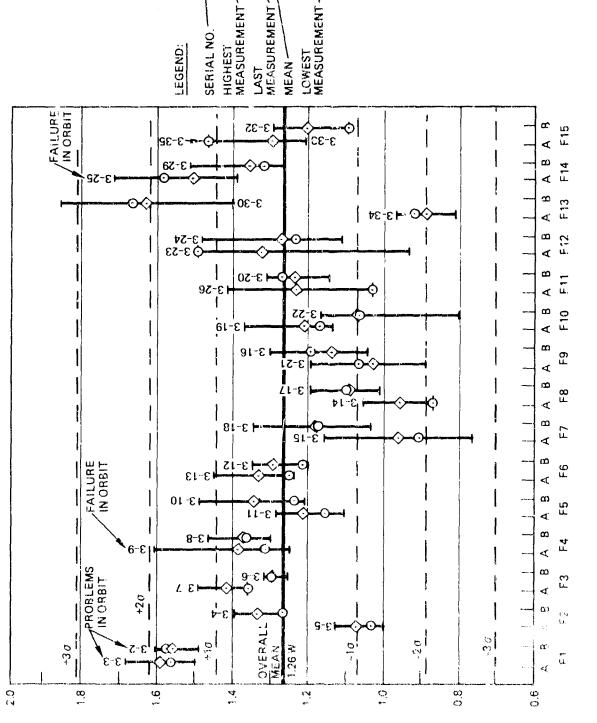
Of particular interest is that the mean output power of the failed transmitter on Flight 14 (S/N 3-25) during I&T was one of the highest even measured. Only transmitter 3-30 on Flight 13 and the two transmitters on Flight 1 (which had problems in orbit) had higher average output. Transmitter 3-9 on Flight 4 (which failed in orbit) also had some relatively high power measurements, although the Tast measurement in I&T was near the overall mean. This raised the question of whether high transmitter output power was correlated with failure.

To assure that the transmitter power variations shown in Figure 3-4 are not just due to normal random variations, statistical significance tests were performed on the data in Appendix C. First an analysis of variance was conducted on the output power measurements made during I&T on the 30 transmitters. This analysis is summarized in Appendix D. As might be expected, the results show that the observed variation in output power is significant and it is highly unlikely that all transmitters come from the same statistical population. Although all transmitters are of the same design, their performance is highly dependent on their tuning.

A second statistical test was performed to determine if the two transmitters which failed abruptly in orbit (S/N 3-9 and S/N 3-25) had significantly higher output power than the average of non-failed transmitters (excluding Flight 1). This analysis is shown in Appendix E. The results indicate that the observed higher output power of the two failed transmitters is statistically significant and there is less than a 5 percent chance that this observation is due just to random fluctuation. The mechanism of failure and how it is related to output power has not been determined.
