RELIABILITY AND MAINTAINABILITY EVALUATION OF THE TOWER CAB DIGITAL DISPLAY SYSTEM

FEDERAL AVIATION ADMINISTRATION TECHNICAL CENTER

FINAL REPORT

DECEMBER 1980

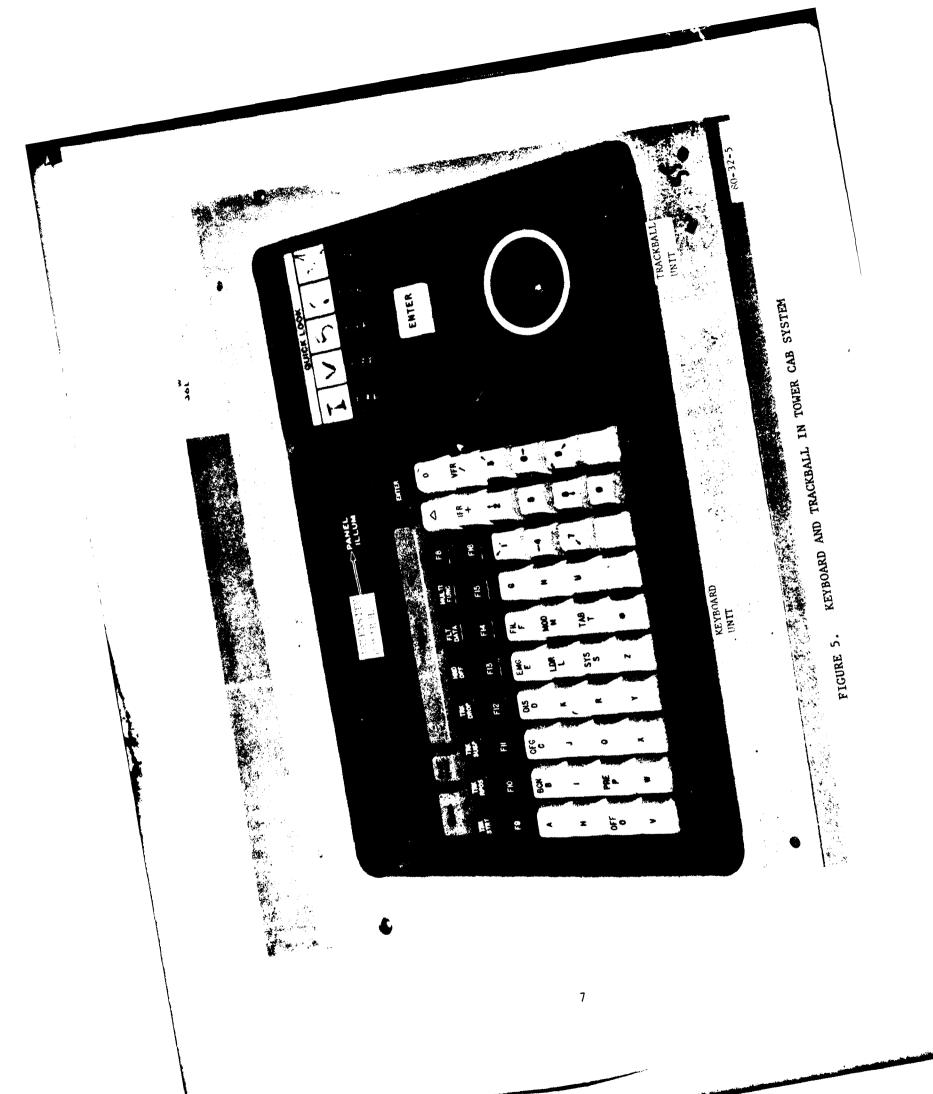
a. Inputted erroneous information when panel lights were turned up full. Heat from lights damaged keyboard code logic PCB 4A2.

- a. <u>Keyboard Heat Problem</u> At St. Petersburg, erroneous data were outputted from the keyboard when the panel was at its highest light intensity. The keyboard code logic PCB was damaged by the excessive heat generated. Figure 5 shows this intensity control on the keyboard.
