MISCELLANEOUS PAPER SL-80-19

CONCRETE DETERIORATION IN SPILLWAY WARM-WATER CHUTE RAYSTOWN DAM, PENNSYLVANIA

Structures Laboratory
U. S. Army Engineer Waterways Experiment Station
P. O. Box 631, Vicksburg, Miss. 39180

December 1980
Final Report

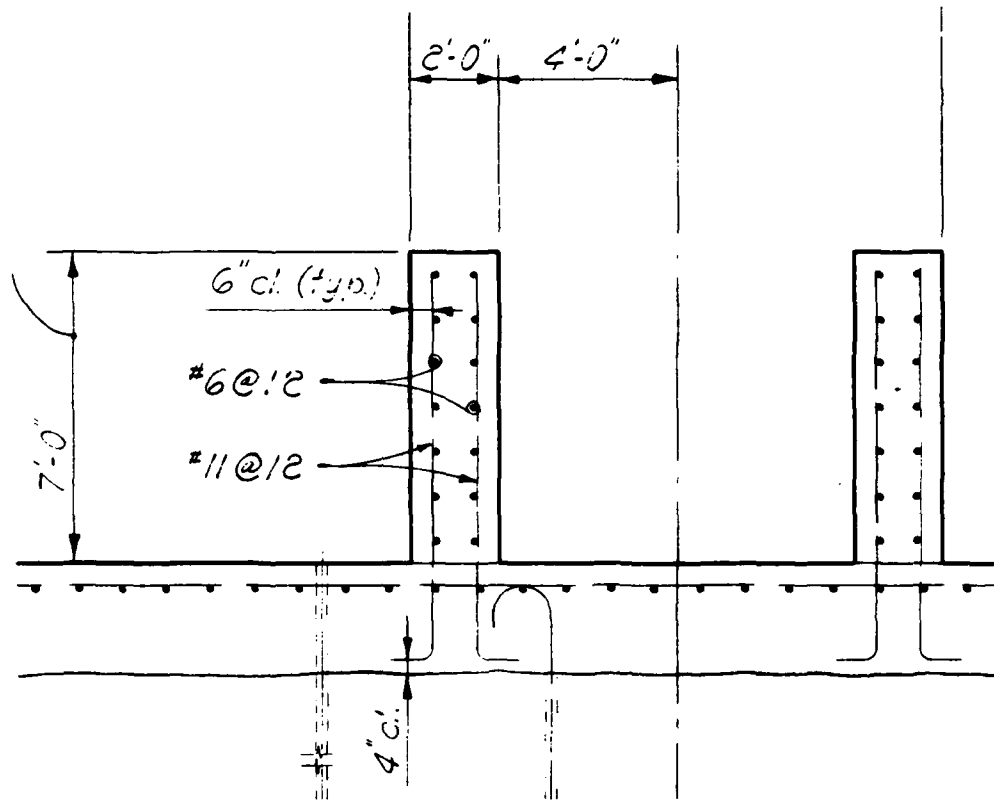
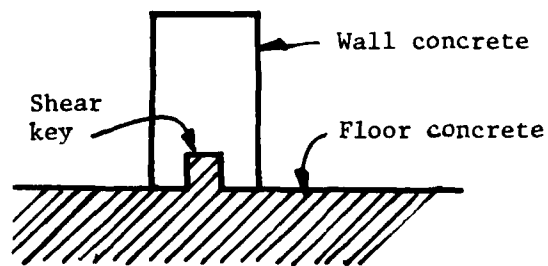
Figure 15. Warm-water chute wall construction technique

surface which is apparently a shear key. Figure 15 compares the contract drawings and the actual construction. The construction technique as shown has allowed water to flow under and inside the walls of the warm-water chute.

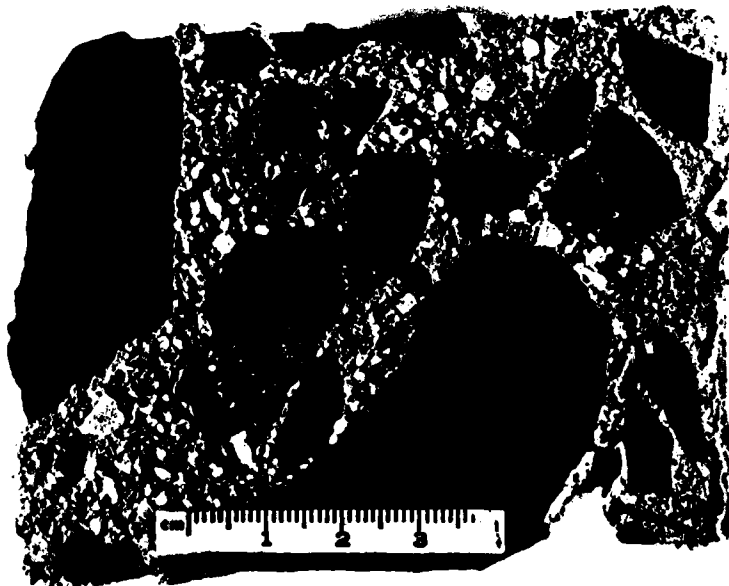
Photo B4. Sawed surface of core RLP No. 4 that was etched in dilute hydrochloric acid for 20 minutes (X1.1). Compare with previous photos
