Mechanical Engineering Technical Memorandum 397

AN INVESTIGATION INTO THE ICE BUILD UP ON THE NOZZLE
MATRIX OF THE 'PEGASUS' ICING SPRAY SYSTEM

C.S. WILSON and P.B. ATKINS

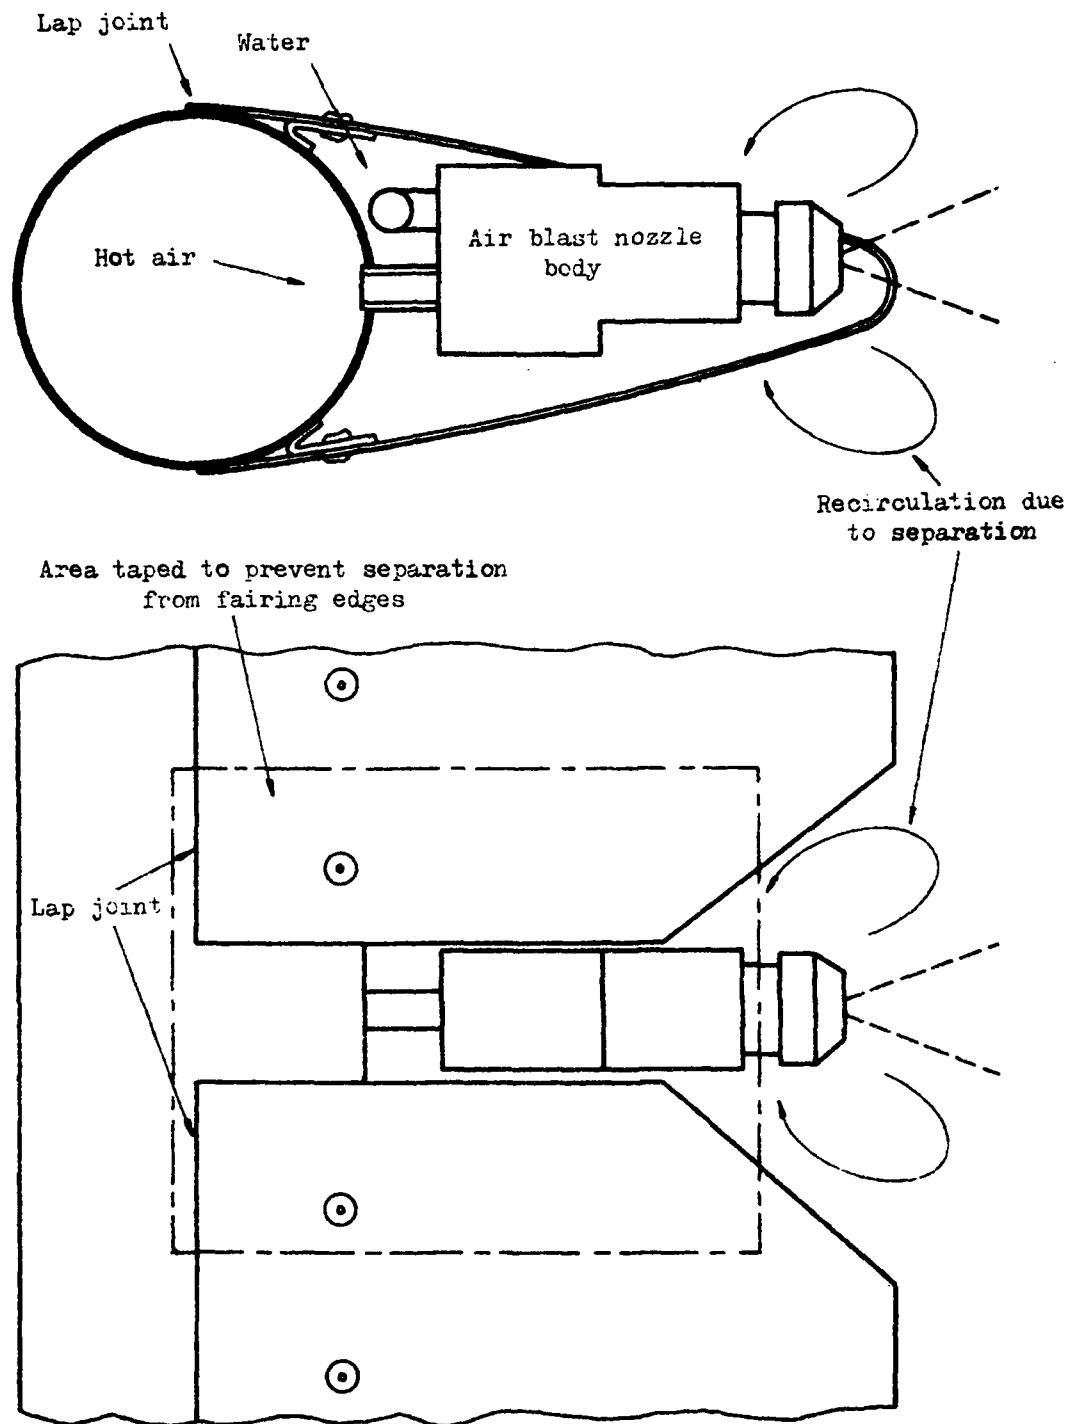
The arrangement of air and water supply tubes, nozzle and fairings is shown in Fig. 6. The area of recirculation due to aerodynamic separation is shown in this figure; this not only caused entrainment of water drops onto the fairing in the region of the cut out at the trailing edge, but also allowed the entrained water to run inside the fairing trailing edge. It was thus concluded that this water was draining, not only under gravity but

also due to pressure difference, to the fairing intersection where it was freezing.

Attention was then directed to conditions on the upstream part of the matrix which proved to be the root cause of the problem. From flow visualisation experiments in the blower rig, using wool tufts and titanium dioxide in oil, it was ascertained that separation was taking place at the lap joint of the fairing and the air supply tube (Fig. 6). An attempt to eliminate this separation by use of vortex generators was unsuccessful.

FIG. 6 NOZZLE MODEL ARRANGEMENT.

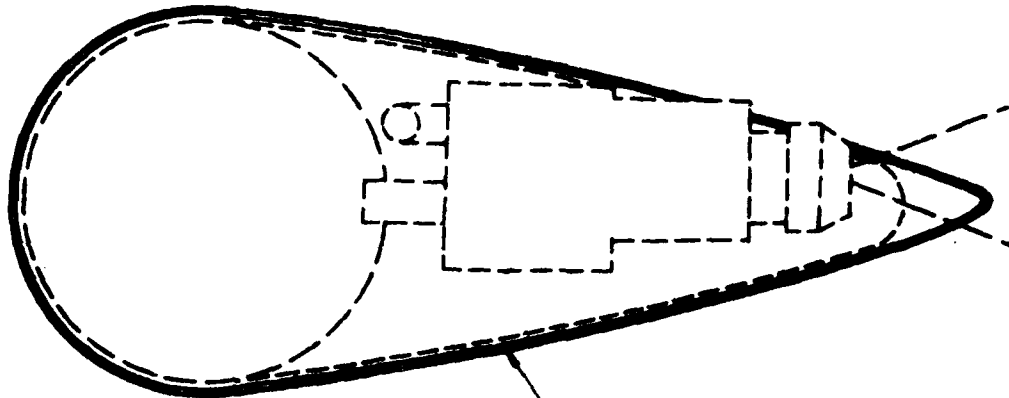
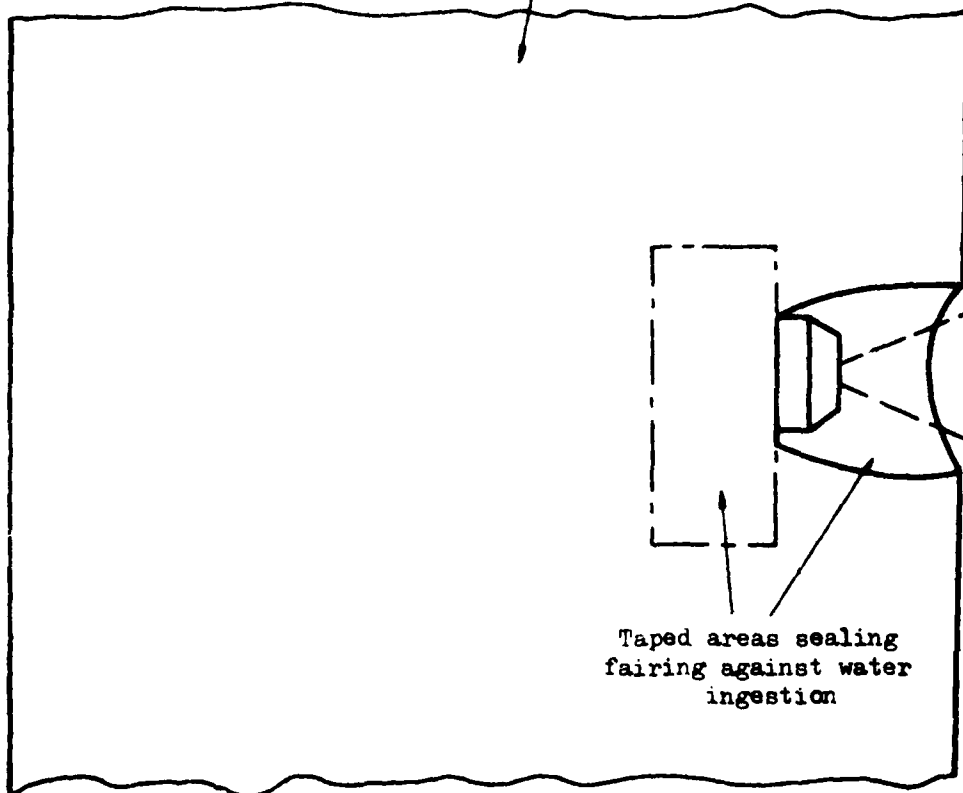
FIG.9 SUCCESSFUL MODIFICATION TO PREVENT ICE BUILD UP.

Wrap around fairing to provide smooth contour

Taped areas sealing
fairing against water
ingestion

A wrap around fairing (Fig. 9) was designed and made to provide a smooth contour at least as far aft as the nozzle. Areas just forward and aft of the nozzle were faired smoothly with tape, and arranged to prevent any water ingestion into the fairing. This modification was tested in the blower outlet using titanium dioxide and oil, and although the flow remained attached to the trailing edge over a range of approximately +10 deg. to -10 deg. incidence, a laminar separation bubble was present at the 20% chord position. When tested in the icing rig, ice formed on the fairing at this laminar separation position, but was physically removed during the test. The justification for doing this was based on the fact that such icing had not been observed in flight, and that the moisture content level in the icing rig (causing this ice build up) was much higher than that at altitude under the flight test condition. This modification performed extremely well under icing conditions, producing very little ice growth on the fairing after prolonged exposure.

- (2) The most effective way of preventing both intersection ice build up and fairing ice build up near the nozzles, was to replace the existing fairing with a full wrap round fairing. The reasons for this are first, to prevent aerodynamic separation around the bluff air supply tubing of the matrix which caused fine water droplets from the spray nozzle to be entrained forward onto the fairing, and second, by sealing any gaps in the fairing, to prevent migration of water to the intersection.
- (3) A solution which would be less sensitive to the separation problem, would be to use a fairing at the leading edge of the tubing giving an aerodynamic shape of higher fineness ratio.
