Technical Report 627

CABLE FAILURES IN THE AN/BQS-15 SONAR SYSTEM

Analysis of failures in the depression/elevation
drive-motor power cable and recommendations
for their prevention

June 1980

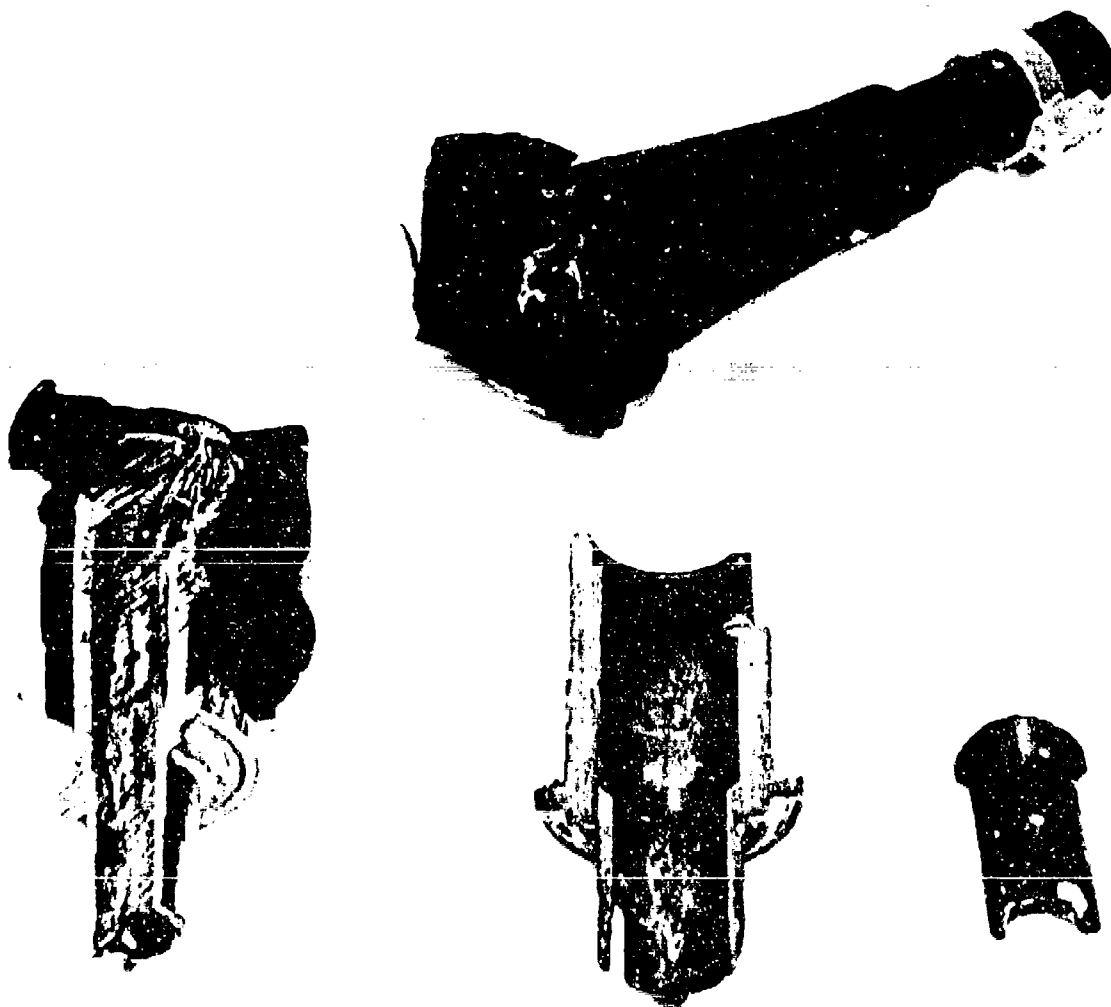
NOSC 848-3-80

Figure 9 shows an additional dissection of the same P2 connector. The rusted area in the center of the metal sleeve indicates the principal water path which caused failure in this connector. Pink areas in the rubber mold (top center) and near the cutout portion of the connector (left) clearly illustrate water leakage; the gray area inside the blue insert is the hard epoxy water block. The hard epoxy shows fracture at the interface of the metal sleeve and the stress relief section which is the tail of the uppermost part in this photograph. A section of the insert is shown at the right.

Figure 9. Additional dissection of P2 connector on cable W31.

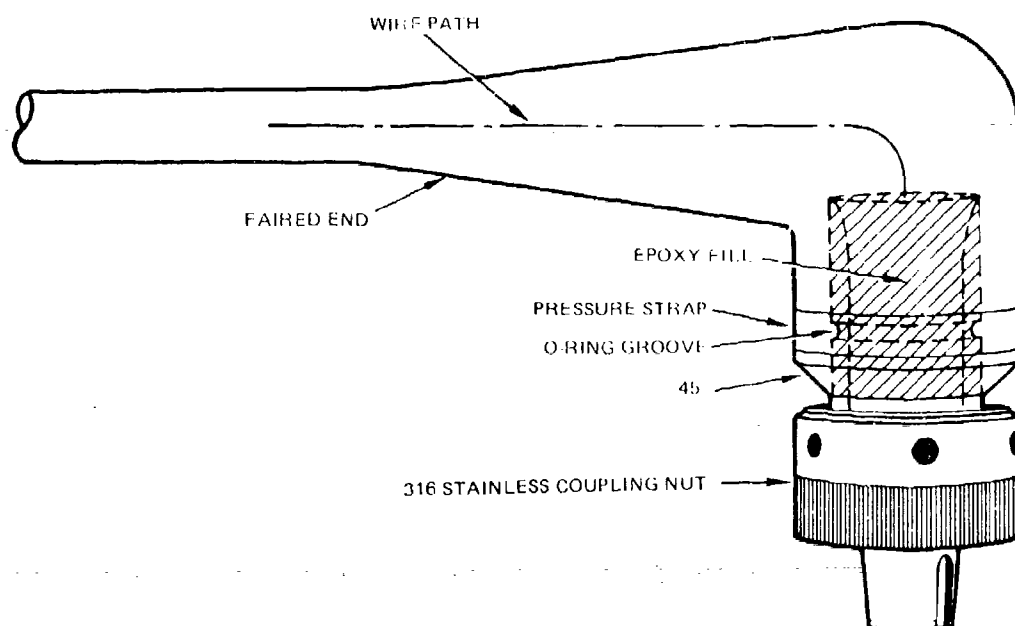
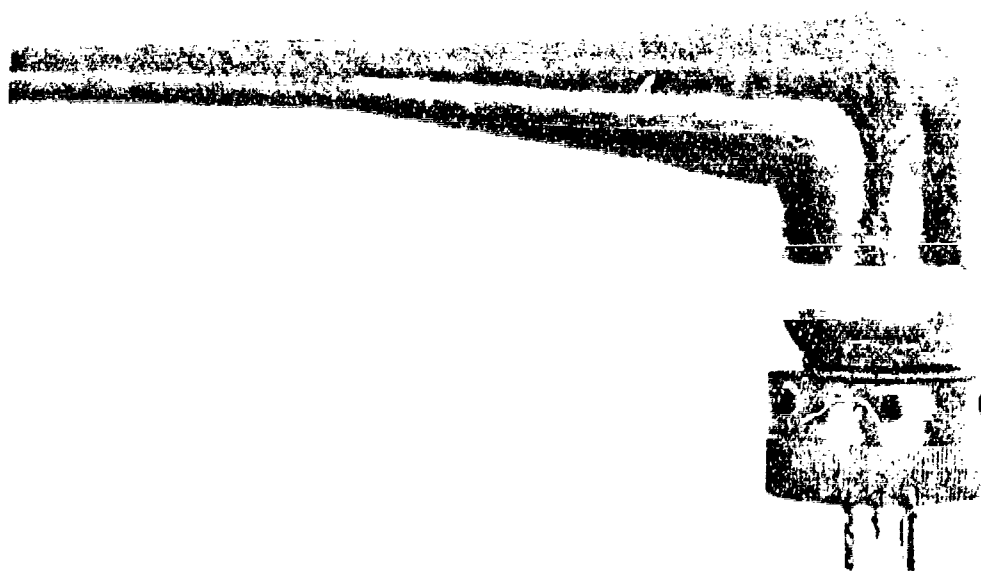
a. Recommended internal modification to the MH-C-2421 2/3-001 connector.

b. External modification

Figure 16. Proposed change for connector P2 of cable W 31.

The material used for a water block in the system should not extend into the stress relief portion of the mold but should be terminated at the end of the metal sleeve. Additionally, the stress relief portion of the mold should be faired into the cable rather than terminate as a step at the cable end. The cutout portion of the smaller MIL-C-24217/3-001 connector should be eliminated, the lines routed up and over the metal sleeve, and the mold changed to accommodate this in a manner similar to that of MIL-C-24231/2-001. A sketch showing this can be seen in figure 16. It illustrates the 90° termination, the fairing into the cable, routing of the wires around the rear of the metal sleeve, the epoxy water block, a metal pressure strap, and an O-ring groove in the metal sleeve directly under the metal strap. The metal strap is recommended since there have been laboratory results (at NUSC) showing that its use apparently aids in the tolerance of the bond to a severe pressure environment. Some results using the strap have shown bond failure in all areas except directly below the metal strap. Installation of the metal strap can be simple. One method would be to tighten the strap so that the exposed surface of the strap just becomes flush with the exterior surface of the neoprene. A buckle would be used to tie the strap in a manner presently used on many deep-submersible transducers. A specially designed tool has been fabricated for this purpose; details of the tool are available from NOSC.

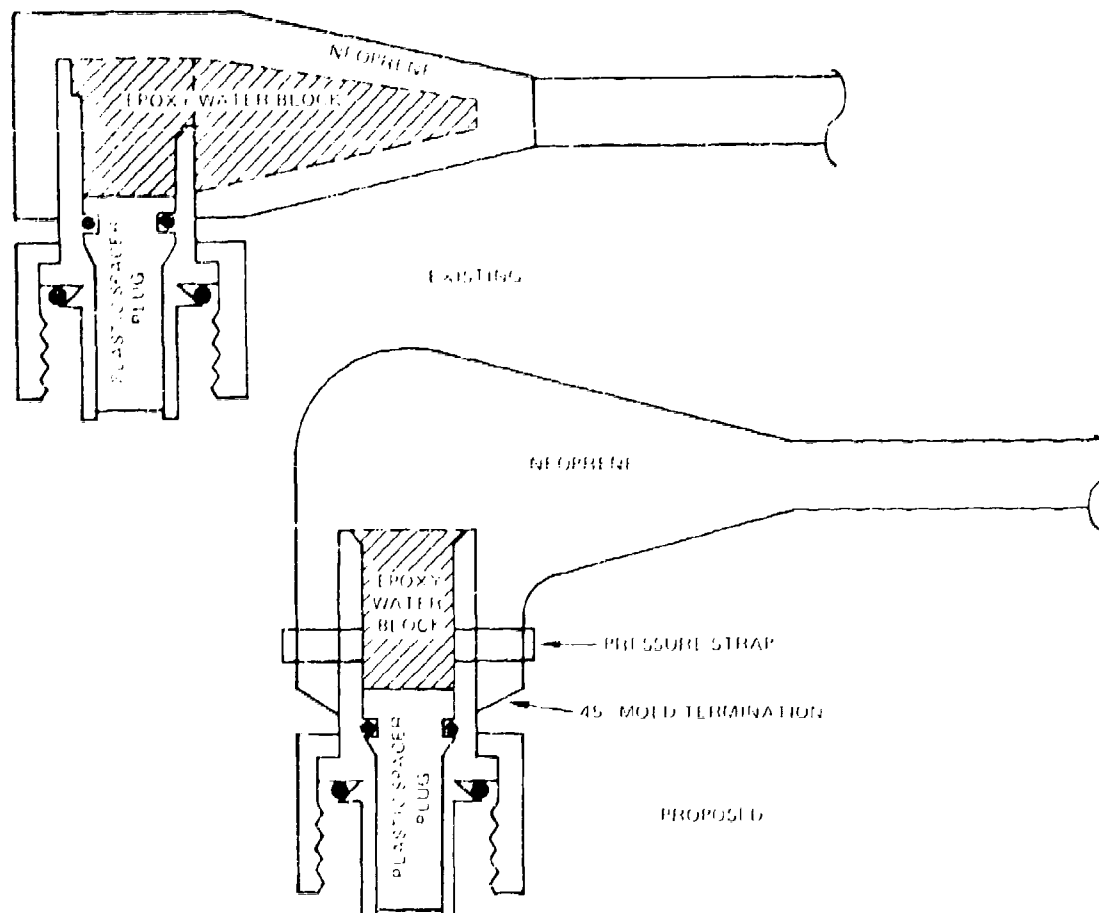
A proposed solution to the problem was presented for comments. This solution is illustrated below along with the existing connector.

A principal fault with the existing 90° connector emanates from the laying up of the epoxy water block. The volume encapsulated in the conical strain section has several problems related to it:

1. It reduces the minimum neoprene bond water path from an available 3/8 inch to 1/4 inch.
2. It does not allow the strain relief section to function as designed.
3. It is not layed up uniformly.
4. All dissected pieces showed cracking of the water block closest to the connector metal sleeve near the wire entry notch.

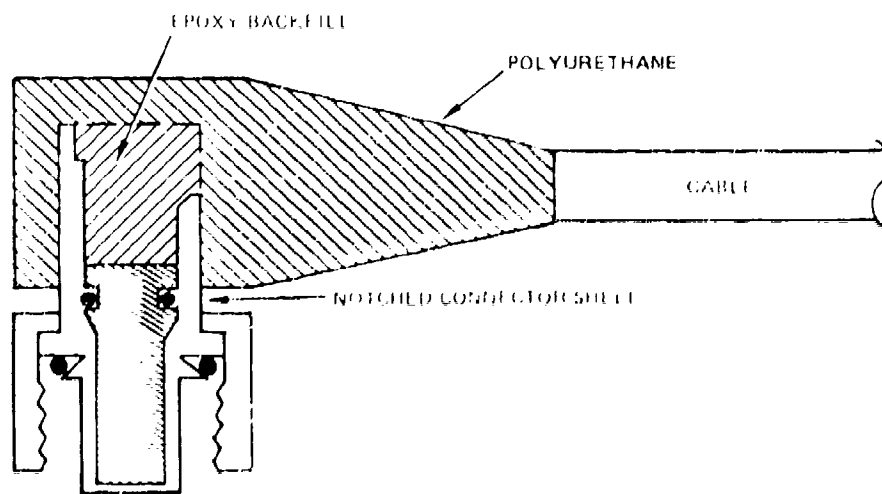
Figure 1. Polyurethane encapsulated MIL-C-24217 right angle connector.

3. We concur with the failure analysis findings that the AN/BQS-15 cable connector assemblies flooded at the cable connector. Suggest that two alternative methods be considered. The methods are to encapsulate connectors with polyurethane, enclosure (1), fig 1, or to manufacture the proposed right angle connector cable assemblies incorporating a straight inline connector shell, detailed in enclosure (1) of reference (a).

4. Polyurethane encapsulated connectors have proven to be reliable for deep submergence service. The uniformly molded polyurethane encapsulation eliminates the stress fracture failure at the strain relief area and increases the available bond surface from 0.25 inches to 0.375 inches, enclosure (1), fig 1. The polyurethane to metal interface can be visually inspected for bond integrity without the use of prying tools, which could damage bond integrity. The
