O'BRIEN AND GERE ENGINEERS INC PHILADELPHIA PA F/G 13/13  
NATIONAL DAM SAFETY PROGRAM. LAKE COMO DAM (DE 00028), DELAWARE--ETC(U)  
NOV 80 J J WILLIAMS DACW61-80-0-0013

4. TITLE (and Subtitle) Phase I Inspection Report National Dam Safety Program Lake Como Dam Kent County, Delaware	5. TYPE OF REPORT & PERIOD COVERED FINAL

Based on visual observations made during the inspection (which followed overtopping and partial failure of the dam on July 29, 1980), information provided by the Town of Smyrna, and conversations with town officials, Lake Como Dam is considered to be in poor overall condition.

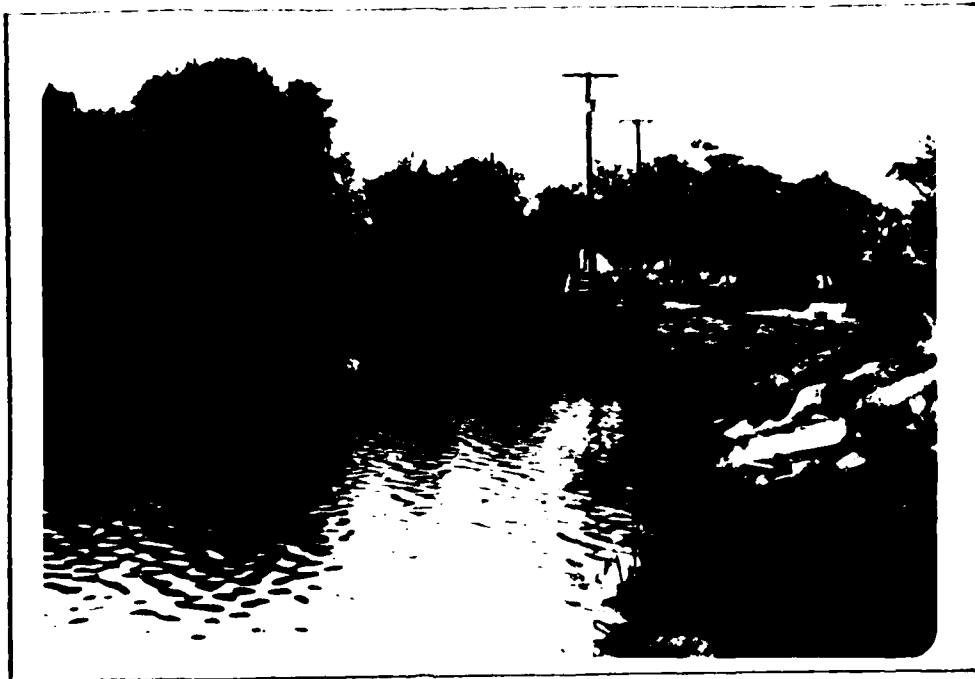
UPSTREAM OVERVIEW LOOKING TOWARDS LEFT ABUTMENT  
(8/12/80)

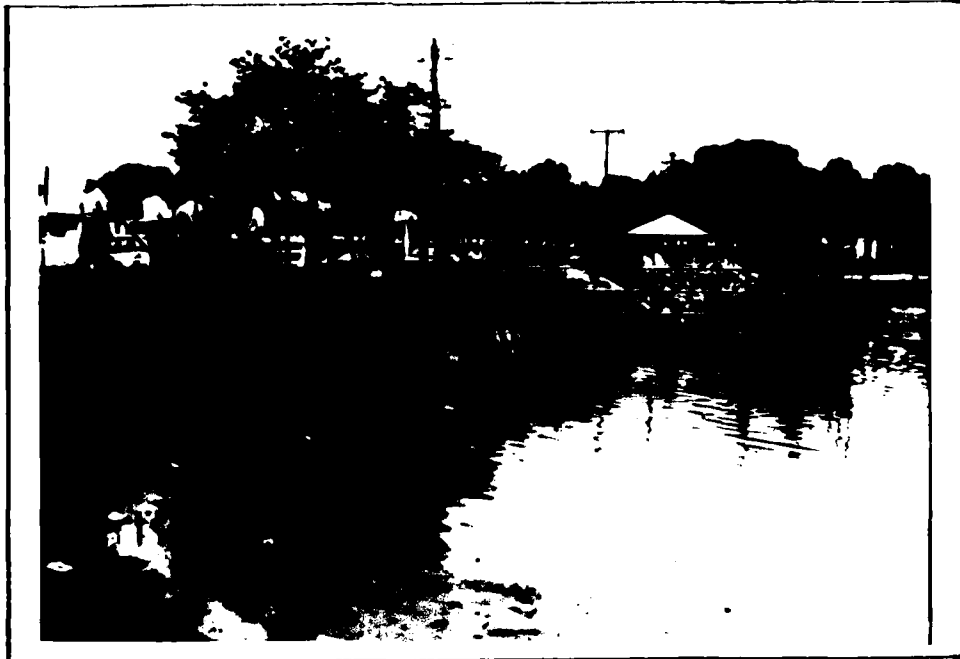
1. UPSTREAM OVERVIEW LOOKING TOWARDS RIGHT ABUTMENT.  
(8/12/80)

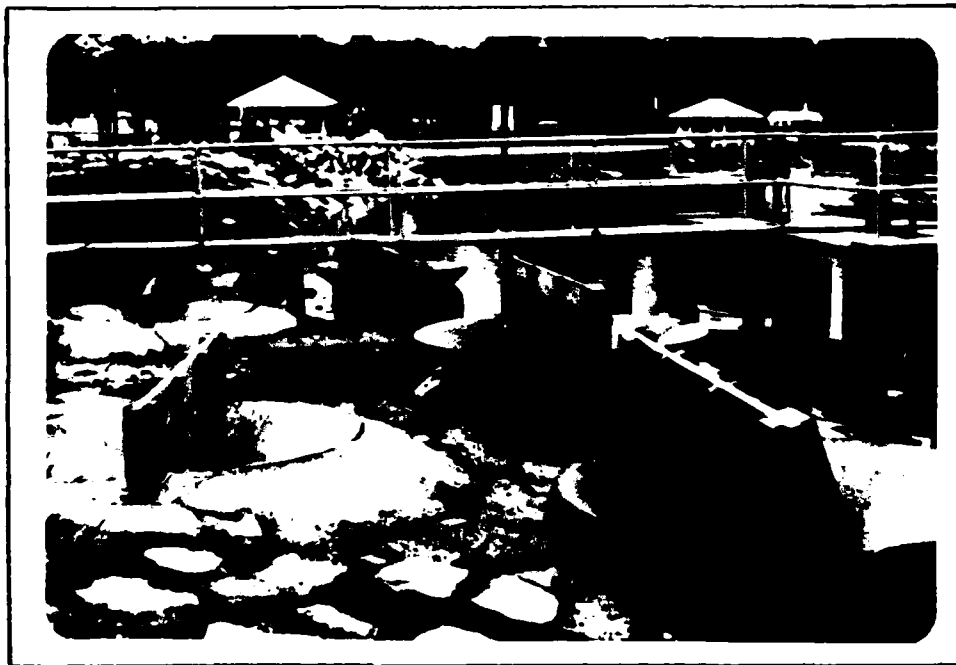
2. VIEW OF MULTIPLE DROP INLET SPILLWAY, ACCESS BRIDGE  
AND OPERATORS FOR LOW-LEVEL OUTLET.  
(8/12/80)

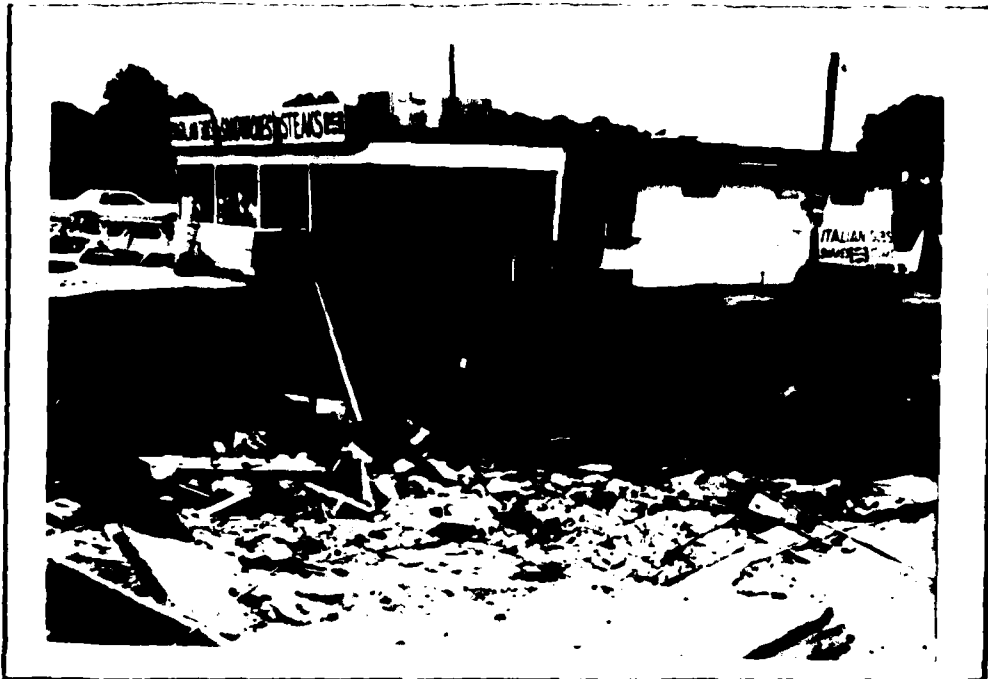
5. VIEW EXHIBITING UNDERMINING OF RESTAURANT DOWN-  
STREAM OF THE RIGHT ABUTMENT. AUTO IN LEFT BACKGROUND  
IS TRAVELING UPON U.S. ROUTE 13.  
(8/12/80)

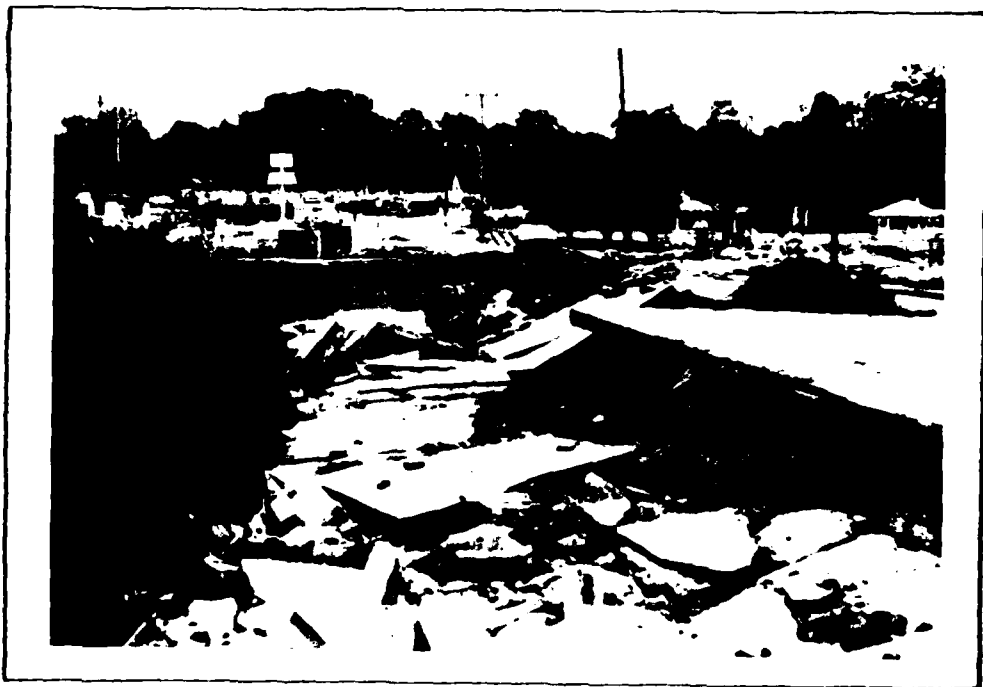
6. VIEW OF FAILURE ZONE LOOKING TOWARDS RIGHT ABUT-  
MENT. AREA OF OVERTOPPING EXTENDED ABOUT 500 FEET TO  
CEMETARY IN BACKGROUND.  
(8/12/80)
