**DEPARTMENT OF DEFENCE
DEFENCE SCIENCE AND TECHNOLOGY ORGANISATION
AERONAUTICAL RESEARCH LABORATORIES**

Structures Technical Memorandum 327

A REVIEW OF AUSTRALIAN INVESTIGATIONS ON
AERONAUTICAL FATIGUE DURING THE PERIOD
APRIL 1979 TO MARCH 1981

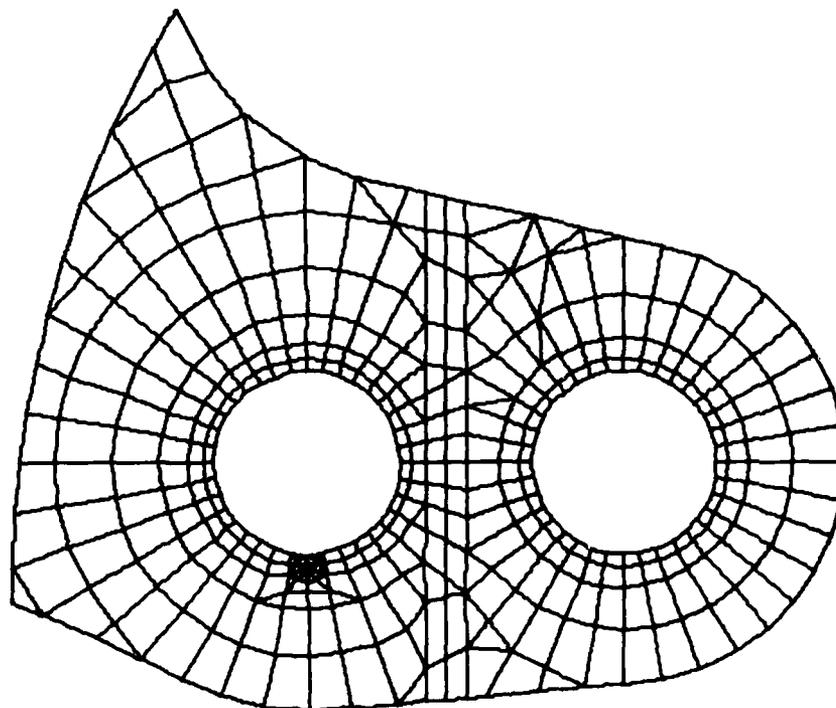
FIG. 9.9 CANBERRA LUG FINITE ELEMENT MESH (CRACK DEPTH = 3.40 mm)

The estimation of residual strength has been approached both analytically and by means of finite element analysis, Fig. 9.9. Analytically, the lug is approximated using Newman's 1976 approach⁸ for through and part-through cracks in a partially pin loaded hole-in-bar. It turns out that the analytical solutions provide stress intensity estimates just above those of the corresponding finite element analysis; their direct use therefore provides a little inbuilt conservatism, as well as complete manipulative flexibility, in crack growth and residual strength assessments. The critical crack depth is typically rather shallow, but above the threshold of detectability.

Crack growth predictions have been made using Forman's equation⁹. Insofar as no retardation is allowed for in that formulation, crack growth predictions are likely to be conservative particularly in the low crack growth rate region. Even so, calculated inspection intervals are reasonable, so that the feasibility of the proposal has in fact been established on the basis of calculations to date¹⁰. Before implementation in service, however, fatigue testing of lug specimens under a representative loading sequence is to be carried out to check all predictions concerning the fatigue and residual strength behaviours of the cracked lug.

In view of uncertainties now known to exist in the assessment of fatigue damage, ARL is investigating the feasibility of operating these aircraft on a safety by inspection basis. Such a consideration requires the evaluation of the residual strength and crack growth characteristics of the fatigue critical region and, of course, accessibility for inspection. This latter requires that both wings and lug bushes be removed. The lugs of all aircraft have recently been inspected and have been found to be free of detectable cracks.

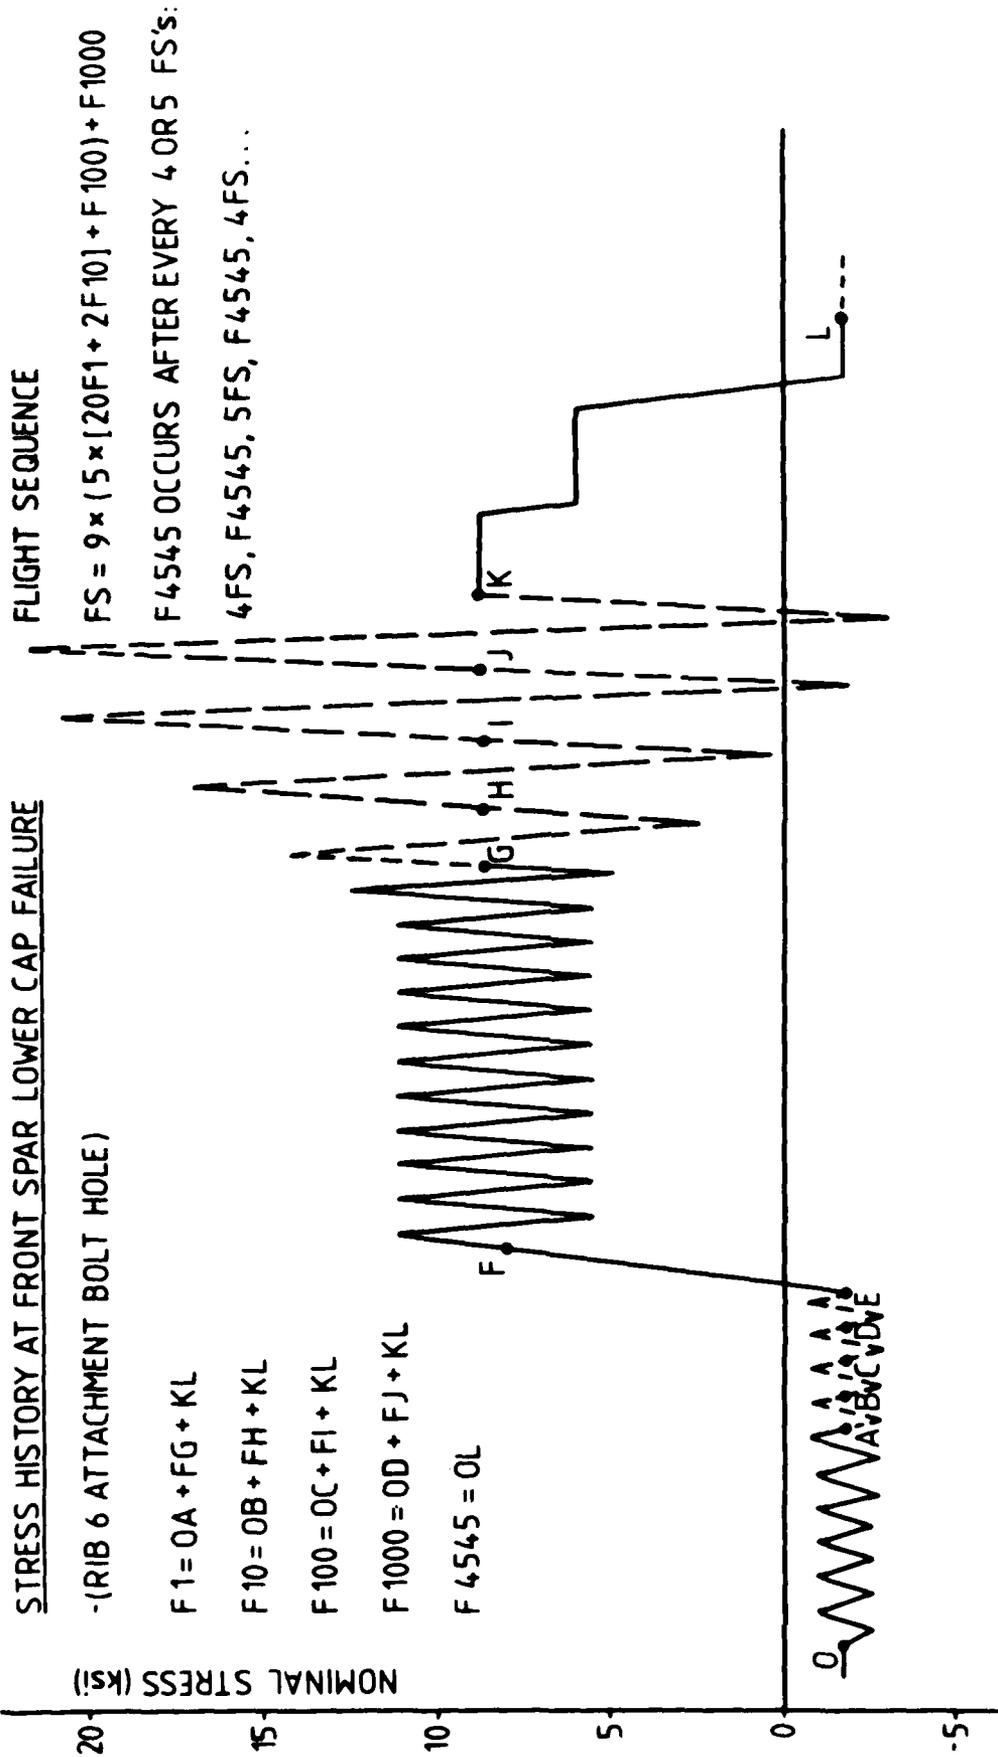
FIG. 9.11 BANDEIRANTE FATIGUE TEST SEQUENCE

The sequence adopted for the fatigue test is illustrated in Figure 9.11. The spar failed in the fatigue test rig at the rib 6 attachment bolt hole during the last gust cycle of the last flight in the 188th application of the 1,000 flight program of the fatigue test i.e. the peak load of the 188th block. Flight F4545 has the highest peak load in the entire program, and this occurred after block numbers 185, 181, 176, 172, 167, 163, 158, 154, 149, 145, 140, 136, 131 and so on.
