VALLEY VIEW LAKE DAM

NDI ID No. PA-01006
DER ID No. 19-75

PHASE I INSPECTION REPORT

(11) FEBRUARY 1981

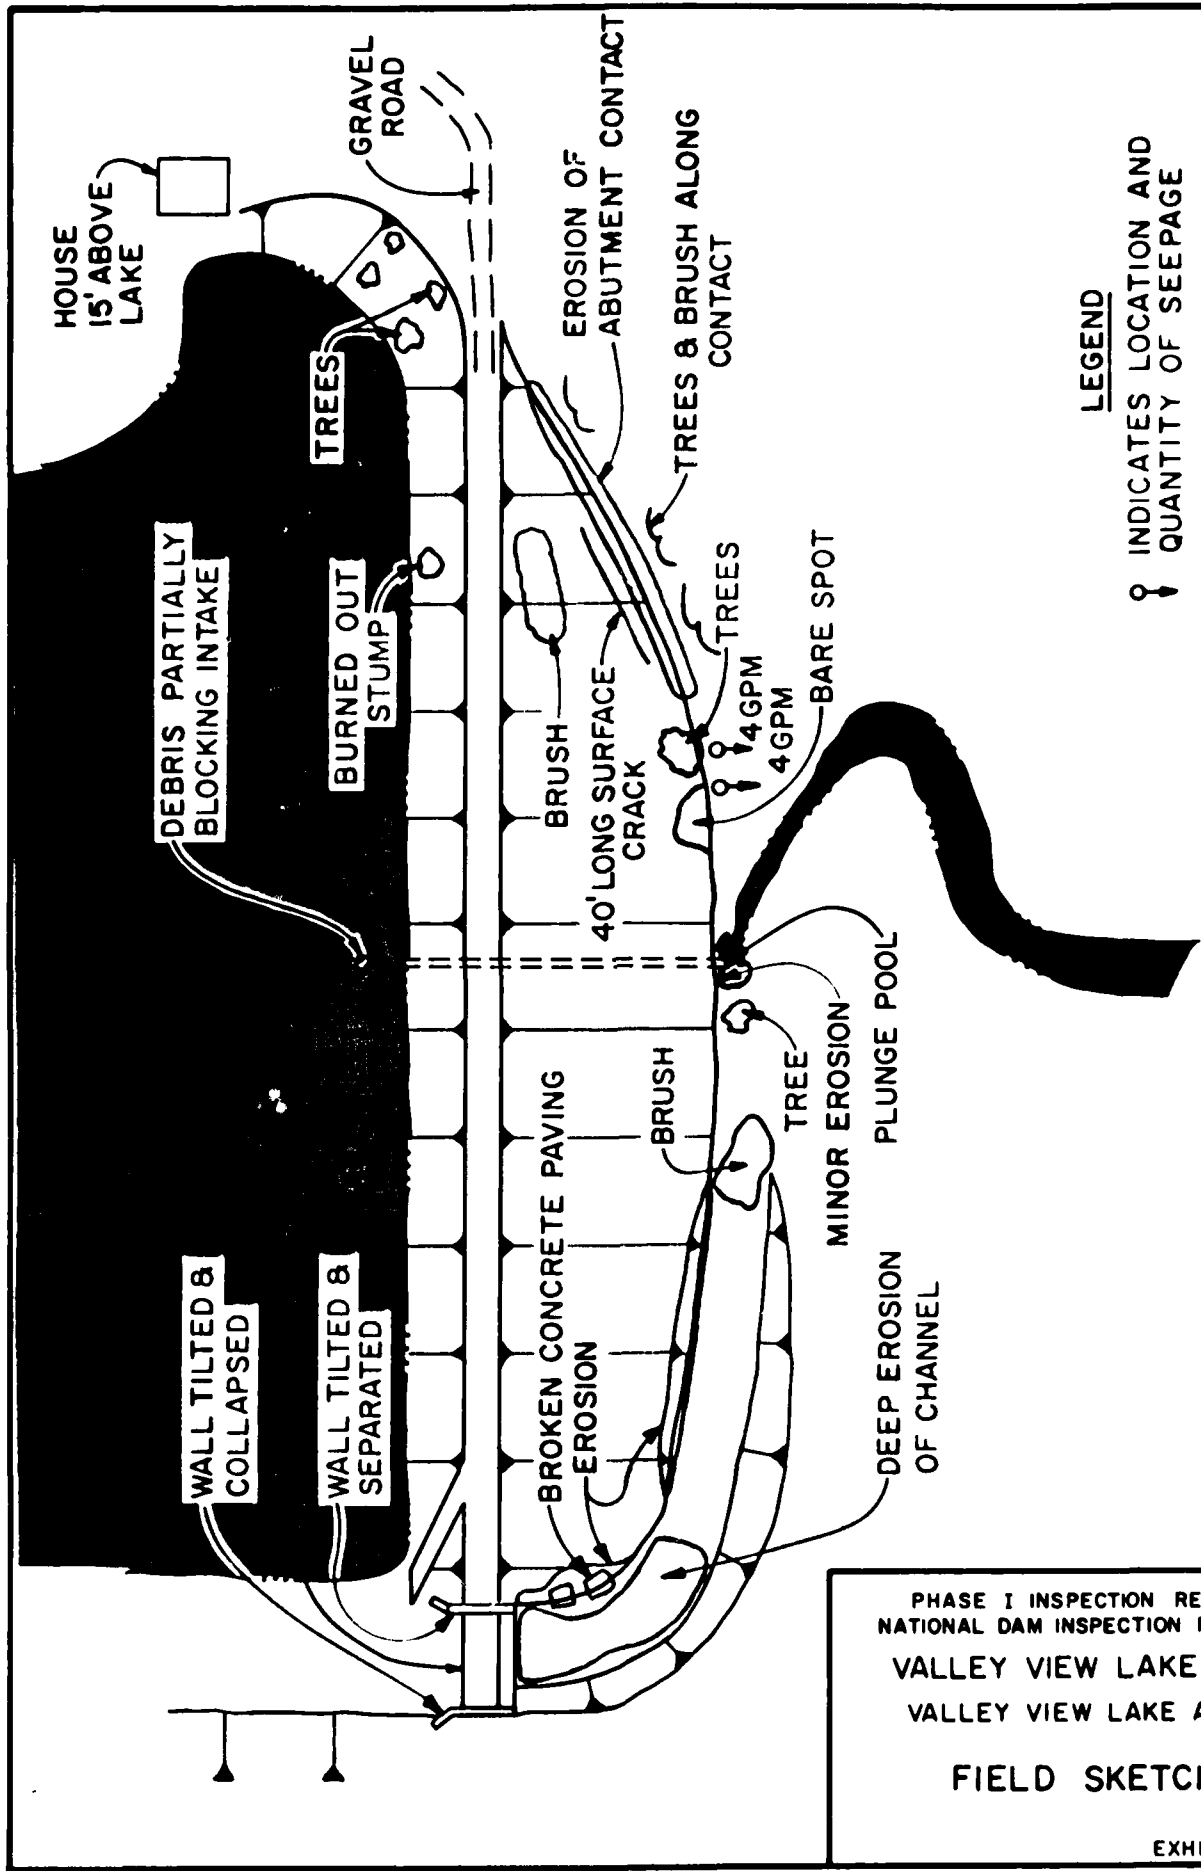
PHASE I INSPECTION REPORT
 NATIONAL DAM INSPECTION PROGRAM
 VALLEY VIEW LAKE DAM
 VALLEY VIEW LAKE ASSN.
 FIELD SKETCH
 EXHIBIT A-1

Drainage along downstream left junction has created ditch which is eroding and causing a crack to form in embankment (see below).
Left spillway wall is leaning in toward spillway but present effect on embankment is minimal; however failure of this wall would permit erosion of dam.

40 foot long crack is developing along downstream face parallel to the embankment/abutment contact and 7-8 feet upslope of the contact. A drainage ditch has formed along this junction with erosion causing sloughing of embankment.

Runoff along downstream left junction of embankment and abutment is causing erosion of contact and dam. Ditch should be lined with rock or paved. See related items on Exhibit A-1. Spillway flow is eroding some of the embankment immediately downstream of the left spillway wall and along the toe of dam where discharge channel parallels toe. Concrete paving apparently was placed to protect area downstream of left spillway wall but this has been undermined and has broken into several large pieces.

Deeply eroded; 12-15 foot vertical drop off end of spillway. Area filled recently with leaves which obscured thorough investigation; however it appears the spillway slab is being undercut. Dam embankment on left side immediately downstream of slab is eroding. Concrete apparently was placed to prevent erosion but undercutting has caused this paving to break-up into several large pieces. First 50 feet beyond spillway slab has bottom and vertical right side in bedrock. Left side is eroded embankment. Channel follows toe of dam with bedrock disappearing. Toe of embankment is eroded to slope of 3V:4H. Needs protection.

3. The erosion of the ditch along the left abutment contact on the downstream side of the embankment should be monitored, along with the associated minor cracking occurring adjacent to the ditch. Appropriate remedial measures should be taken if the condition worsens significantly.

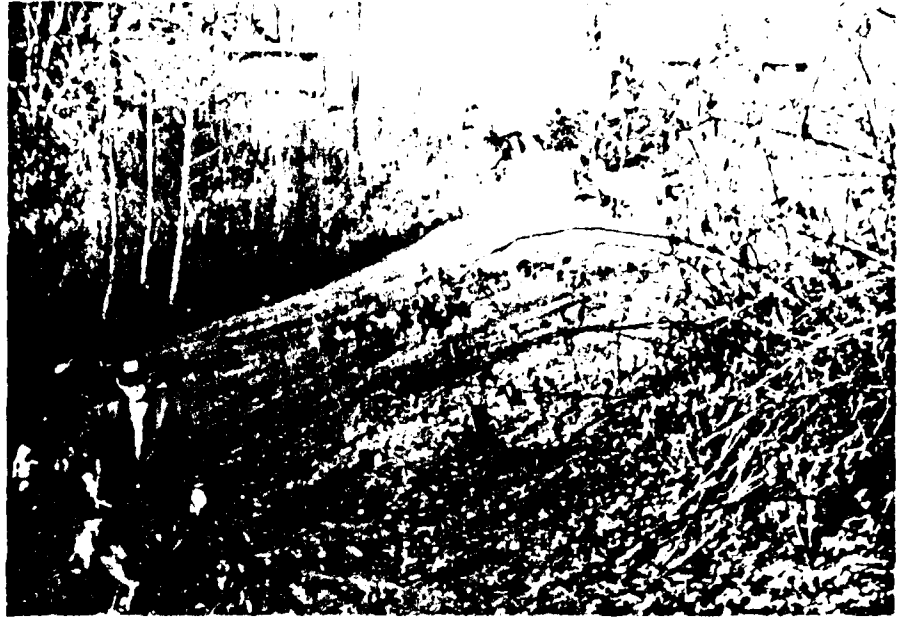
3. Downstream slope of embankment

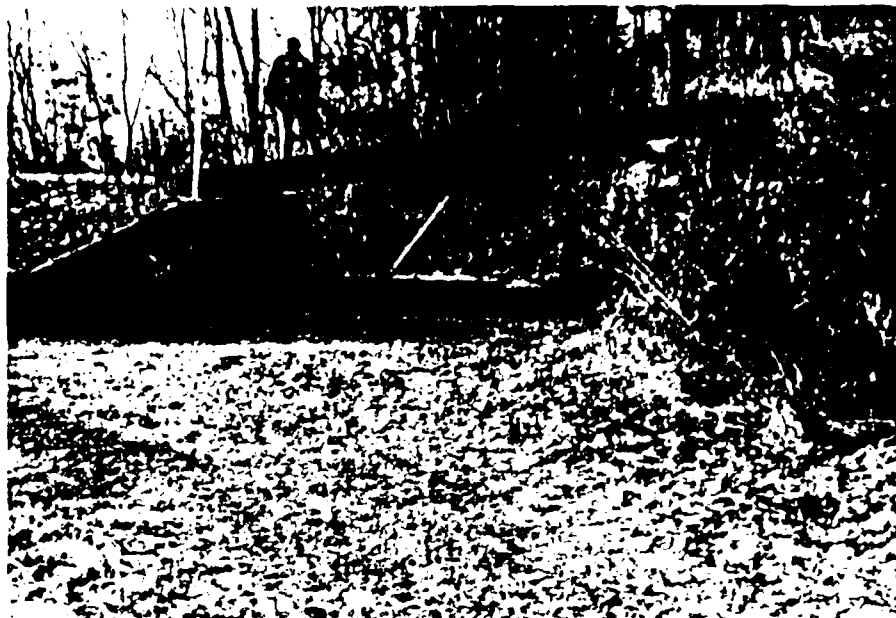
5. Approach Channel to Spillway

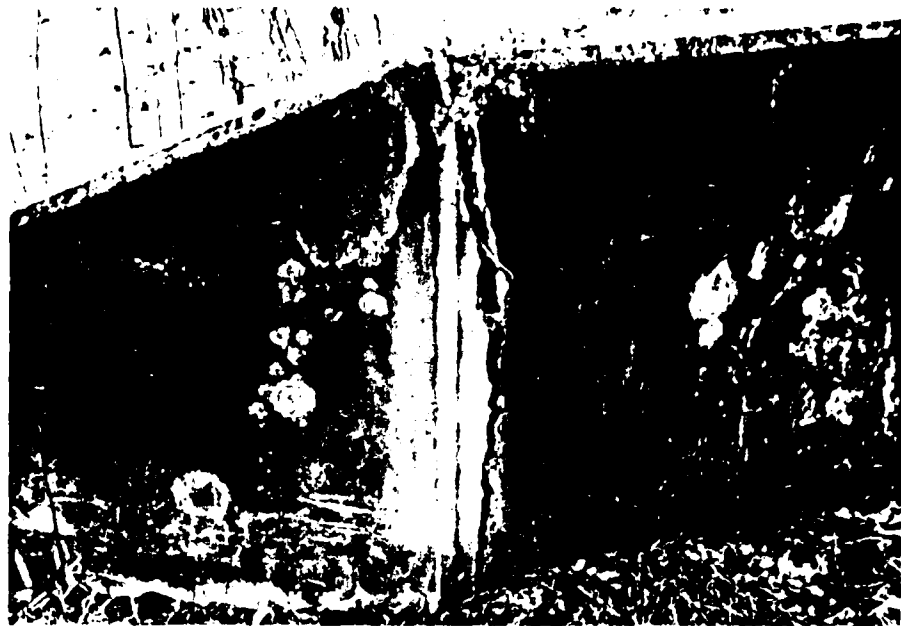
Concrete slab; broad crested. Minor cracking. Left wall leaning in toward spillway. Joint w/upstream wingwall separated.

7. Crack in Approach Wall of Left Spillway Wall

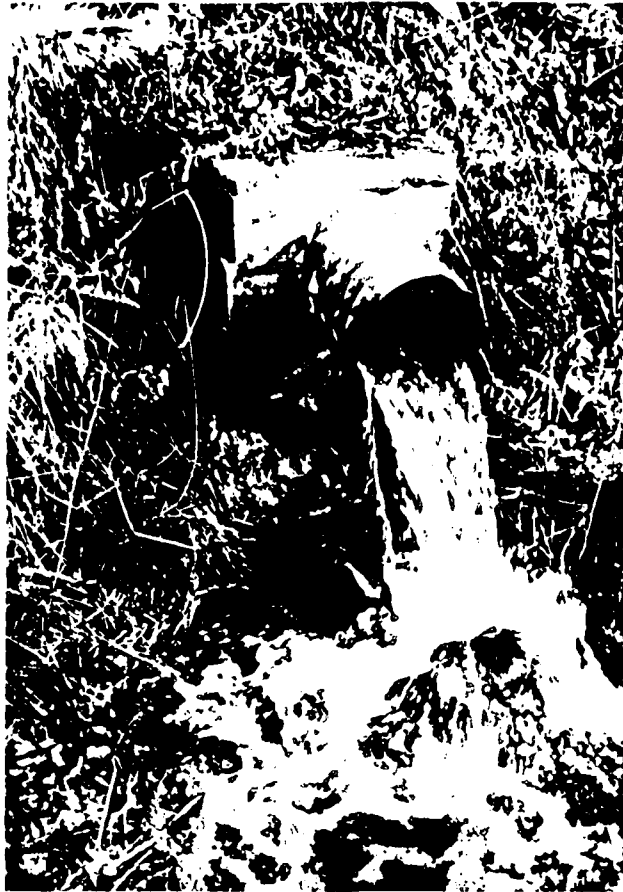
11. Outlet Conduit at
Downstream Toe of Embankment

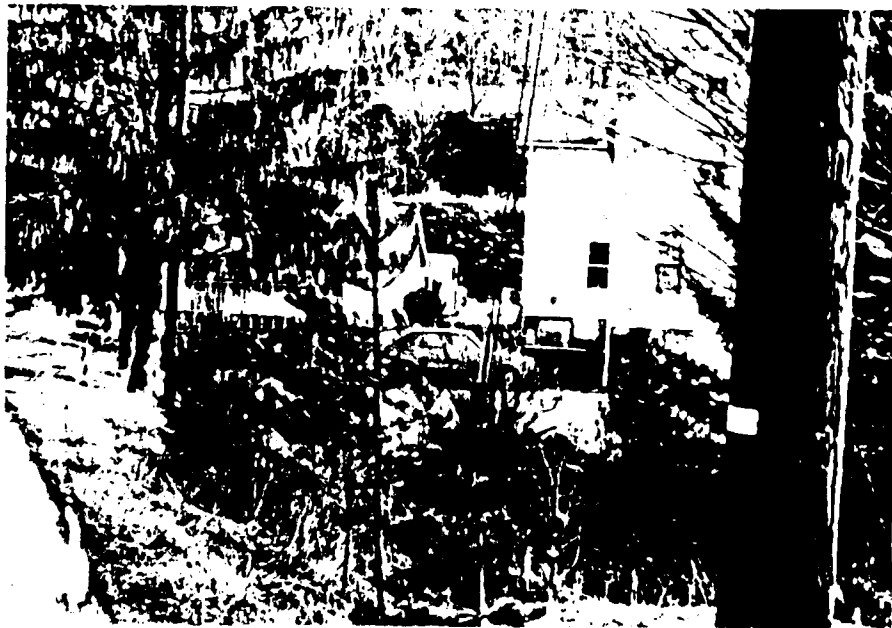
14. Downstream Damage Area. First Floor level is 5 Feet Above Streambed.

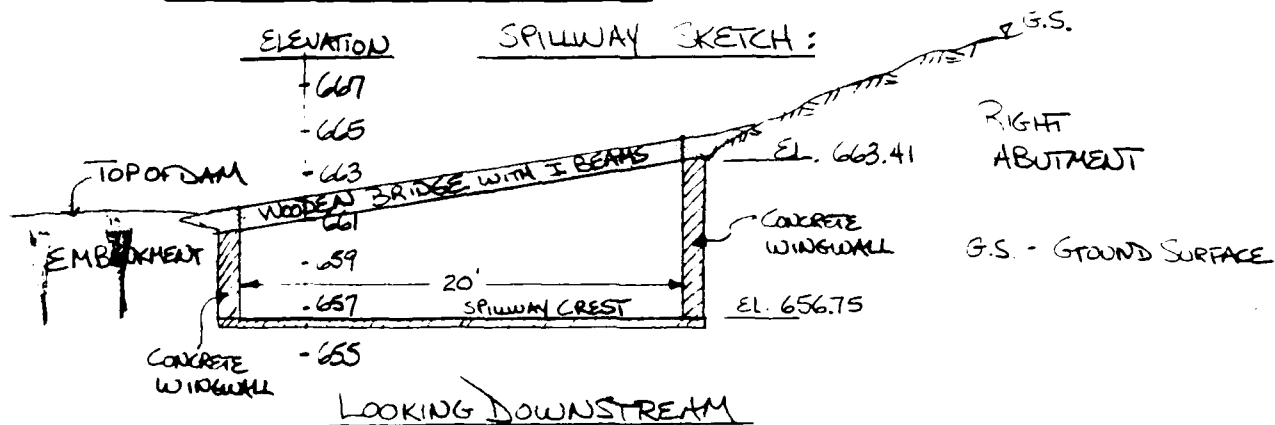
NOTE: ONCE WATER SURFACE ELEVATION REACHES 660.55, STEEL I-BEAMS IN BRIDGE BEGIN TO BLOCK SPILLWAY FLOW AS SHOWN ABOVE. THIS OCCURS FIRST ON LEFT SIDE ON SPILLWAY WHERE BRIDGE SLOPES DOWN ONTO EMBANKMENT.

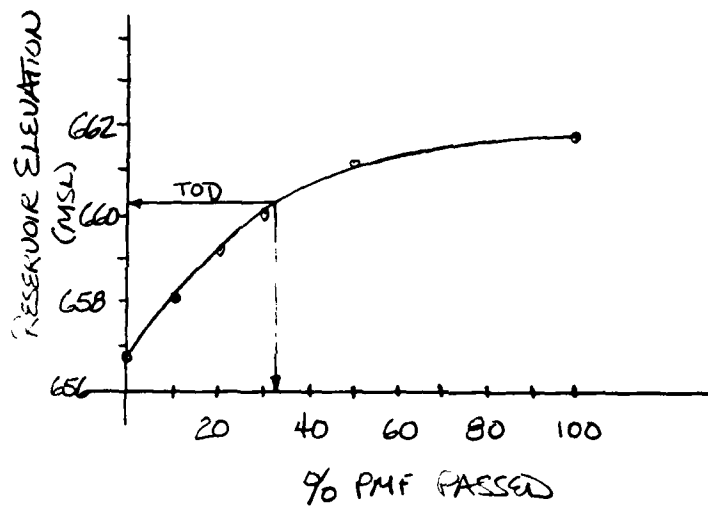
CAN PASS 32% OF THE PMF PRIOR TO OVERTOPPING THE EMANKMENT.

TOP OF DAM ELEVATION IS 660.20
