# BRONSON POND DAM

NDI ID NO. PA-00143  
DER ID NO. 64-42

## PHASE I INSPECTION REPORT NATIONAL DAM INSPECTION PROGRAM

(11) FEBRUARY 1981

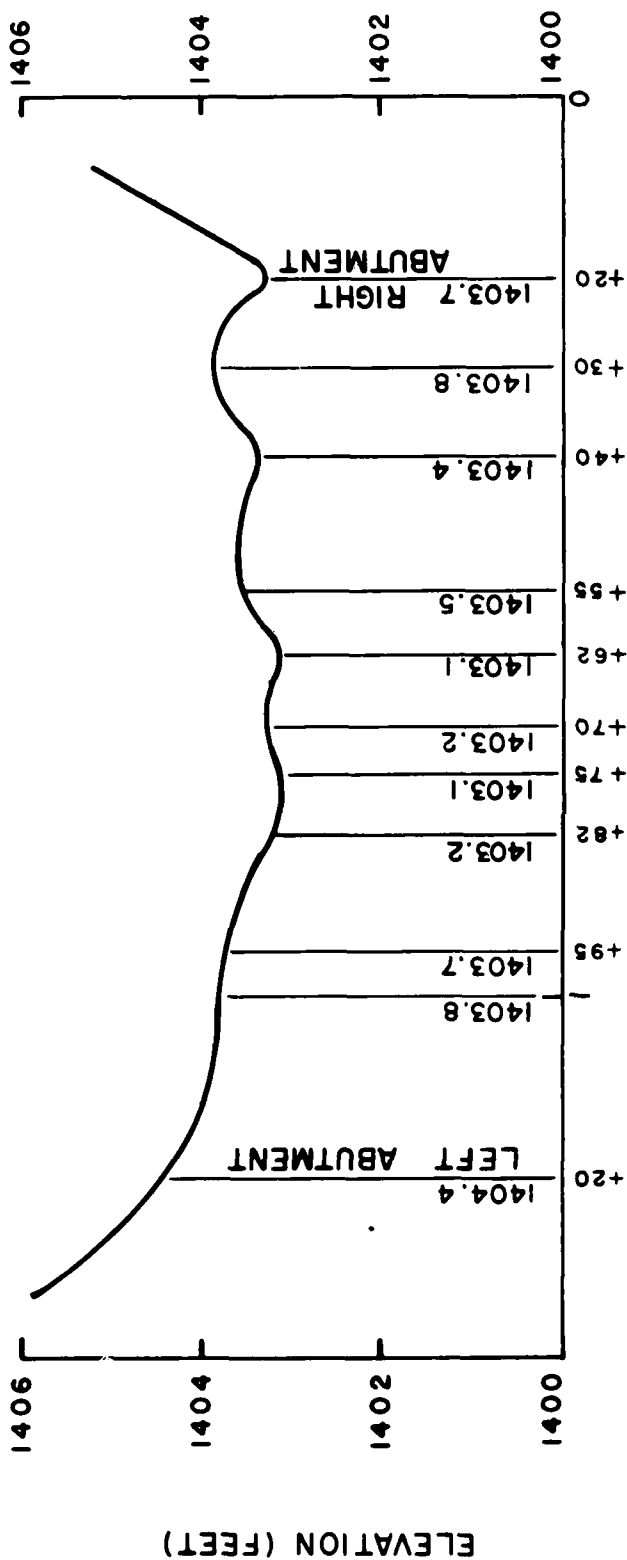
### TOP OF DAM - PROFILE

VISUAL EXAMINATION OF	OBSERVATIONS
CREST ALIGNMENT: Horizontal Vertical	Irregular due to random placement of rock. Varies 0.7' between high and low points.
SURFACE CRACKS:	None observed
JUNCTION OF EMBANKMENT WITH: Abutments Spillway	Good, trees on right end. Dam crest acts as ungated spillway.
UNUSUAL MOVEMENT OR CRACKING AT OR BEYOND THE TOE	Unable to determine due to nature of structure. Rock is dumped periodically at random on downstream face.
SLOUGHING OR EROSION OF EMBANKMENT AND ABUTMENT SLOPES	None observed.

(3) Establish uniform profile and width for the dam crest.

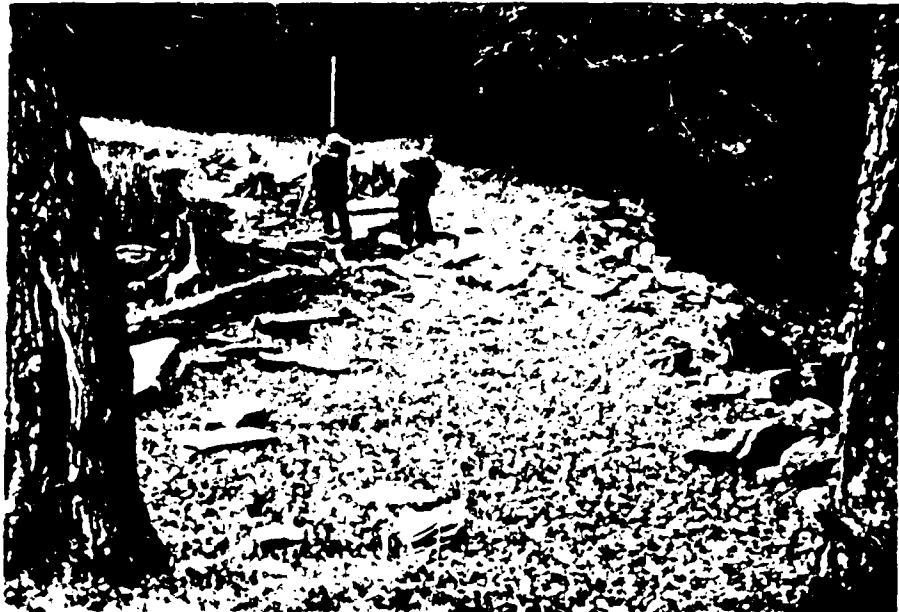
1. Embankment crest and left abutment.

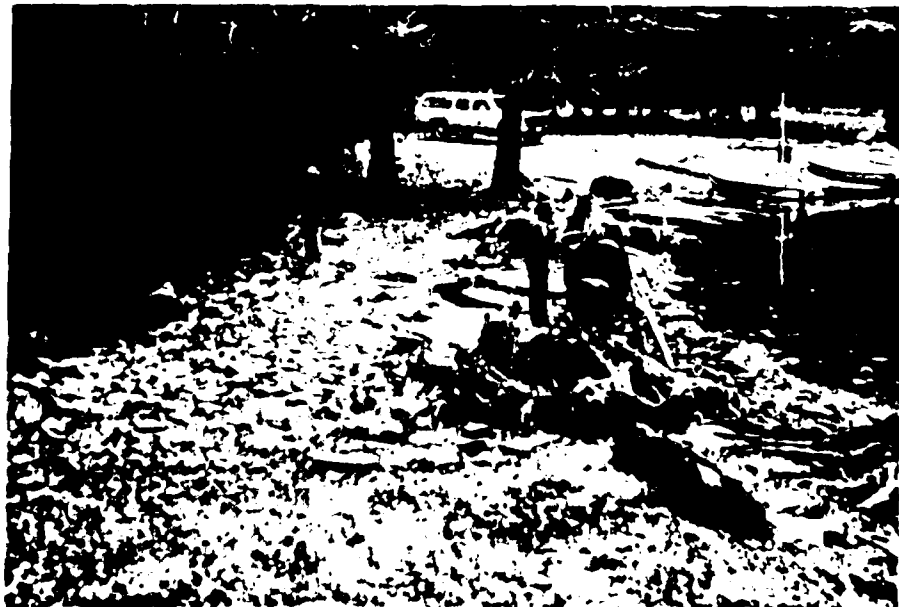
2. Embankment crest and left abutment.
