LAKE QUINN DAM

NDI ID NO. PA-00145
DER ID NO. 64-43

PHASE I INSPECTION REPORT NATIONAL DAM INSPECTION PROGRAM

DEPARTMENT OF THE ARMY
Baltimore District, Corps of Engineers
Baltimore, Maryland 21203

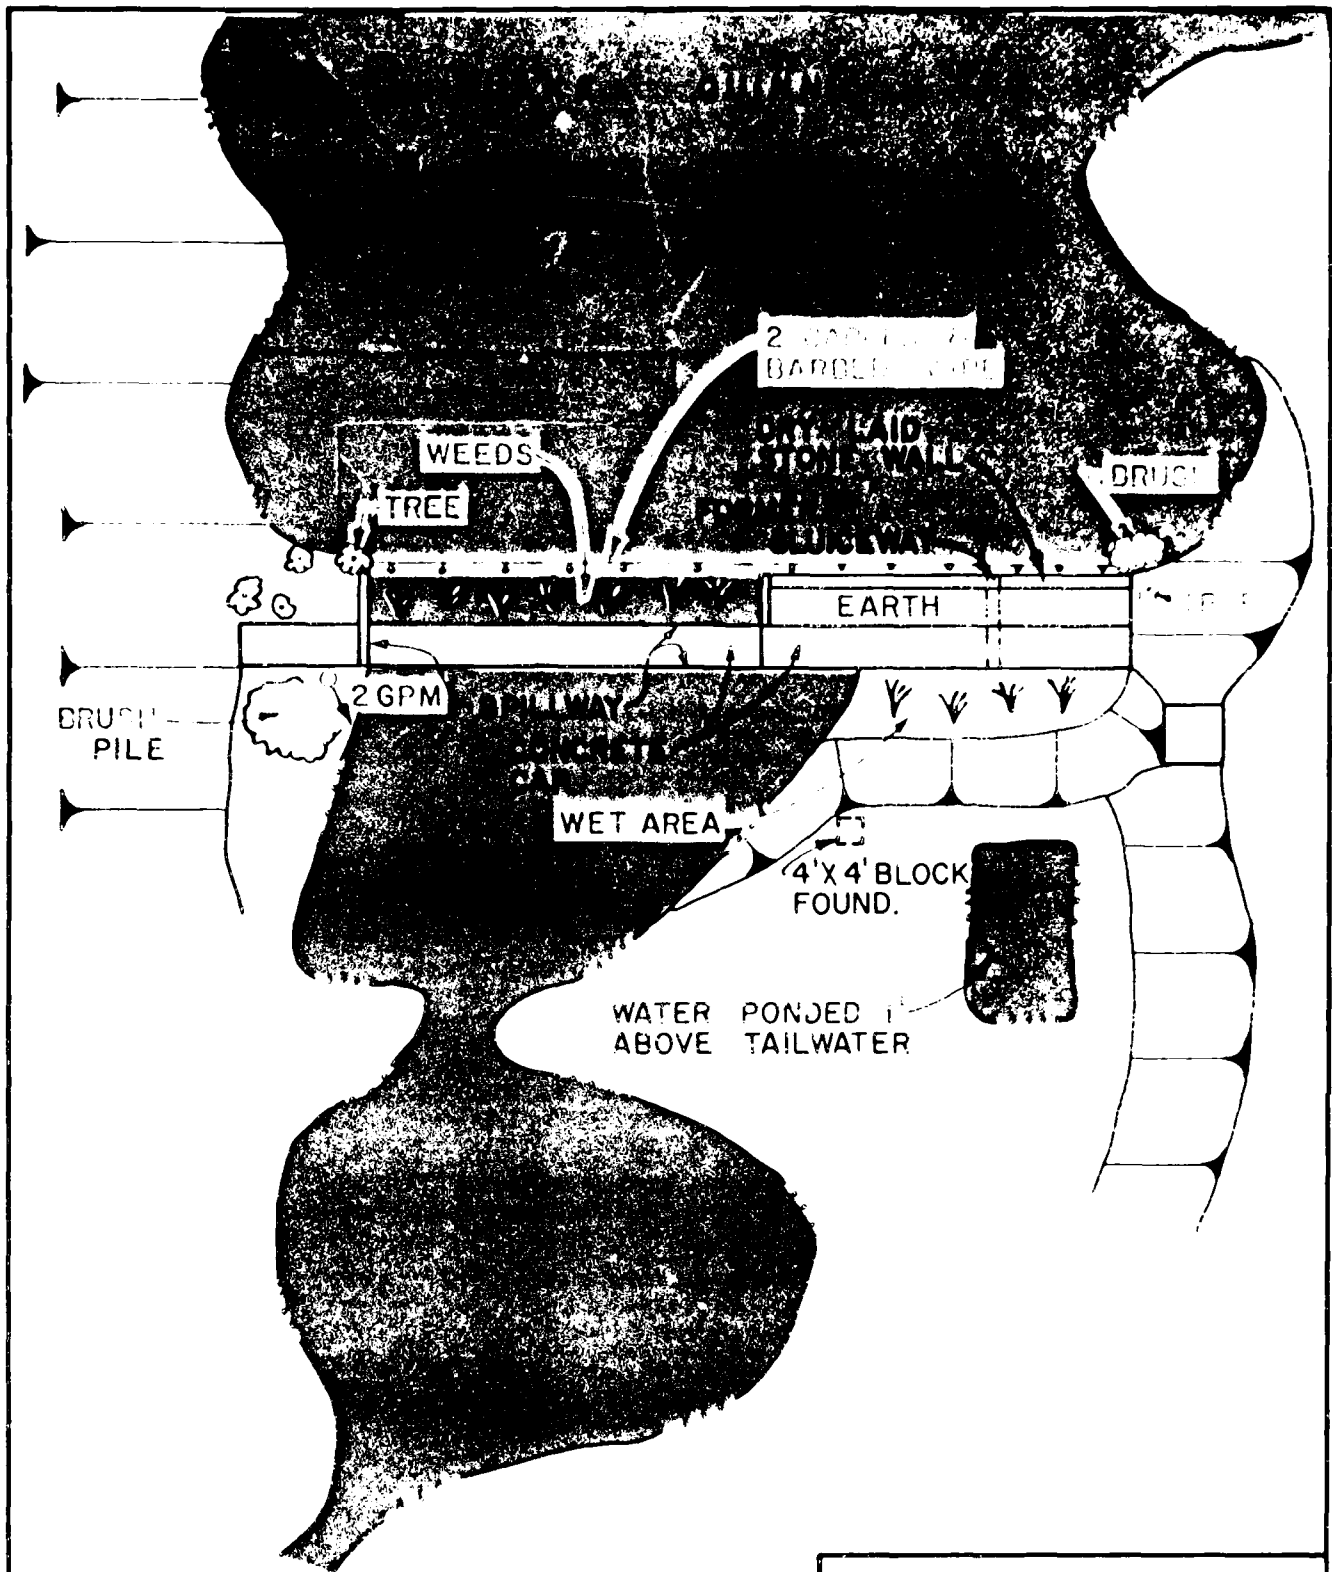
EXHIBIT A 1

Q 2 GPM

INDICATES LOCATION AND QUANTITY OF SEEPAGE
