PENNSYLVANIA
NDI No. PA 01069
PENN DER No. 10-26

TREESDALE FARM DAM

**PHASE I INSPECTION REPORT
NATIONAL DAM INSPECTION PROGRAM**

MARCH 1981

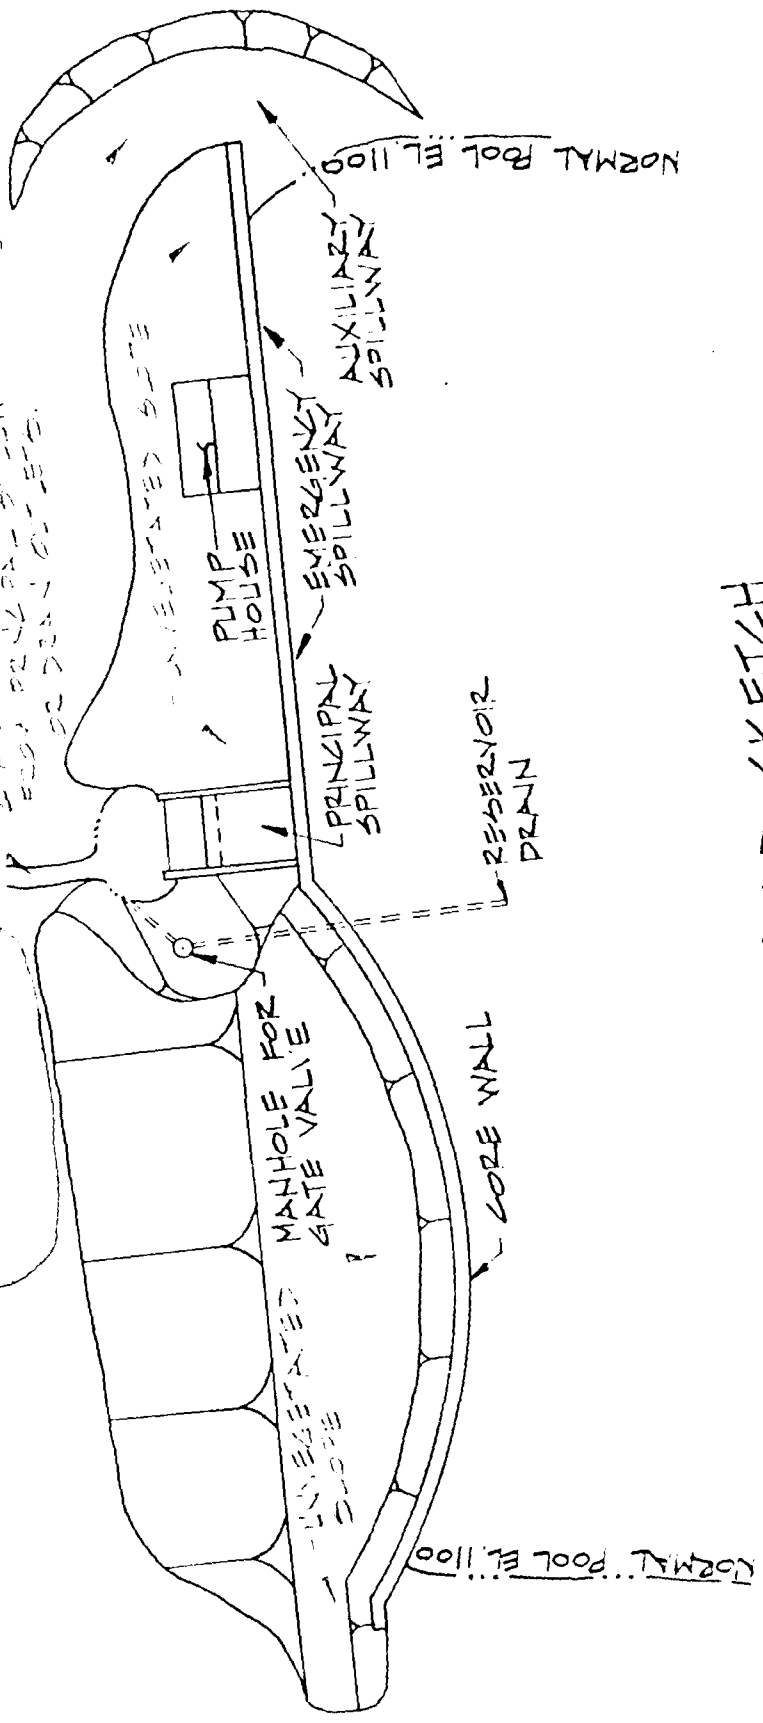
TREESDALE FARM DAM FIELD SKETCH

3. Wet Zones: A wet zone with ponded water was observed below the downstream toe and to the left of the downstream channel. The wet zone is situated in a low lying area and is believed subject to surface runoff from rainfall and springs in the left abutment. A spring emanating from the left abutment was observed and is shown on the field sketch.

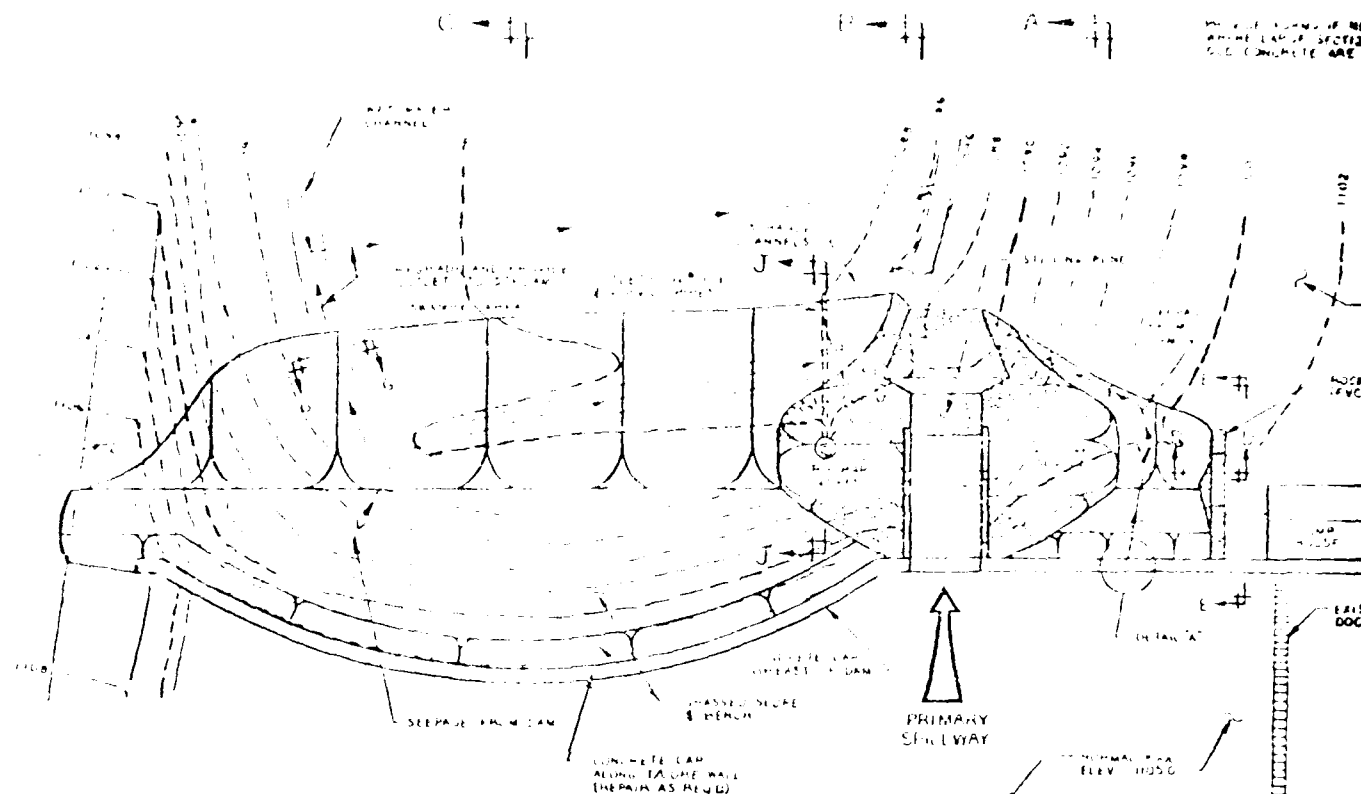
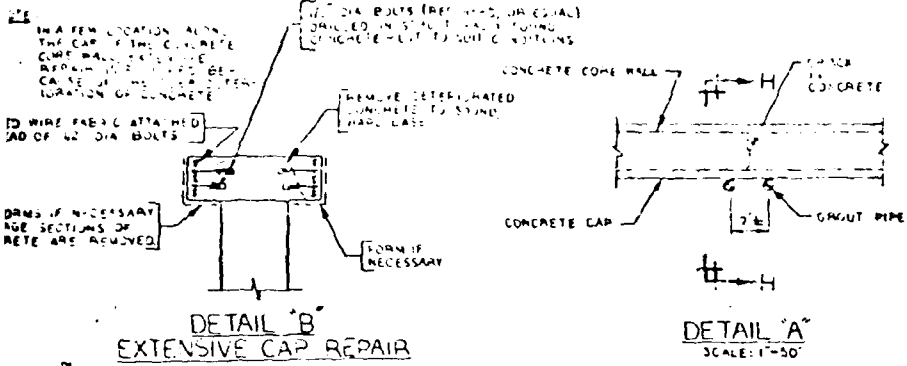
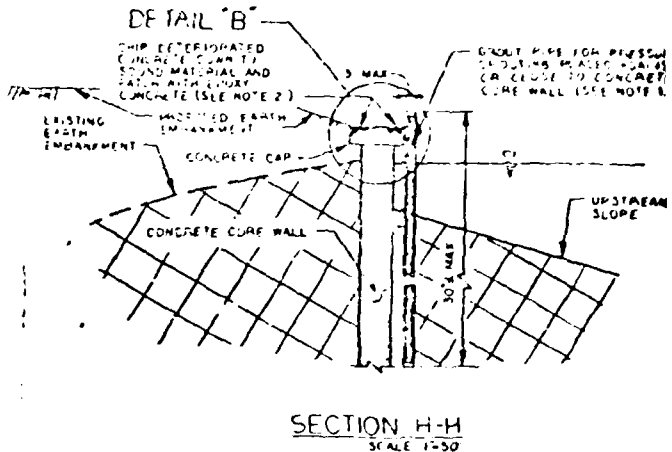
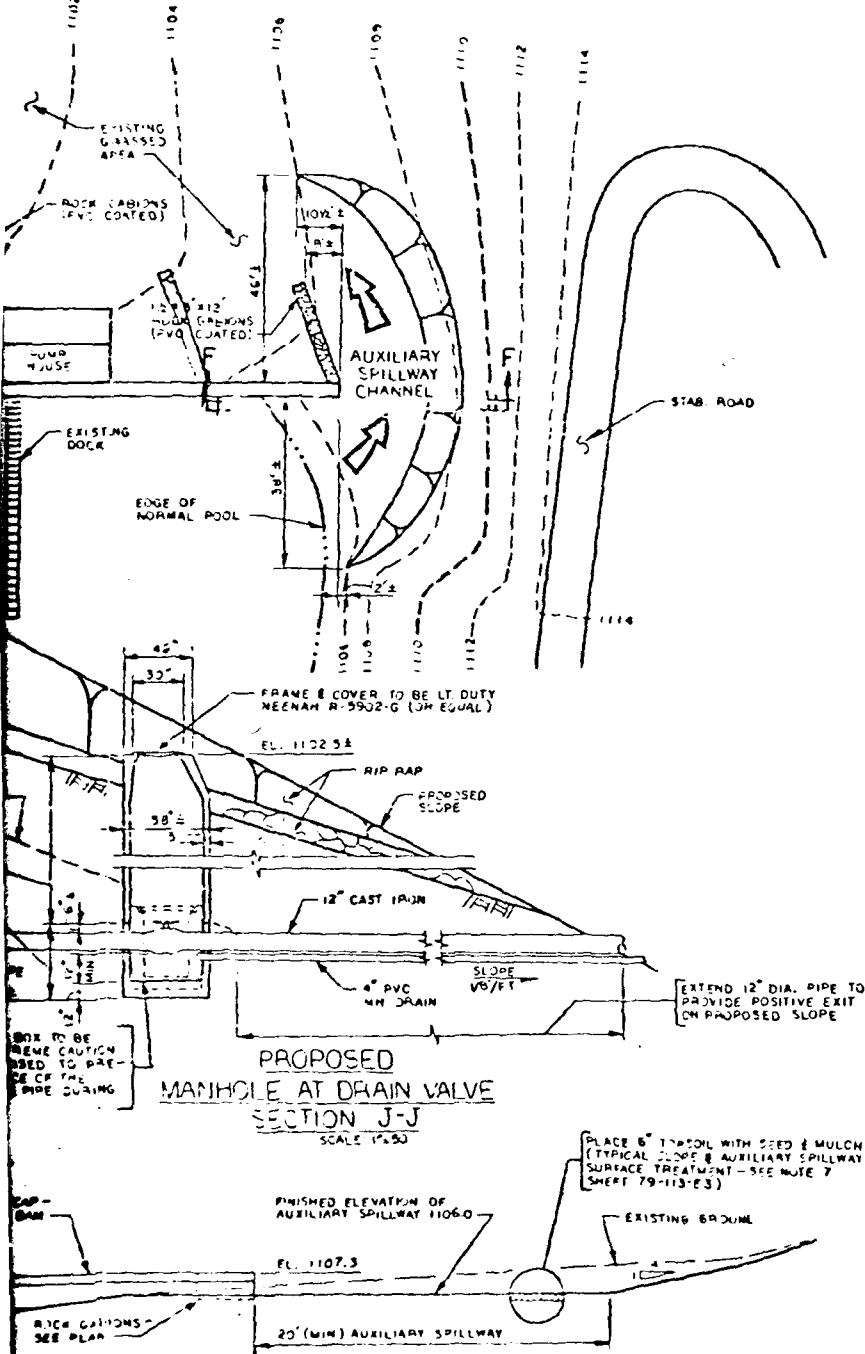
PLAN PROPOSED EMBANKMENT REINFORCEMENT
 SCALE 1:50
 [1" = 40']

The crest of the fill on the downstream slope left of the principal spillway varies from El. 1101.8 to El. 1102.5 rather than El. 1103.5 as proposed (Plate No. 8). Until construction is completed, the dam will have less freeboard than planned. This may or may not be a deficiency, depending upon the results of the hydrologic/hydraulic analysis.

- REINFORCEMENT AND REPAIR OF CONCRETE AND EARTH DAM WITH SPILLWAY**
- Place drill pipes and grout area bould dam (upstream behind cracks) in concrete core-wall as shown in Detail "A".

- Use grout mix of one part Portland Cement with one part water.
 - Pressure-grout each boring from the bottom upward, beginning at toe of rock (or 3 maximum depth of drill hole, whichever occurs first).
