BEAVER RUN, COLUMBIA COUNTY
SUSQUEHANNA RIVER BASIN

MOUNTAIN SHADOW LAKE DAM

NDI ID NO. PA-00244
DER ID NO. 19-80

PHASE I INSPECTION REPORT NATIONAL DAM INSPECTION PROGRAM

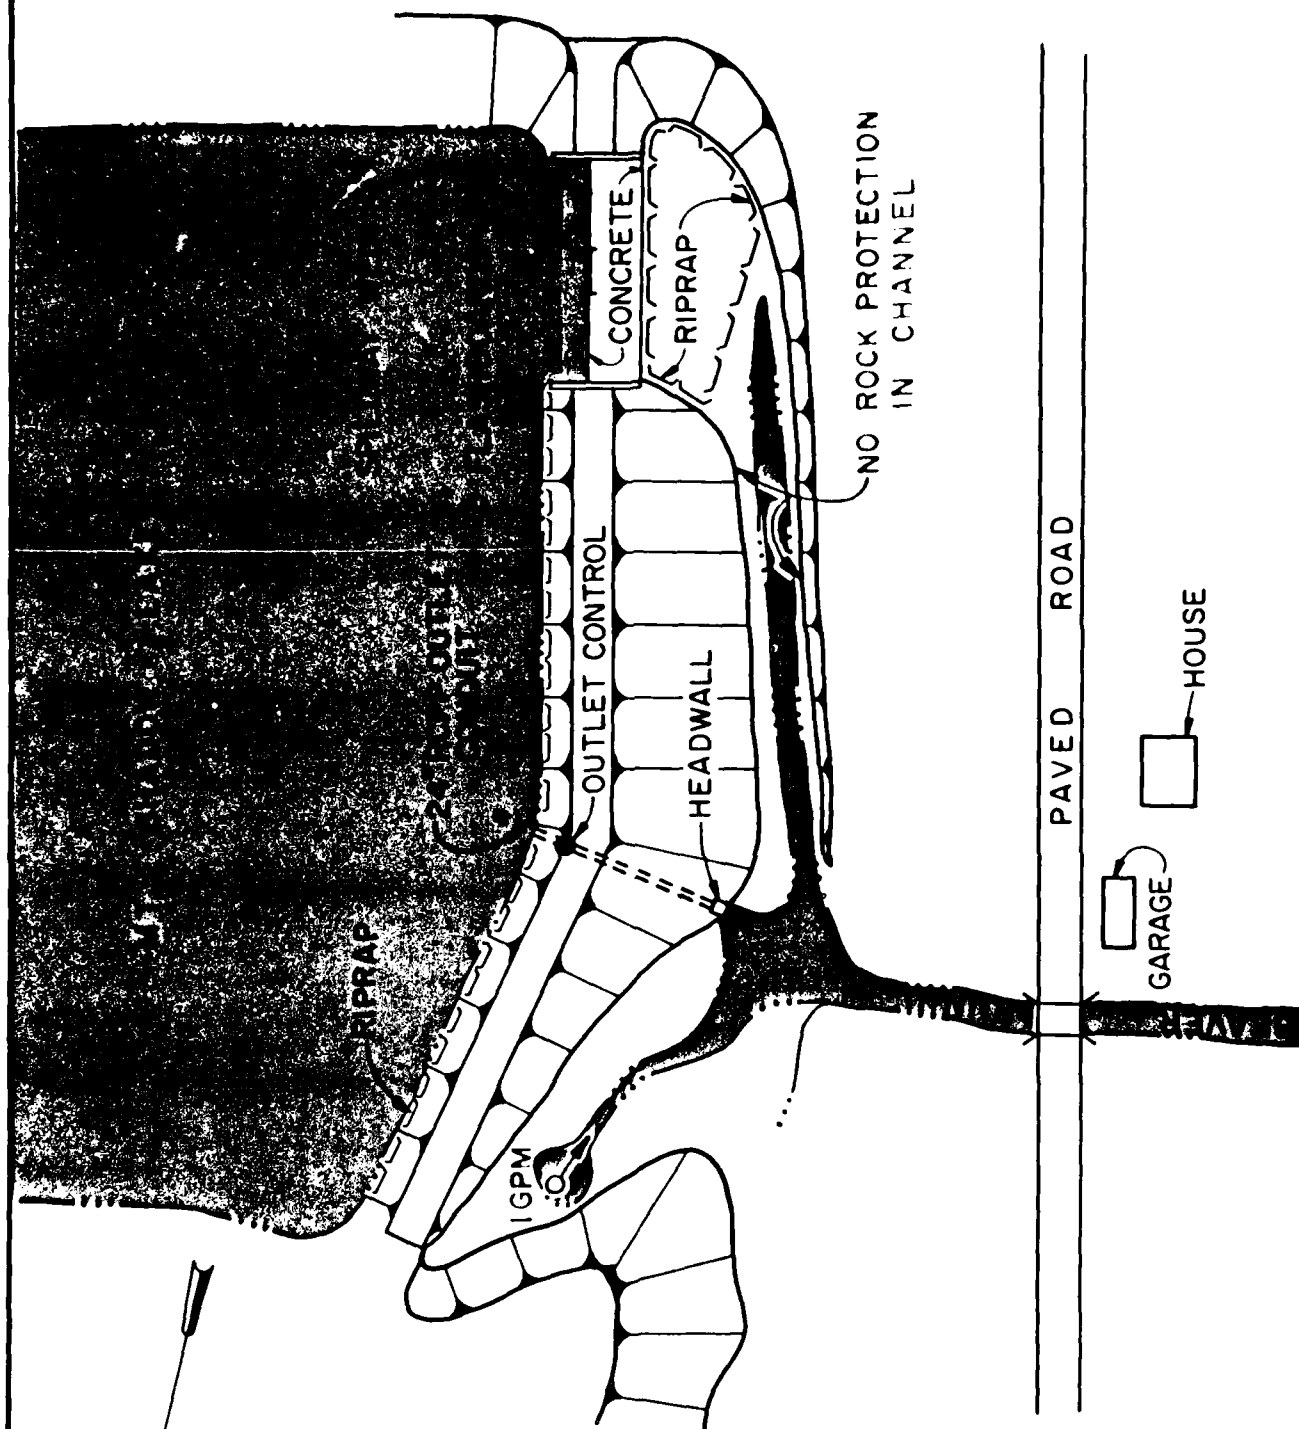
EXHIBIT A-1

None observed. One gpm coming from hillside 20 feet d/s right abutment; source is apparently springs since another spring is about 50 feet away.

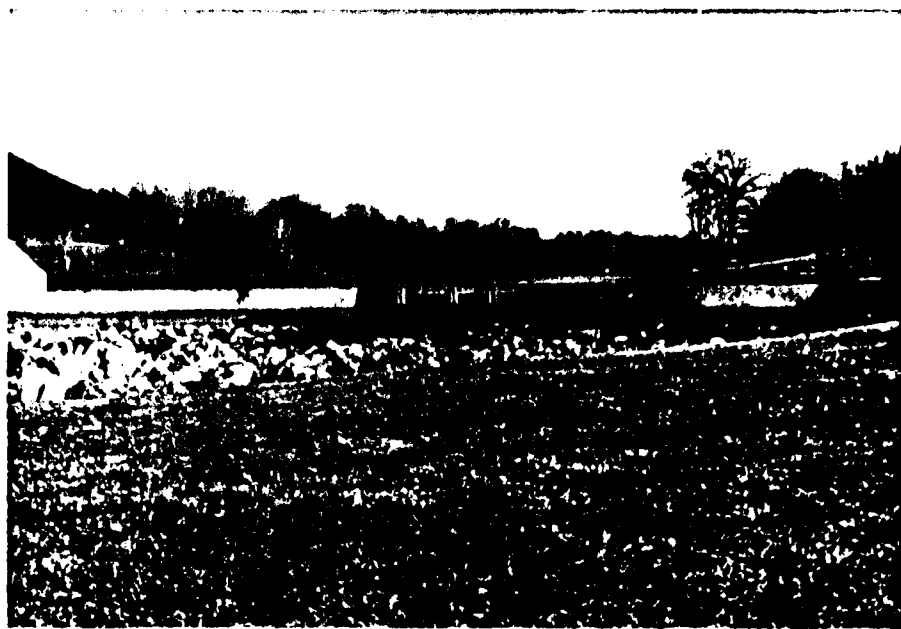
Riprap on upstream face in good condition. Riprap in spillway discharge channel adjacent to toe of dam has been recently pushed out of channel bottom and against left bank.

Rock in good condition in upper part immediately downstream of spillway slab. Channel bends to right, narrows and parallels toe. Rock has been pushed out of channel bottom and from toe of dam to provide protection for left bank of channel.

6. Spritlock cut and open part of discharge channel.

1. The owner should restore the riprap protection for the spillway discharge channel to design condition without delay.

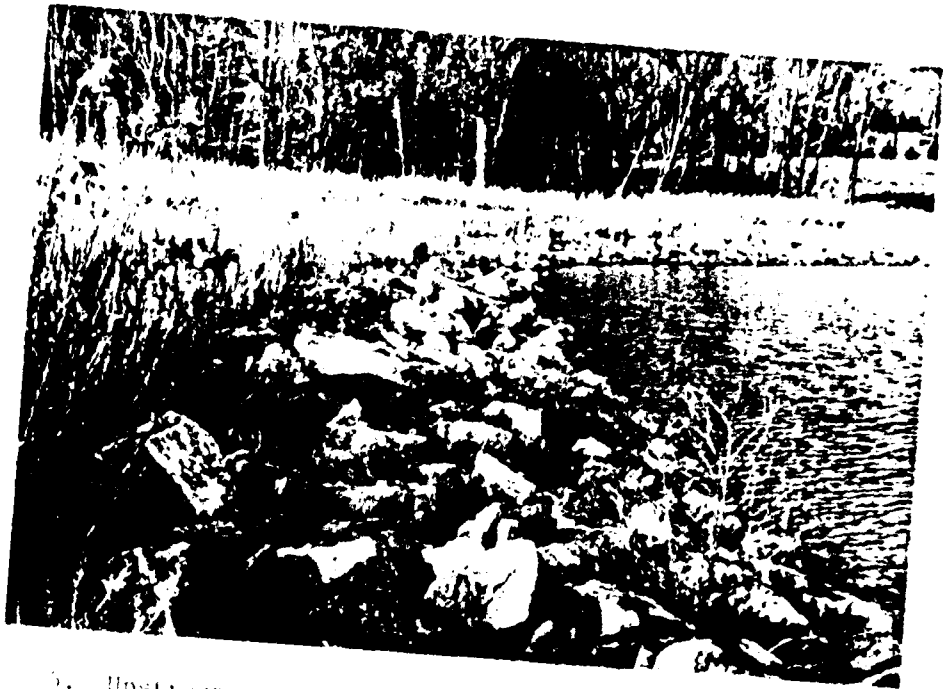
5. Upstream look of confluence.

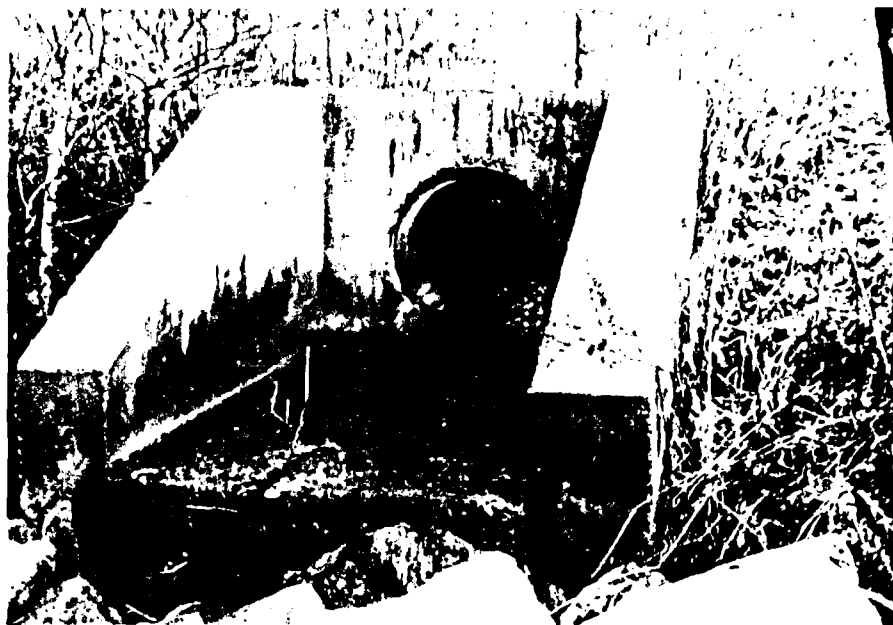
The outlet works consists of a 24-inch diameter reinforced concrete pressure conduit through the dam with a concrete headwall at the discharge end. The intake structure was not observed but the plans show it as a headwall equipped with a trash rack. Flow through the conduit is controlled by a sluice gate which is housed in a manhole that is located in line with the upstream side of the dam crest. The control for the gate is on top of the manhole and is not locked or secured in any manner. The interior of the manhole and the gate proper were not observed. Flow from the outlet drops approximately 8 feet over 12-15 inch riprap at a near vertical slope to the original streambed. The outlet structure and conduit are in good condition.

9. Downstream end of outlet conduit and headwall.

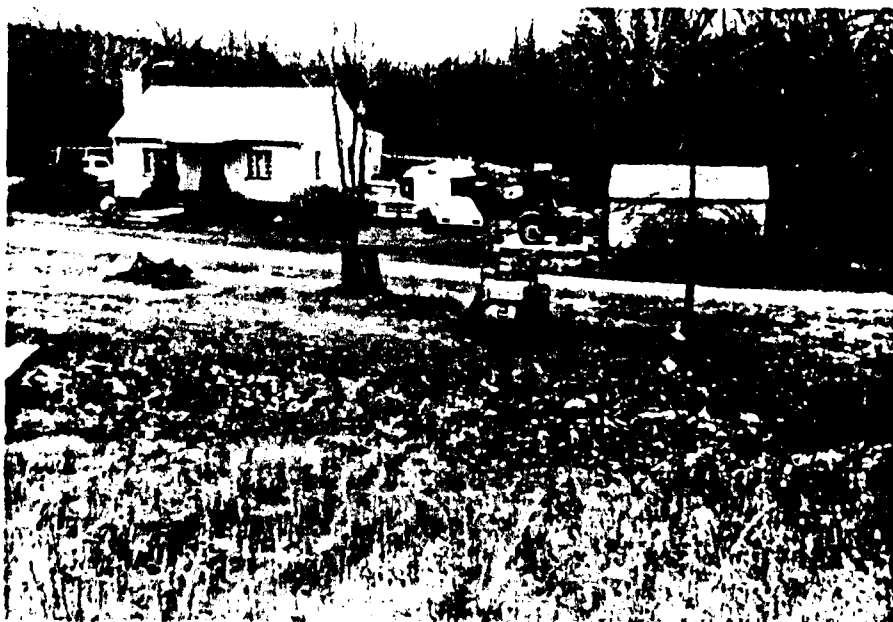
10. Downstream hazard area from top of embankment.

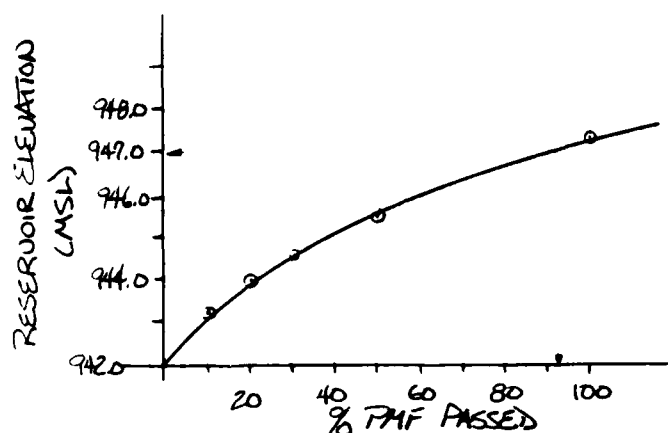
THE DAM AND SPILLWAY
CAN ACCOMMODATE
92% OF PMF PRIOR
TO OVERTOPPING THE
EMBANKMENT.

SINCE THE $SDF = 1/2 PMF$, AND THIS FACILITY CAN ACCOMMODATE 92% OF THE PMF, THE SPILLWAY IS CONSIDERED TO BE ADEQUATE.
