LAKE ONDAWA DAM

NDI ID NO. PA-517

6 National Dam Inspection Report
LAKE ONDAWA DAM

PHASE I REPORT
NATIONAL DAM INSPECTION REPORT

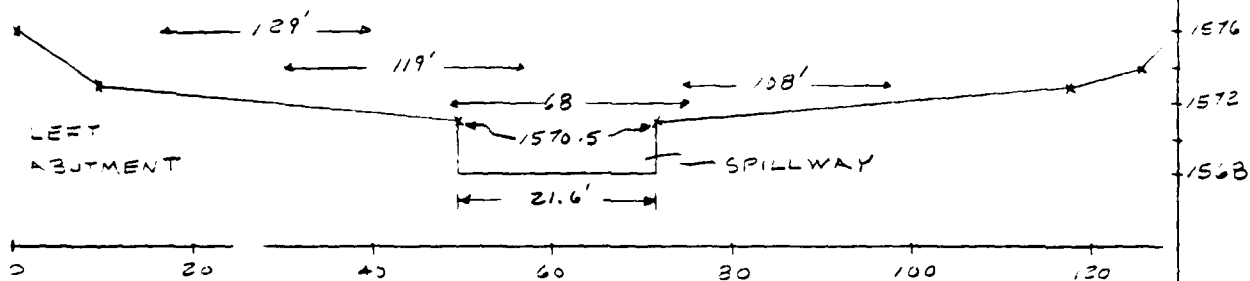
TOP OF DAM PROFILE
VIEWING DOWNSTREAM

RATING CURVE INCLUDES OVERTOPPING.

THE PMF ANALYSIS INDICATES THE DAM IS OVERTOPPED BY 3.45 FEET DURING THE 1/2 PMF. THE DEPTH OF OVERTOPPING AND DURATION IS CONSIDERED SUFFICIENT TO CAUSE FAILURE OF THE STRUCTURE.
