INDIAN LAKE DAM

(NDI I.D. PA-0057

PHASE I INSPECTION REPORT

⑪ 19 Mar 81

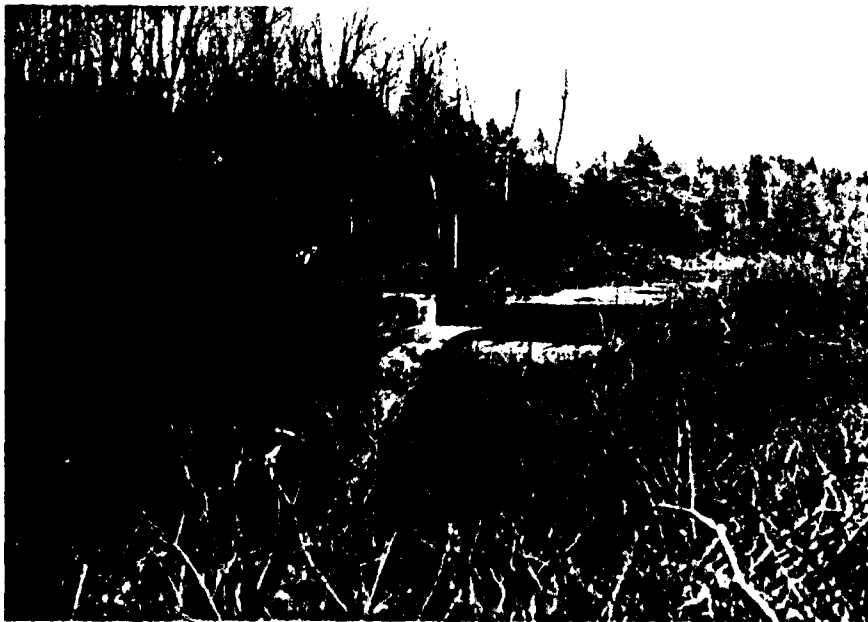
Downstream Face

In general, the condition of the embankment is considered to be poor. Due to thick brush, the downstream slope of the embankment could not be adequately inspected. Other than the generally poor maintenance conditions, no other significant problems with the embankment were observed.

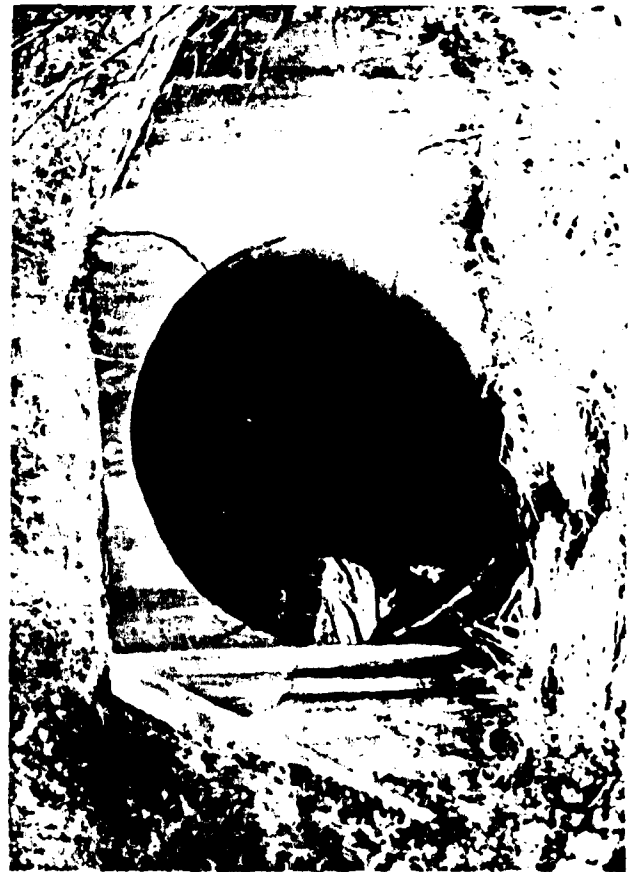
PHOTOGRAPH NO. 7

e. Downstream Channel. The downstream channel flows approximately one-quarter mile to a highway and through a 13-foot-diameter culvert. Further description of the downstream conditions is included in Section 1.2 d.
