D'APPOLONIA CONSULTING ENGINEERS INC PITTSBURGH PA  
NATIONAL DAM INSPECTION PROGRAM. COOKS POND DAM (NDI I.O. PA-00--ETC(U)  
1981

PHASE I REPORT  
NATIONAL DAM INSPECTION PROGRAM

NAME OF DAM: Cooks Pond Dam  
STATE LOCATED: Pennsylvania  
COUNTY LOCATED: Bradford  
STREAM: North Branch of Beaver Creek  
SIZE CLASSIFICATION: Small  
HAZARD CLASSIFICATION: High  
OWNER: Mr. E. W. Manchester  
DATE OF INSPECTION: November 15, 1980 and February 4, 1981

COOKS POND DAM  
NDI I.D. PA-0041  
DER I.D. 008-035  
NOVEMBER 15, 1980

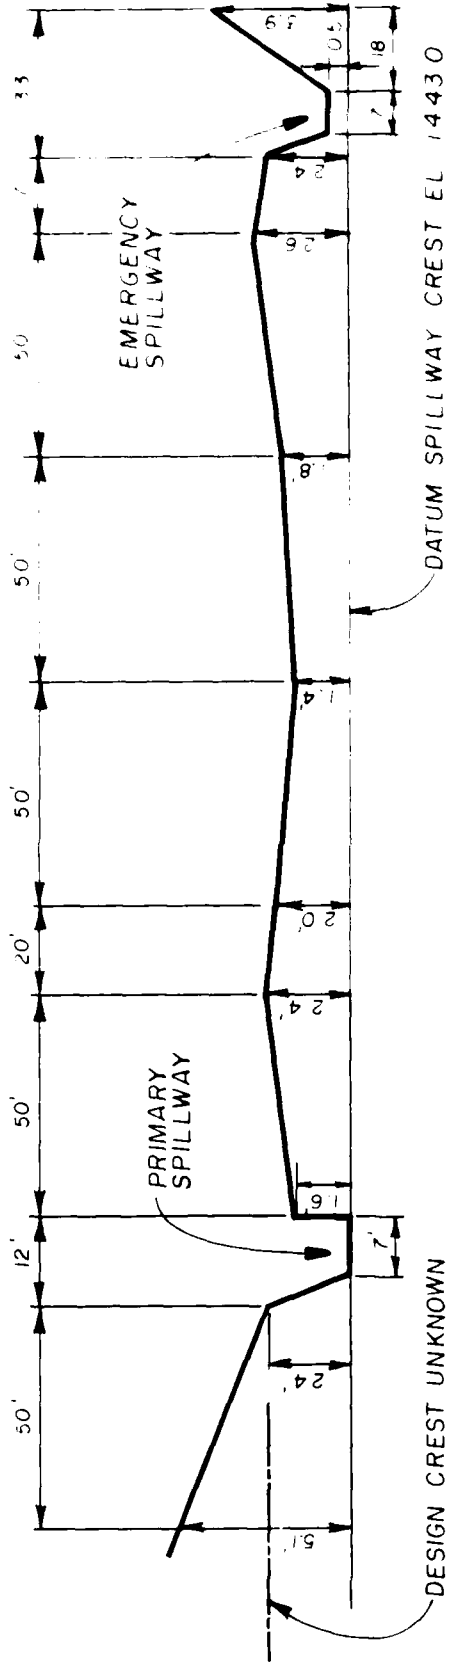
**DAM CREST PROFILE**  
(LOOKING DOWNSTREAM)

The crest of the dam was surveyed relative to the spillway crest elevation and was found to have vertical irregularities. The crest slopes downward to the center of the embankment to approximately one foot below the crest level near the left and right abutments. The dam crest profile is illustrated in Plate 3.

3.2 Evaluation. The condition of the dam is considered to be poor. The middle of the embankment appears to have settled up to one foot below the levels near the left and right abutments. The dry masonry wall near the center of the dam is bulging downstream. The toe of the wall is swampy, which may further affect its stability. The emergency spillway lacks any erosion protection. In view of these conditions, repair and restoration of the dam is required.
