SHARPE'S POND DAM

(NDI I.D. PA-0888

PHASE I INSPECTION REPORT

NATIONAL DAM INSPECTION PROGRAM

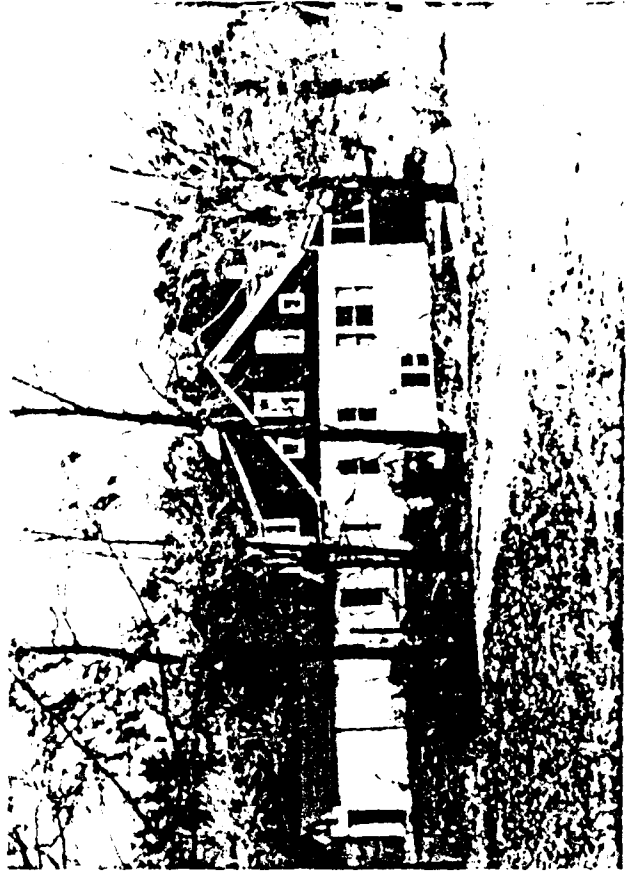
PHOTOGRAPH NO 8

stream flows under two road embankments then discharges into Negro Pond (DER I.D. 066-010) about 1,000 feet further downstream. In this reach, two homes are located within the potential floodplain in the event of a dam failure. In particular, a home 500 feet from the dam is built very close to the streambed and is likely to receive significant damage. It is estimated that failure of the dam could cause loss of more than a few lives at the two downstream houses.
